## PROPERTY INSPECTION REPORT

**Prepared For:** John Doe  
(Name of Client)

**Concerning:** 123 Inspection Way, TX  
(Address or Other Identification of Inspected Property)

# GreenWorks Inspections

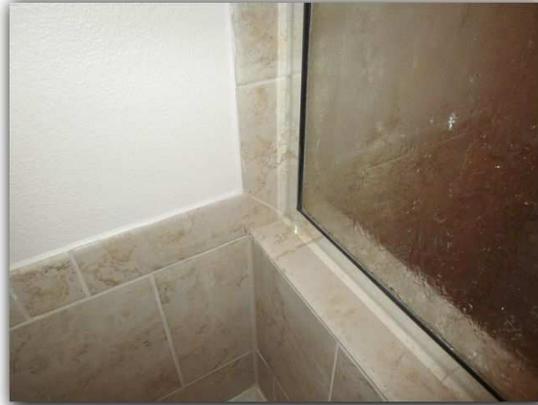
D - The guest bathroom shower enclosure leaks water when the shower is in use. (Picture Below)

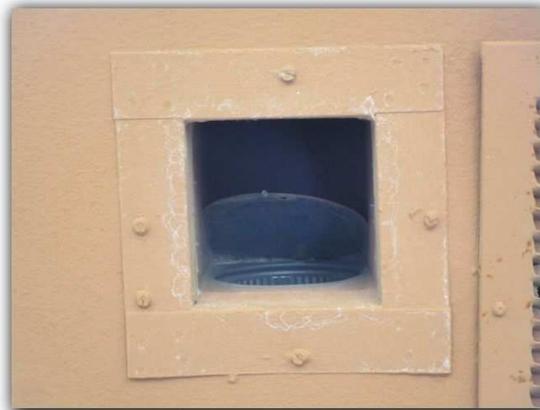
D – The dryer vent flap is stuck in the open position. (Picture Below)

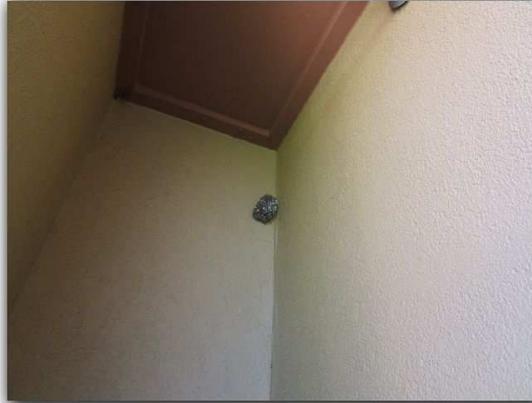
There were wasps and wasp nests observed at the exterior of the home.
