Project No. 18451

April 9, 2020

Re: Foundation Evaluation

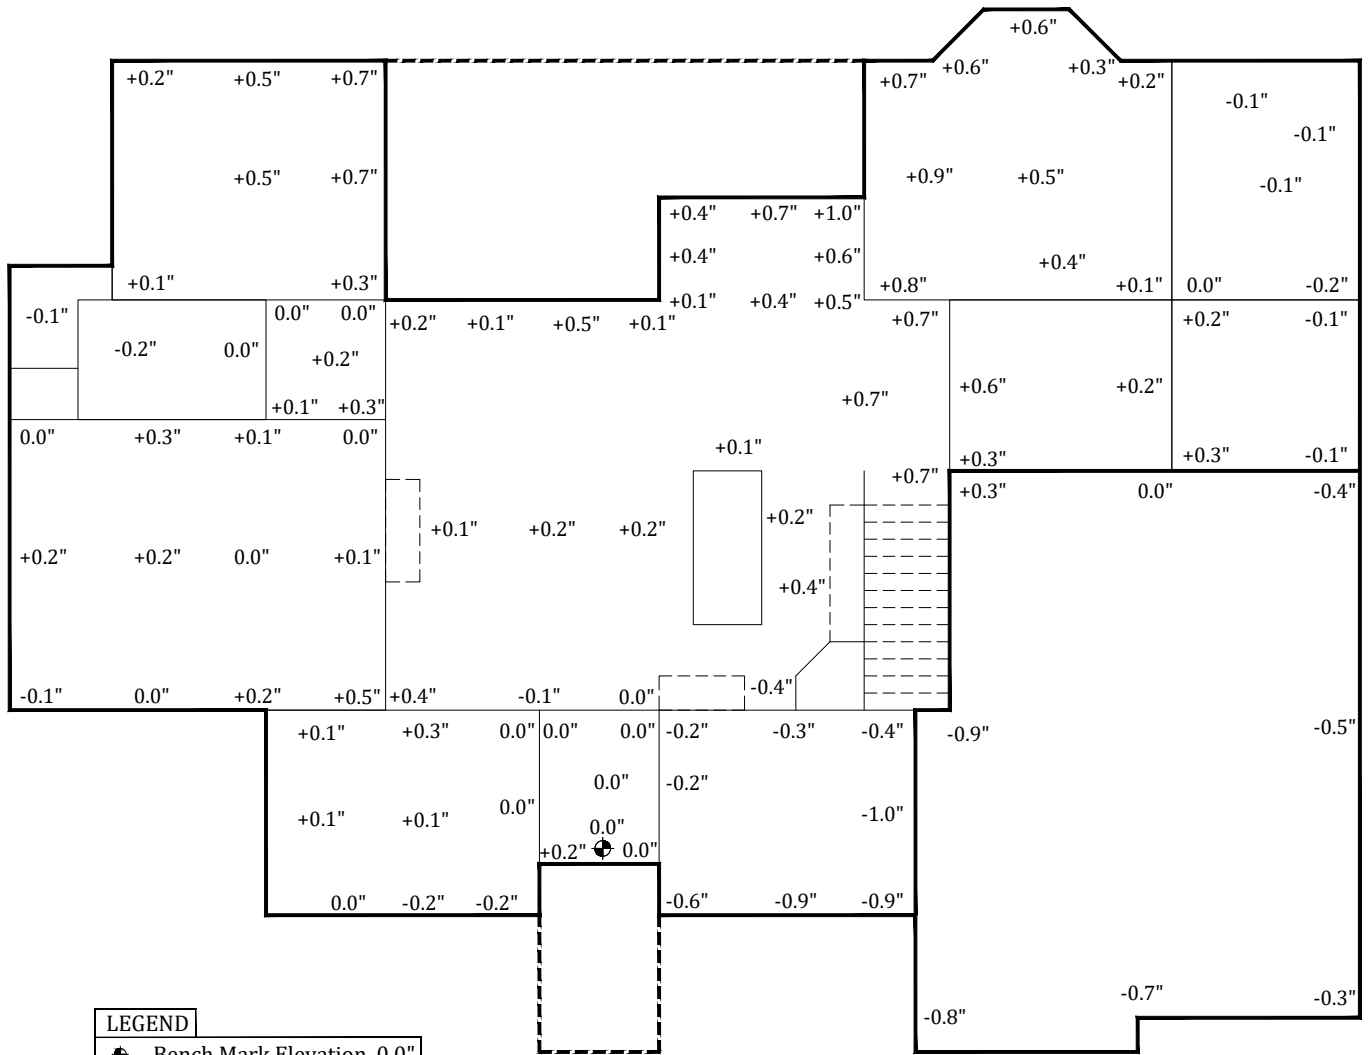
FIGURE 1

An interior floor elevation survey was performed on the living area of the house, with the elevations recorded to the nearest 10th of an inch (0.1"). Adjustments were made to account for the thickness of the floor coverings. A benchmark elevation of 0.0 inches was established near the south wall at the entry as shown in Figure 1 of this report.

Based on our observations of the interior and exterior cosmetic distress, the floor elevations and calculations, it is our opinion that the house has undergone a permissible amount of movement. The maximum differential deflection is 0.4 inches and occurred over an approximate distance of 11.3 feet. This amount of deflection is within the standard allowable deflection of 0.4 inches for a distance of 11.3 feet. The standard allowable differential deflection is based on 1.0 inch of vertical movement, up or down, over a horizontal distance of 30 feet; expressed as Length (in inches)/ 360.
