Project No. 18553

April 21, 2020

Re: Foundation Evaluation

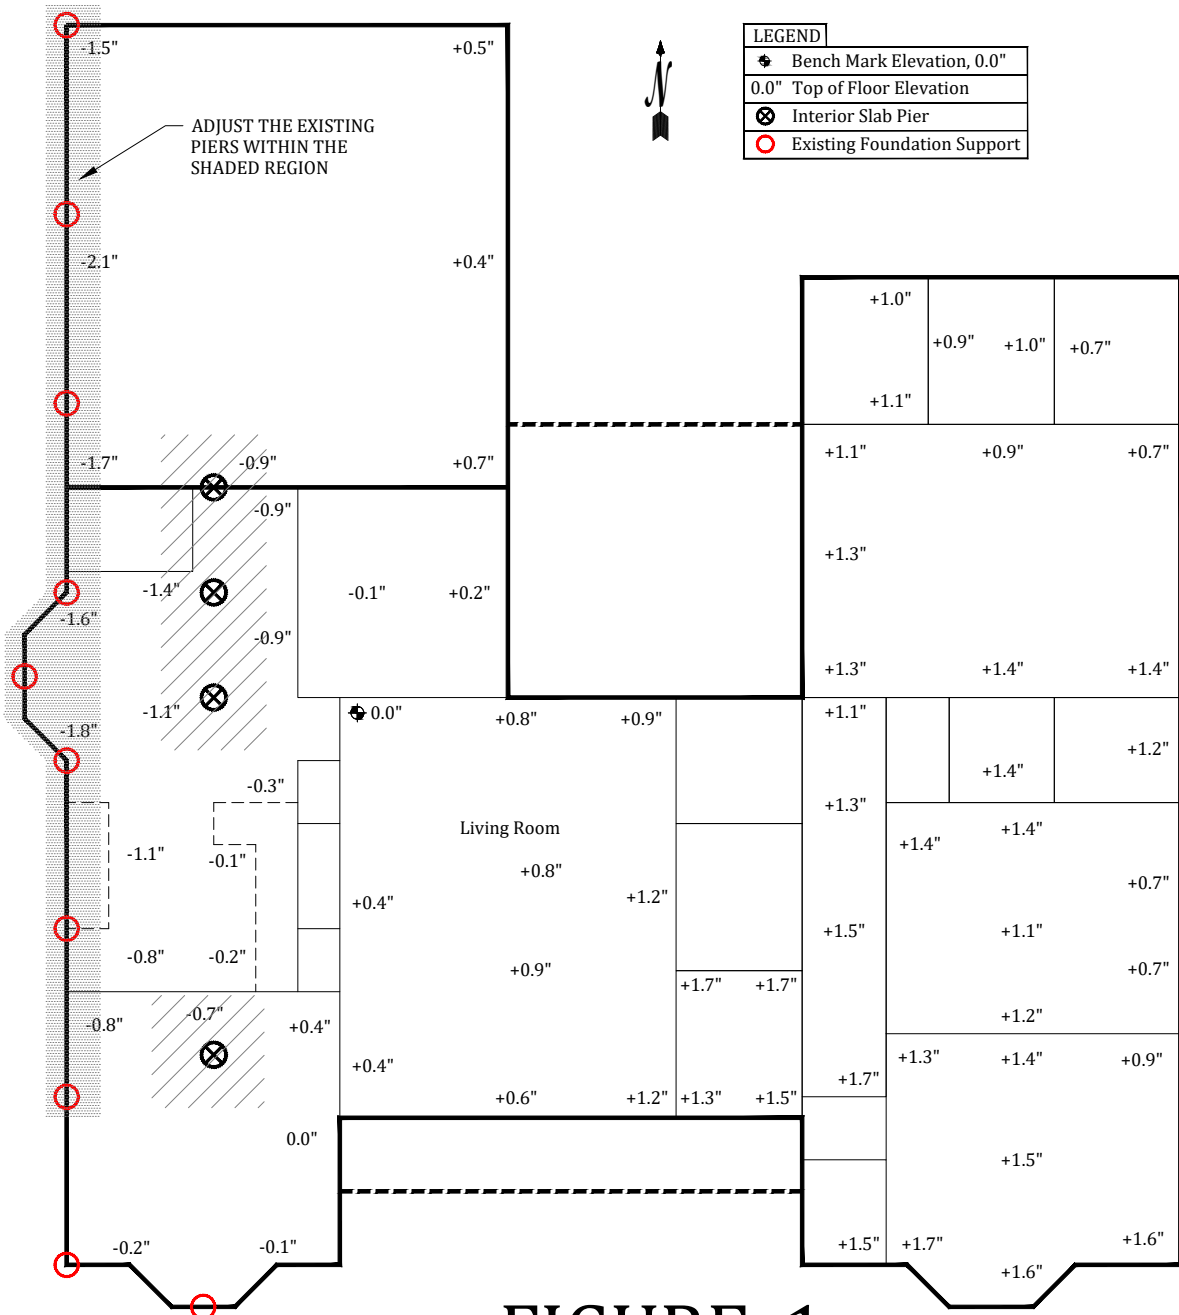
FIGURE 1

An interior floor elevation survey was performed on the living area of the house, with the elevations recorded to the nearest 10th of an inch (0.1"). Adjustments were made to account for the thickness of the floor coverings. A benchmark elevation of 0.0 inches was established near the northwest corner of the living room as shown in Figure 1 of this report.

The existing foundation has had foundation underpinning in the past. Per the copy of the repair plan by [REDACTED] (10) perimeter foundation piers were installed approximately 19 years ago, according to the current homeowner. Refer to Figure 1 of this report for approximate locations of the [REDACTED] piers. The exact location of the existing piers, the depth and type used is not known.

Based on our observations of the interior and exterior cosmetic distress, the floor elevations and calculations, it is our opinion that the house has undergone an excessive amount of movement. The maximum differential deflection is 0.5 inches and occurred over an approximate distance of 10.5 feet. This amount of deflection exceeds the standard allowable deflection of 0.3 inches for a distance of 10.5 feet. The standard allowable differential deflection is based on 1.0 inch of vertical movement, up or down, over a horizontal distance of 30 feet; expressed as Length (in inches)/ 360.

- 1) Adjust (8) existing perimeter piers as required to stabilize and lift the perimeter foundation wall. Refer to Figure 1 of this report for the approximate location of the piers to be adjusted. Note, any foundation movement, even corrective movement, can cause additional cosmetic distress.

- 2) To achieve an approximate level condition of the interior floor, install (4) interior piles or drilled piers as shown on Figure 1 of this report. The piles can be concrete cylinders, steel pipe, or helical screws. Refer to Figures 2, 3, 4, and 5 of this report. Space the piles or drilled piers within the interior at a maximum of 5 feet on-center.
