Project No. 18742

April 24, 2020

Re: Foundation Evaluation

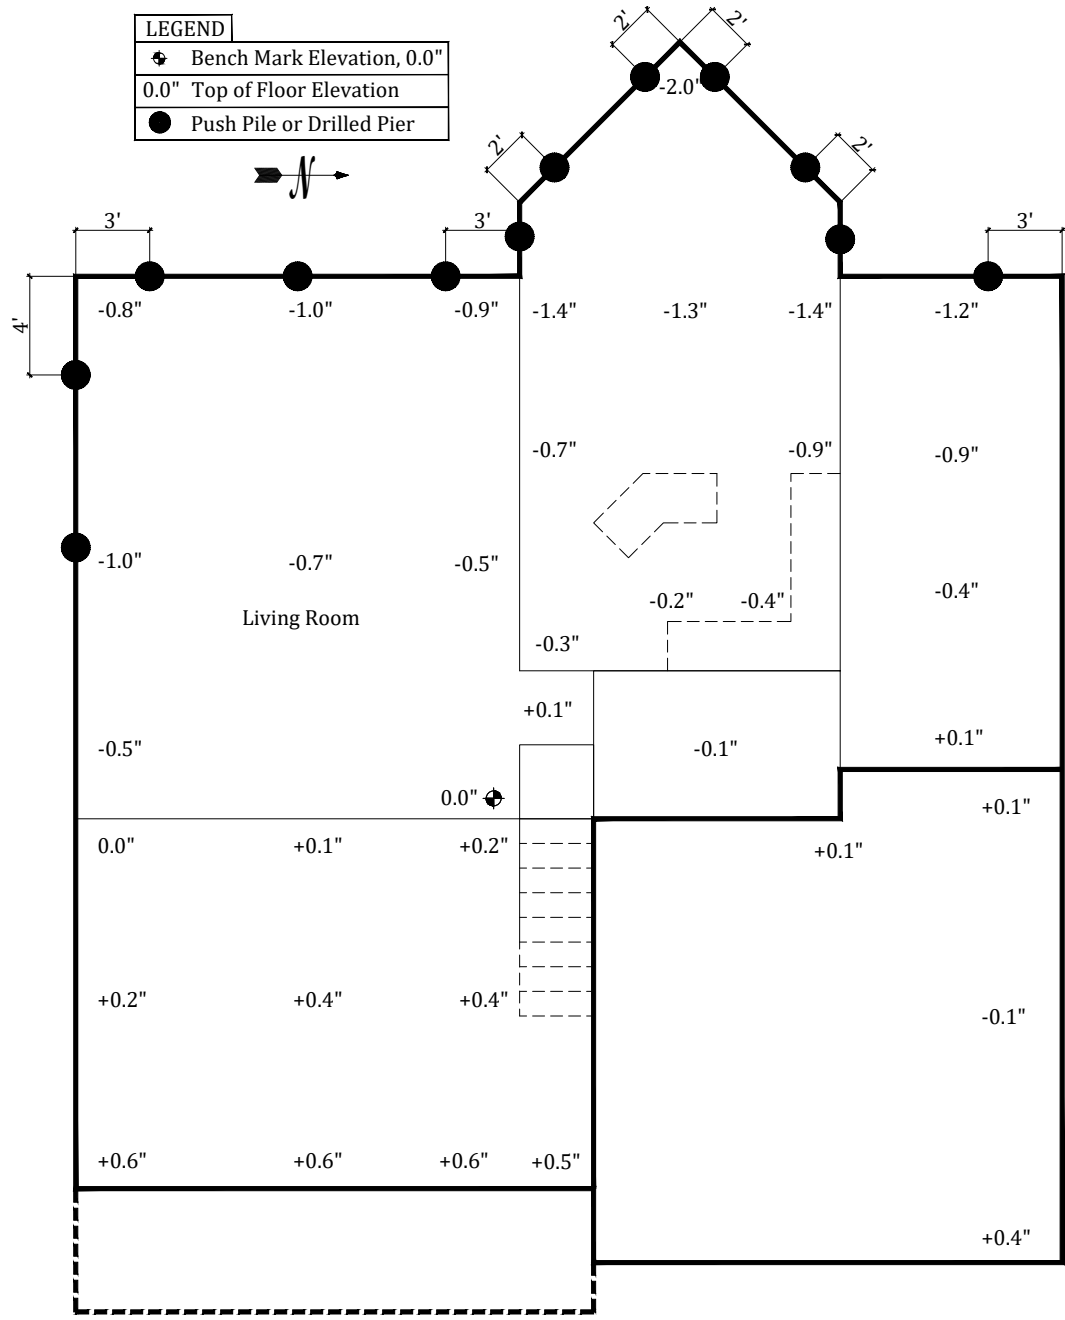
**FIGURE 1**

An interior floor elevation survey was performed on the living area of the house, with the elevations recorded to the nearest 10<sup>th</sup> of an inch (0.1"). Adjustments were made to account for the thickness of the floor coverings. A benchmark elevation of 0.0 inches was established near the northeast corner of the living room as shown in Figure 1 of this report.

Based on our observations of the interior and exterior cosmetic distress, the floor elevations and calculations, it is our opinion that the house has undergone an excessive amount of movement. The maximum differential deflection is 0.4 inches and occurred over an approximate distance of 10.0 feet. This amount of deflection exceeds the standard allowable deflection of 0.3 inches for a distance of 10.0 feet. The standard allowable differential deflection is based on 1.0 inch of vertical movement, up or down, over a horizontal distance of 30 feet; expressed as Length (in inches)/ 360.

- 1) To stabilize and lift the perimeter foundation wall, install (12) perimeter piles or drilled piers as shown on Figure 1 of this report. The piles can be concrete cylinders, steel pipe, or helical screws. Refer to Figures 2, 3, 4, and 5 of this report. Space the piles or drilled

- piers along the perimeter foundation at a maximum of 7 feet on-center. Note, any foundation movement, even corrective movement, can cause additional cosmetic distress.
