Project No. 18774

April 28, 2020

Re: Foundation Evaluation

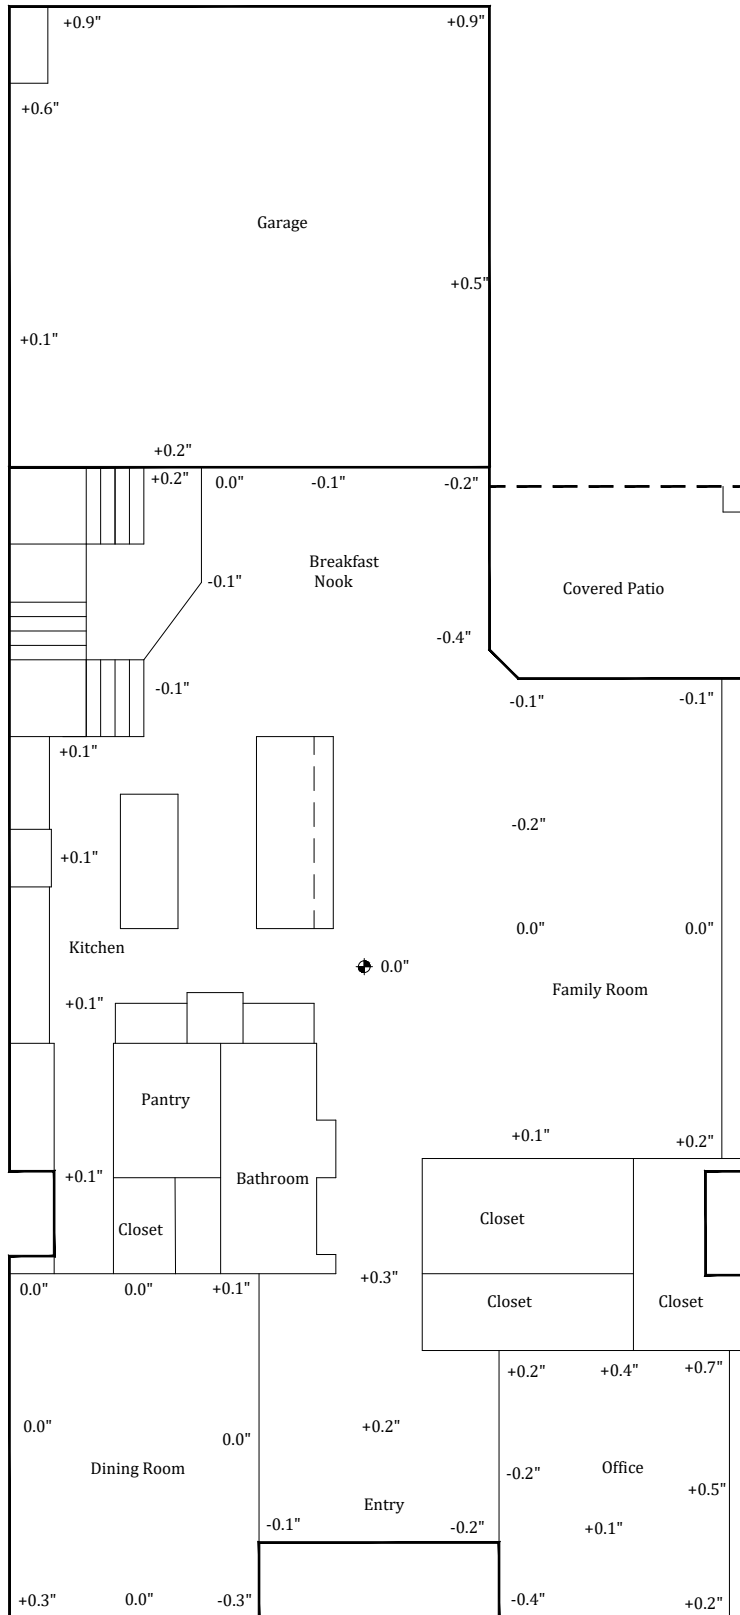
FIGURE 1
NOT TO SCALE

An interior floor elevation survey was performed on the living area of the house, with the elevations recorded to the nearest 10th of an inch (0.1"). Adjustments were made to account for the thickness of the floor coverings. A benchmark elevation of 0.0 inches was established near the northeast corner of the kitchen as shown in Figure 1 of this report.

Based on our observations of the interior and exterior cosmetic distress, the floor elevations and calculations, it is our opinion that the house appears to be in relatively good condition. The maximum differential deflection is 0.5 inches and occurred over an adjusted distance of 25.3 feet. This amount of deflection exceeds the standard allowable deflection of 0.8 inches for a distance of 25.3 feet. The standard allowable differential deflection is based on 1.0 inch of vertical movement, up or down, over a horizontal distance of 30 feet; expressed as Length (in inches)/ 360.

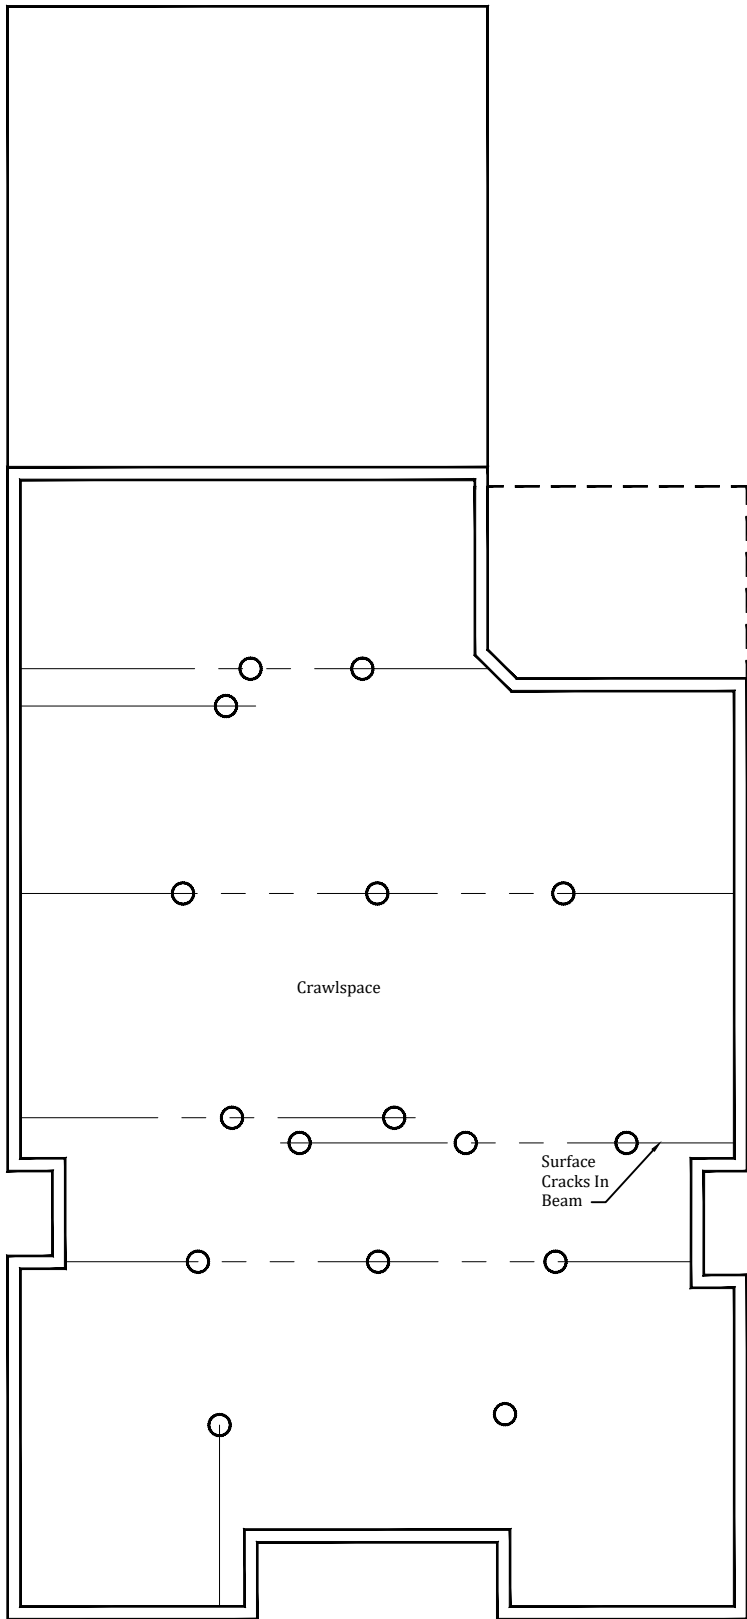
FIGURE 2
NOT TO SCALE

- Plywood shims
- Horizontal cracks in the LVL floor beam

Furthermore, it is our opinion that foundation is within the standard allowable deflection and remedial measures are not required. Note, the floor beam, in the crawlspace, with the horizontal cracks appears to be structurally capable of supporting the anticipated loads and a repair is not required.

- 1) It is recommended that all wood shims be replaced with metal shims due to the wood shims being susceptible to expansion from humidity and can be damaged over the years.
- 2) Interior cracks and separations can be repaired, and exterior separations can be sealed with an elastic silicone caulk. The areas that were void of mortar do not require a repair due to the small size of the voided areas.
- 3) It is recommended, as a proactive maintenance program, to review the performance of the foundation every 6 to 12 months. Retain this report as an elevation baseline for the foundation. Compare all future foundation evaluations to this baseline.
