Project No. 18950

April 30, 2020

Re: Foundation Evaluation

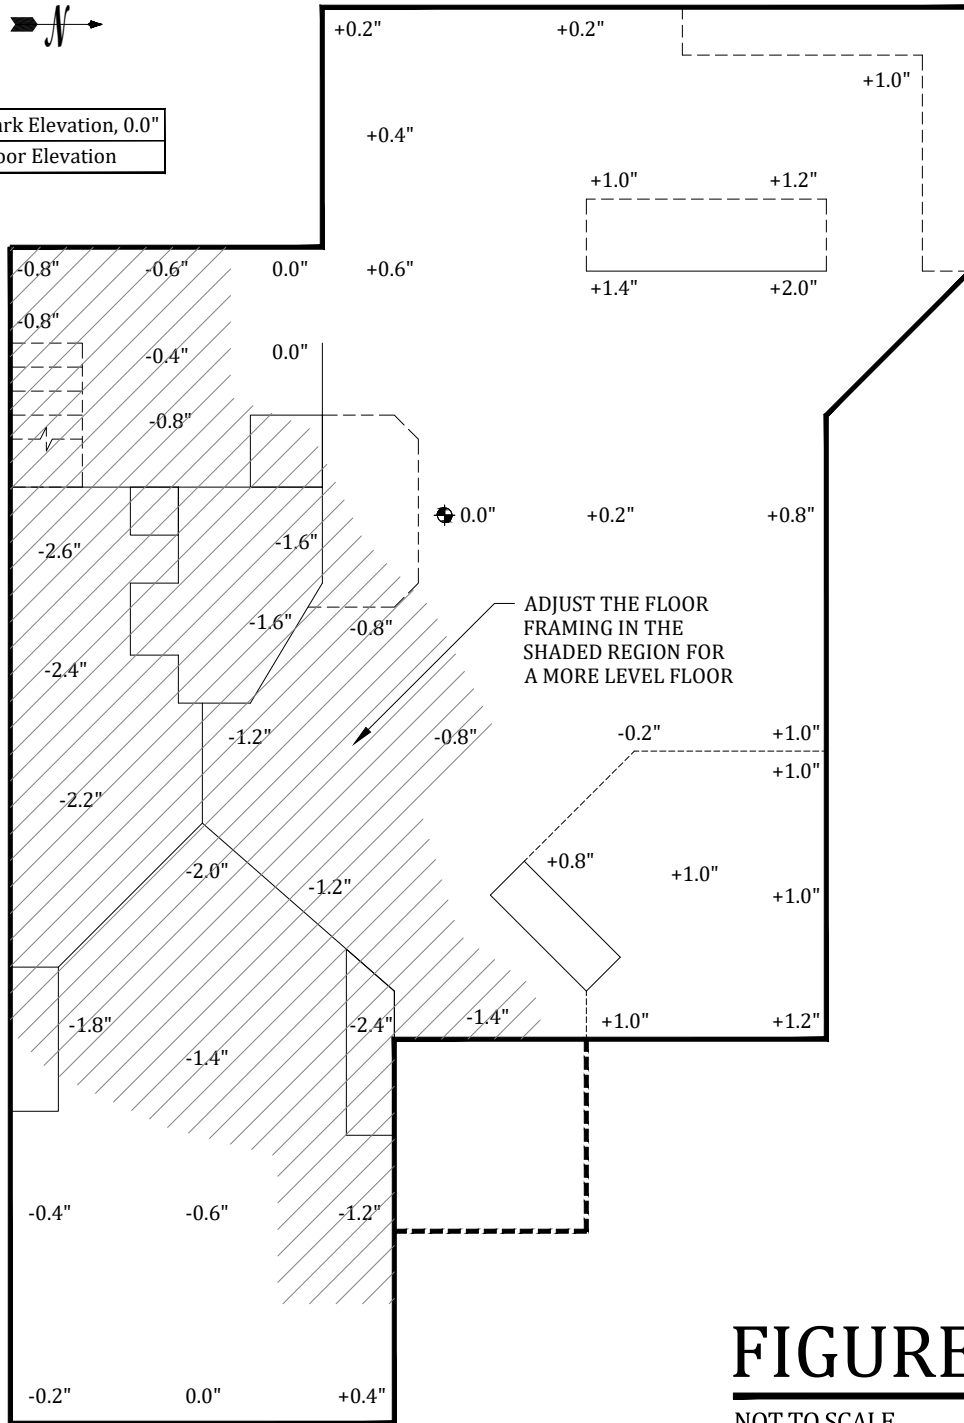
**FIGURE 1**

An interior floor elevation survey was performed on the living area of the house, with the elevations recorded to the nearest 10<sup>th</sup> of an inch (0.1”). Adjustments were made to account for the thickness of the floor coverings. A benchmark elevation of 0.0 inches was established near the fireplace on the south side of the living room as shown in Figure 1 of this report.

Based on our observations of the interior and exterior cosmetic distress, the floor elevations and calculations, it is our opinion that the house has undergone an excessive amount of movement. The maximum differential deflection is 2.1 inches and occurred over an approximate distance of 22.3 feet. This amount of deflection exceeds the standard allowable deflection of 0.7 inches for a distance of 22.3 feet. The standard allowable differential deflection is based on 1.0 inch of vertical movement, up or down, over a horizontal distance of 30 feet; expressed as Length (in inches)/ 360.

- 1) Adjust the crawlspace piers/wood framing as required, using metal shims, to achieve a more level condition on the south side of the house. It is recommended that all wood shims be replaced with metal shims due to the wood shims can be damaged over the years. Note, the height of the metal shims should not exceed 2 inches. The use of additional concrete blocks shall be required.
- 2) Install metal shims where the wood beam is not in contact with the concrete pier.

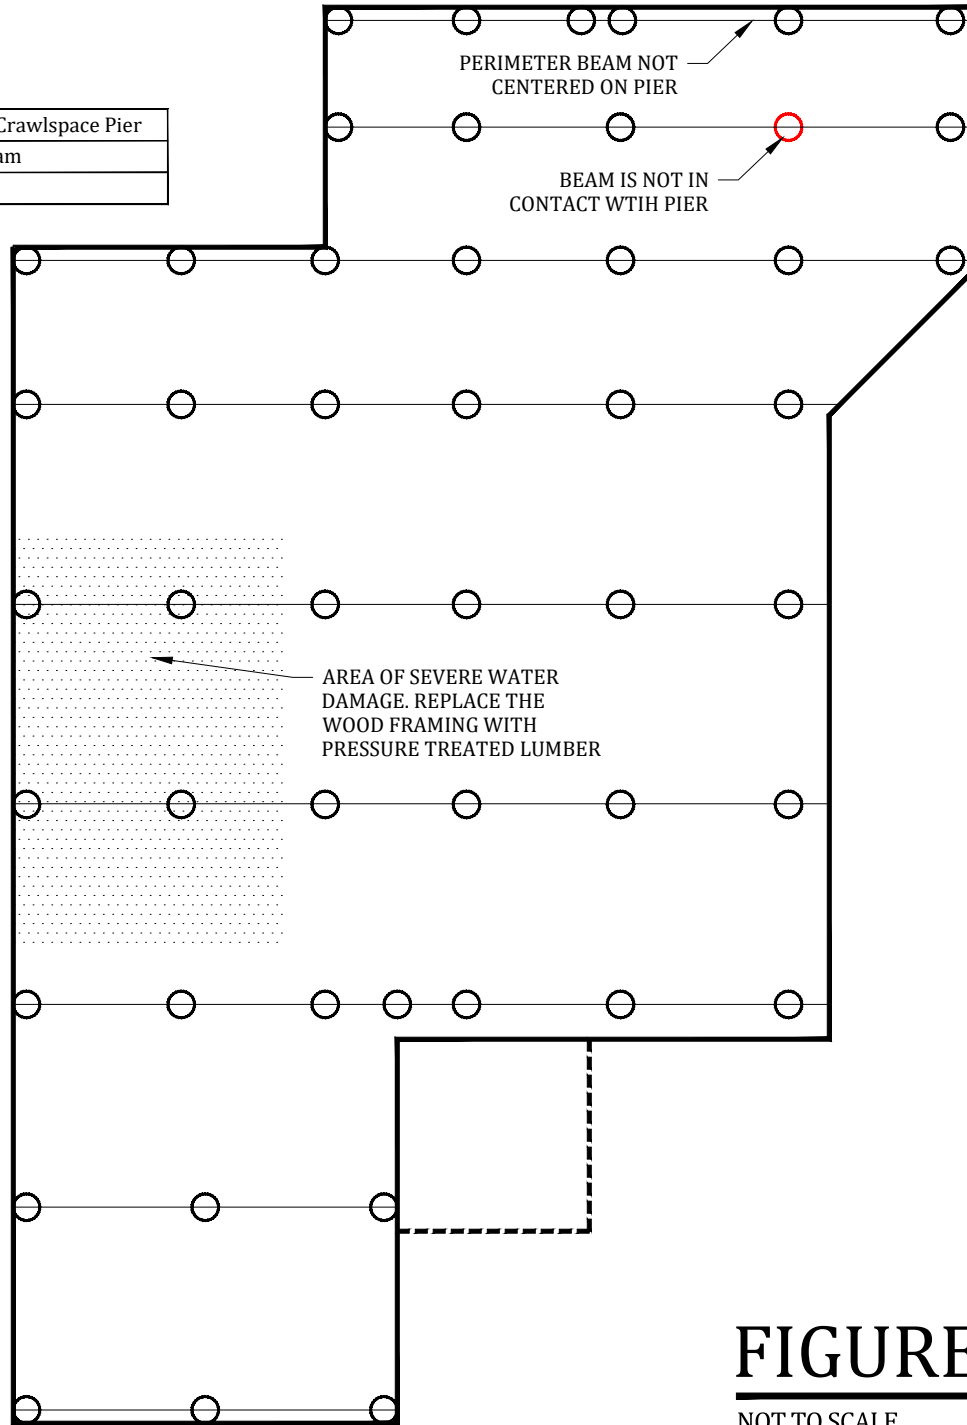
## FIGURE 2

- One perimeter (3) 2x6 beam is not centered on the concrete piers
- Severe wood rot observed below the master bathroom. The wood rot affects all wood framing members; the beams, joists, and the floor sheathing.
- One beam is severely water damaged and twisted
- Wood shims and wood blocks are utilized as shims between the CMU block piers and wood beams.
- One wood beam is not in contact with the concrete pier under the kitchen

PERIMETER BEAM NOT CENTERED ON PIER

BEAM IS NOT IN CONTACT WITH PIER

AREA OF SEVERE WATER DAMAGE. REPLACE THE WOOD FRAMING WITH PRESSURE TREATED LUMBER

- 3) Replace the existing water damaged wood framing members with new pressure treated lumber.
- 4) Attach an additional 2x6 pressure treated member to the wood beam that is not centered on the concrete piers. The new lumber should attach to the new beam using 2 rows of 10d nails spaced at 12 inches, staggered.
- 5) Have the doors that remain poorly functioning adjusted or rehung.
- 6) With the completion of the foundation underpinning, a final elevation survey must be performed to provide a final elevation baseline. It is recommended to review the performance of the foundation every 6 to 12 months. Compare all future foundation evaluations to this baseline.
