PROPERTY CONDITION REPORT

Prepared For: Jane Doe Industries, LLC
(Name of Client)

Concerning: Sample Commercial Inspection Report
(Address or Other Identification of Inspected Property)

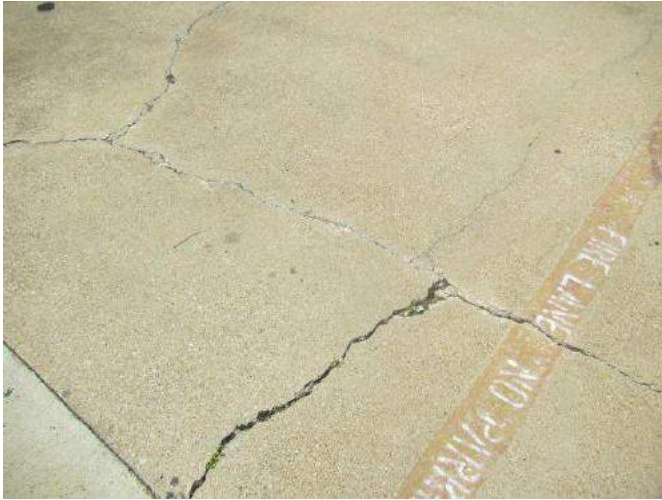
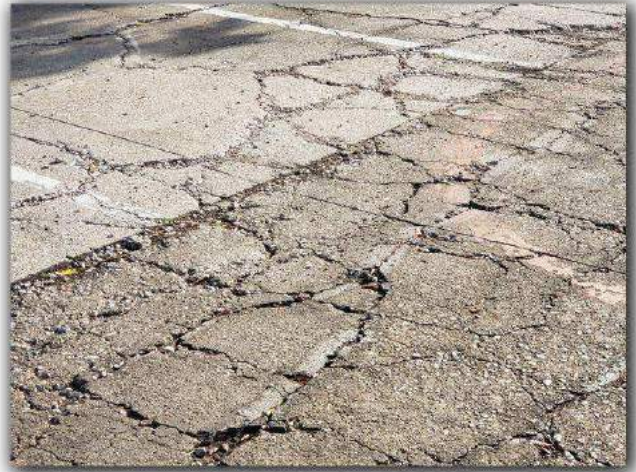
Comments:
Areas of cracking and uplift in the parking lot areas.

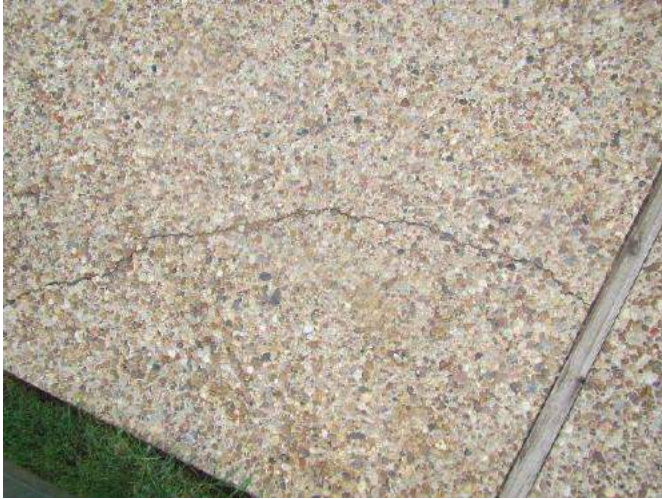
There was cracking at sidewalks. (top left picture below)

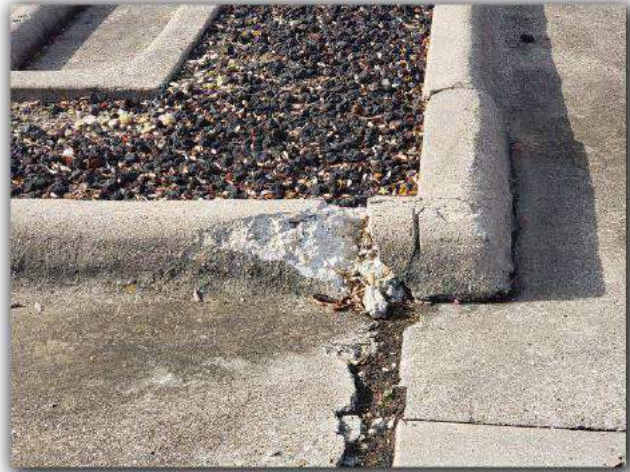
There was cracking and damage to some curbs. (top right picture below)

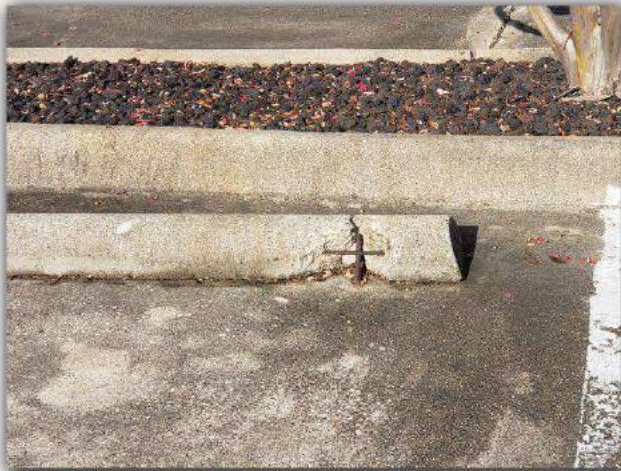
There was cracking at parking bumpers. (2nd left picture below)

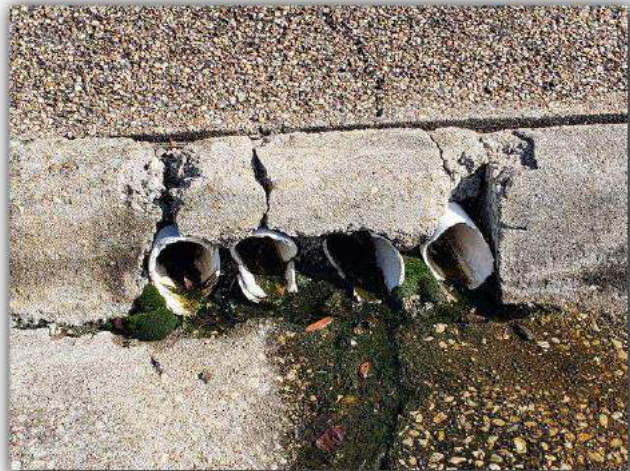
Areas of cracking and damage to the curbs around the drain lines (2nd right picture below)

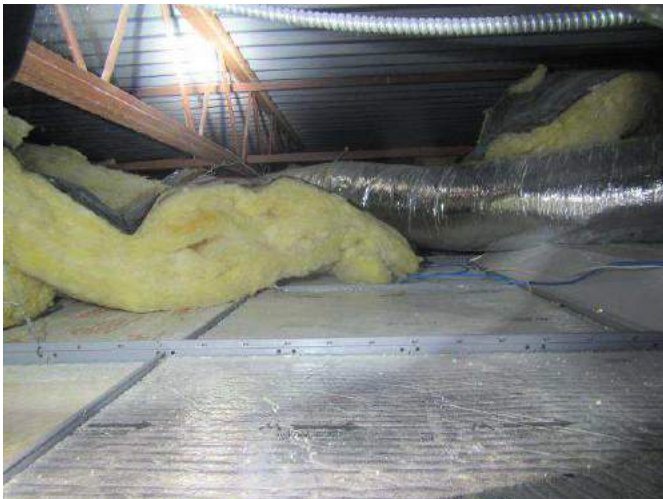
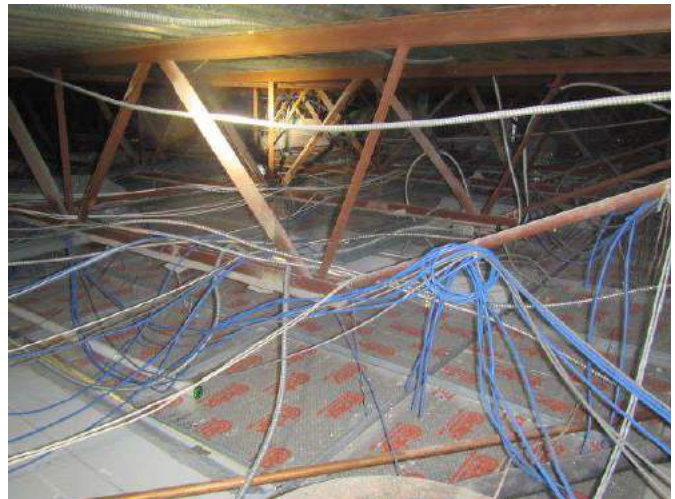
There were areas of missing and displaced insulation in the drop ceiling space. (see pictures below)

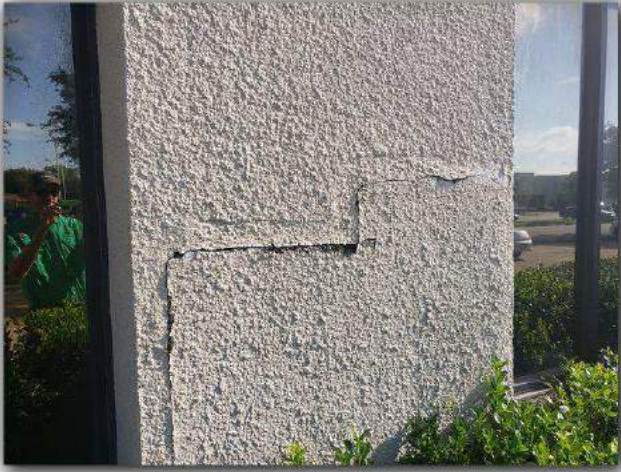
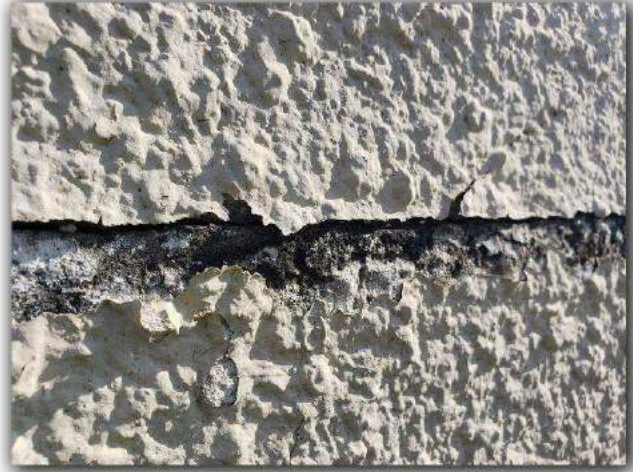
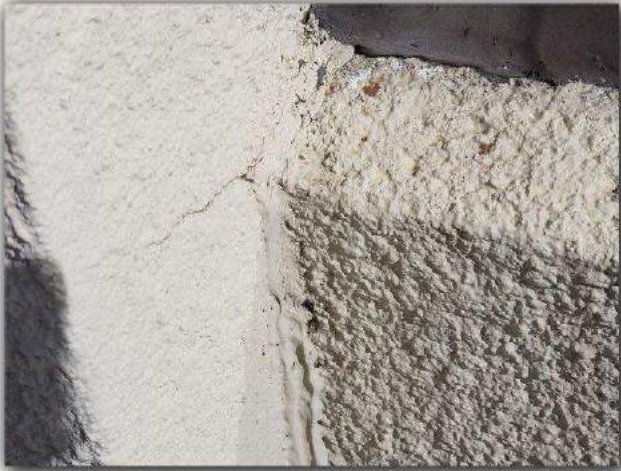
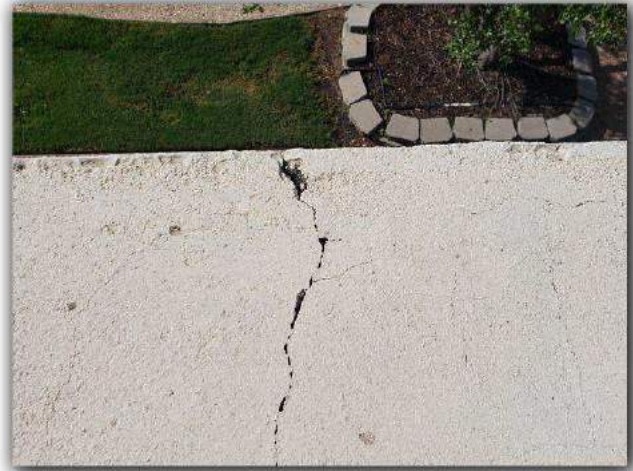
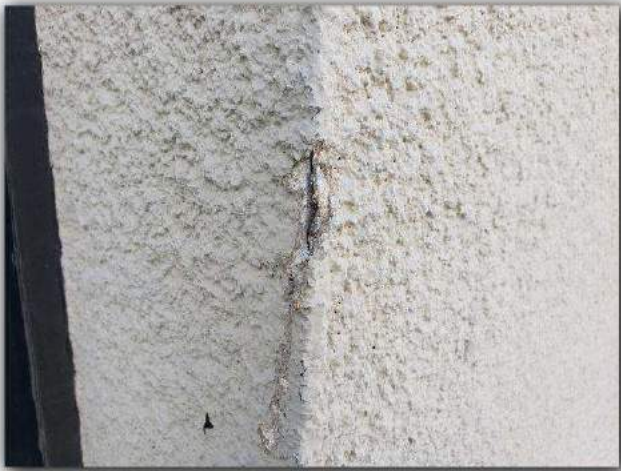
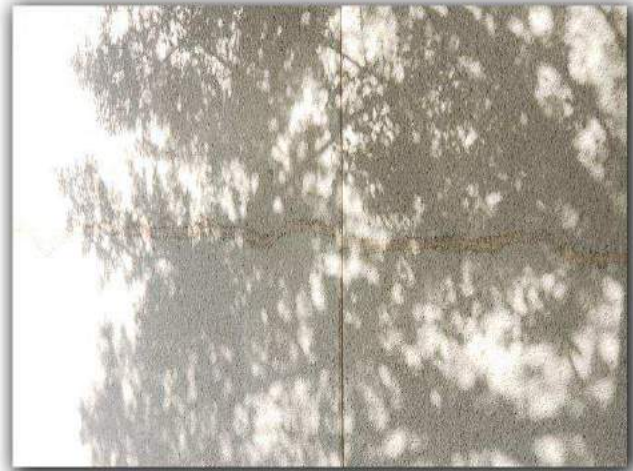
There were cracks in the exterior veneer. Water damaged was visible in some areas. (Top 6 Pictures Below)
The wall penetration for the exterior faucets should be sealed. (5th Left Picture Below)
Areas of water staining at the exterior veneer.
There was siding installed with insufficient clearance to grade.
There was damage to the street numbers at the front of the building. (5th Right Picture Below)

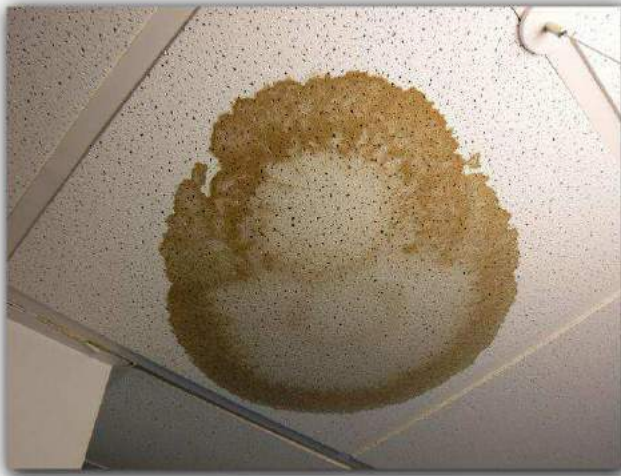
Areas of previous water penetration at ceiling tiles in multiple areas of suite 400. (top left picture below)
Various areas of damaged and missing ceiling tiles on floors 3 and 4. (top right picture below)
There are several cracked ceiling tile in Suite 108.(Left Picture Below)
Several ceiling tiles are missing, several are cracked in the Suite between Suite 101 and 102. (Right Picture Below)
Several ceiling tiles show signs of water penetration in the Suite between Suite 101 and 102. (2nd Left Picture Below)
Water stains on the ceiling tiles in the conference room in Suite 110.(2nd right picture below)
One ceiling tile is missing in Suite 110.(3rd left picture below)
There are water stains on the ceiling in the kitchen area in Suite 110.
There are several cracked and broken ceiling tiles in Suite 110.
There are several missing ceiling tiles in Suite 109.
There are water stains on the ceiling in the janitors office. (3rd right picture below)

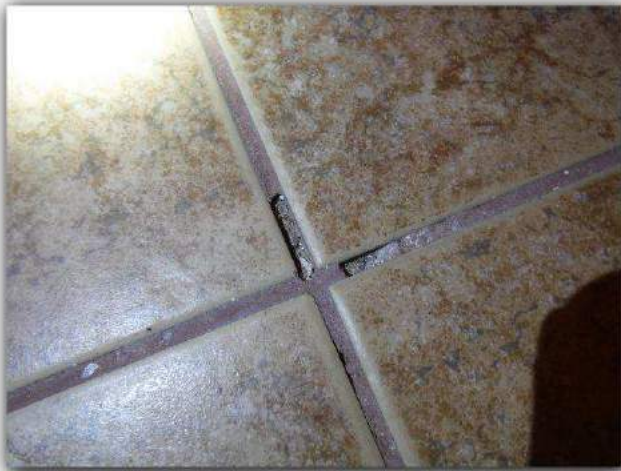
Grout is cracked and damaged between the tiles in the mens bathroom on floor 4. (top left picture below)

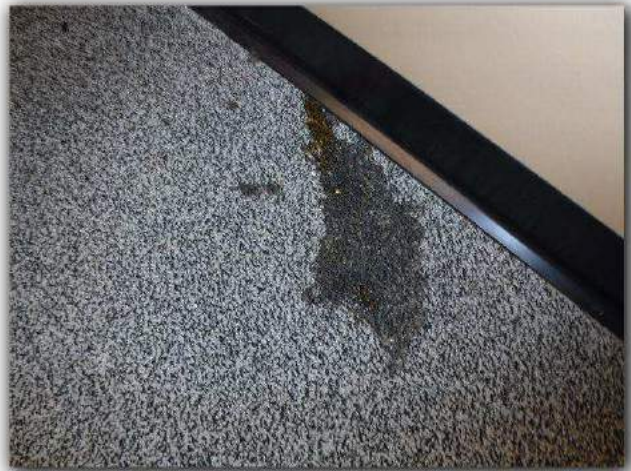
There are several areas of damaged, stained and uplifting carpet in suite 400. (top right picture below)

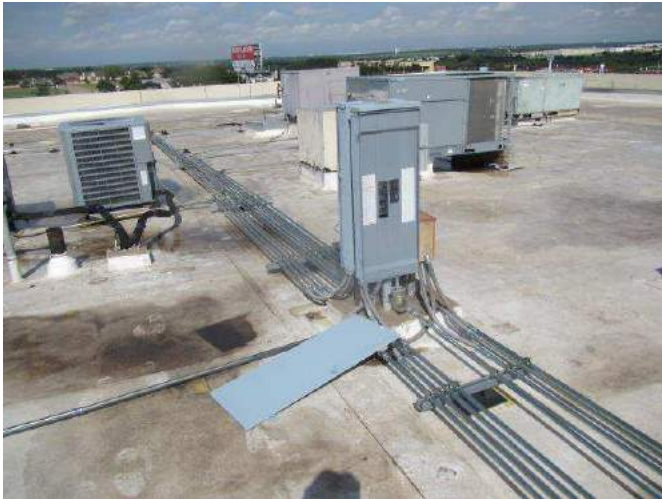
One of the upper roof panel covers was disconnected and the other was damaged. (top left picture below)
There are knockouts missing on the dead front cover at one of the upper roof level electrical panels. (top right picture below)
The roof level electrical panels were not completely labeled.
There are knockouts that were damaged or missing on the dead front cover at the lower left roof level electrical panel. (2nd left picture below)
There was not visible anti-oxidants on aluminum conductor terminations within the lower roof level panels.
There is double lugging evident at one of the circuit breakers in the lower left roof level electrical panel. (2nd right picture below)
The lower rear roof level panel dead front cover is missing screws.
There are knockouts missing on the dead front cover in the 4th floor electrical panel labeled Panel A .
The panel dead front covers are missing screws on the 4th floor in panels 3 and 4. Three screws that hold the electrical panel cover on are missing in the Suite between Suite 101 and 102.

It is highly recommended that the panel be fully evaluated by a licensed Electrician.

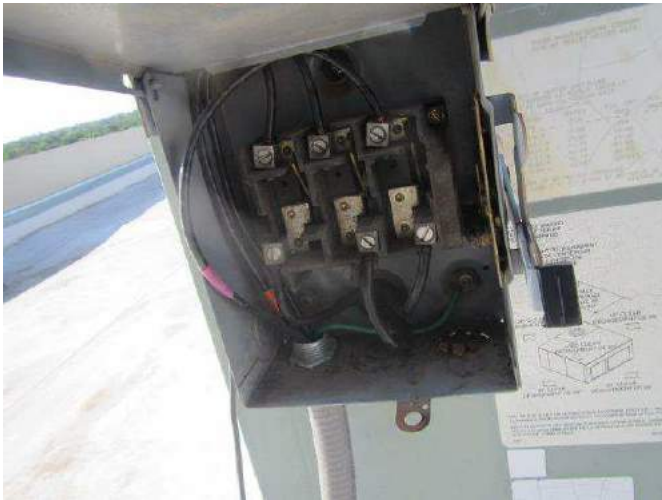
Some lights did not respond to testing.
The dead front cover was not present at the upper roof level exterior condensing unit disconnect for Unit 7, 10 or 13. (top left picture below)
In-use weather proof covers were not present at all exterior outlets. (2nd left picture below)
The upper roof level GFCI outlet was loose and not mounted in place. (top right picture below)
There is an electrical junction box in the Unit 115 drop ceiling that does not have a cover. (2nd right picture below)
Hand held tester had open ground readings in Suite 200 office 3 and 4.

It is recommended that the branch circuits be fully evaluated by a Licensed Electrician.

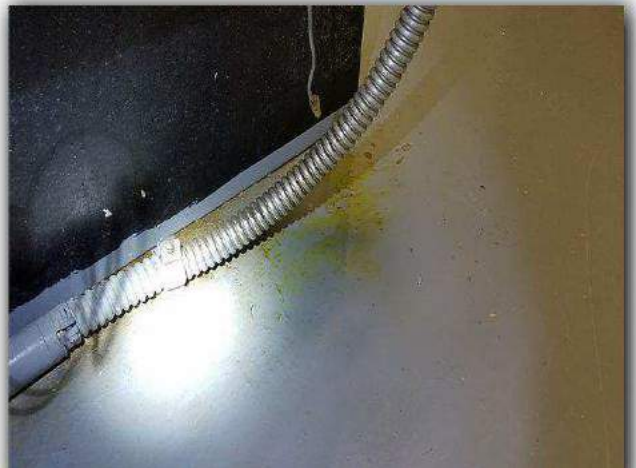
1st floor hydraulic elevator unit was leaking fluid at the time of inspection. (Pictures Below)

Elevator tested for functionality only. If you have concerns about the elevator systems a professional elevator service company should be consulted.

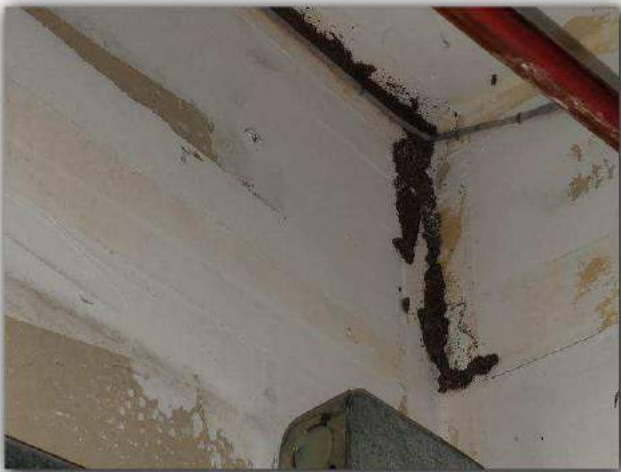
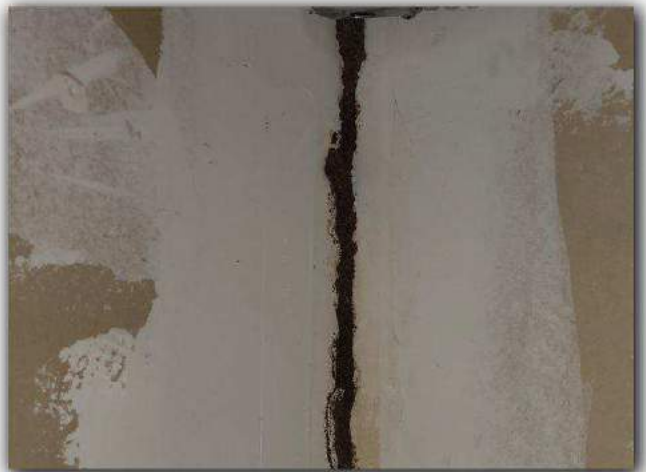
There were areas of possible wood destroying insect activity within the main electrical room and fire suppression room. It is recommended that a treatment be performed. (2nd and 3rd Row Pictures Below)
