GREENWORKS SERVICE COMPANY

GW STANDARD HOME INSPECTION

PROPERTY INSPECTION REPORT FORM

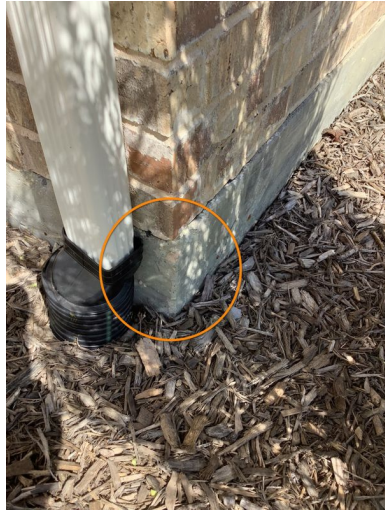
1: Missing Corner Pop

The foundation corner pop is missing at the corner of the home.

Recommendation: Contact a qualified concrete contractor.

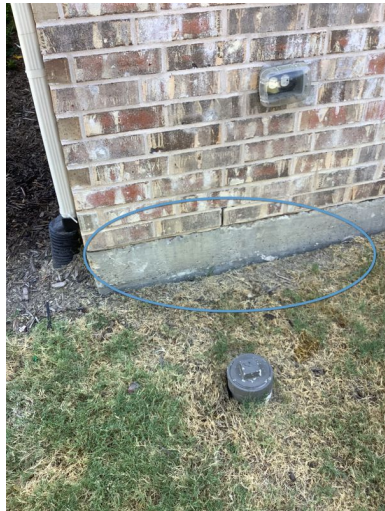
2: Honeycombing

Honeycombing was present at the foundation wall. These areas should be monitored.

Recommendation: Recommend monitoring.

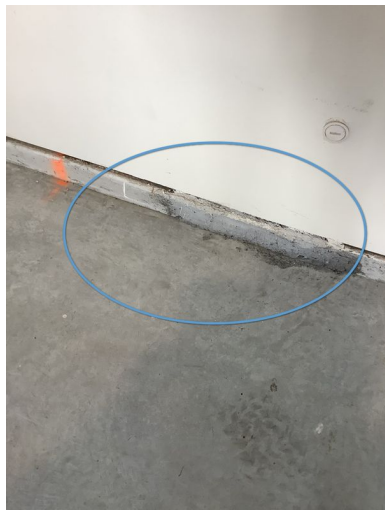
3: Foundation Previous Repair

There was evidence of previous repairs around the perimeter of the home. Inspector cannot confirm the extent or accuracy of the repairs. A Professional Engineer should be consulted if additional information is needed.

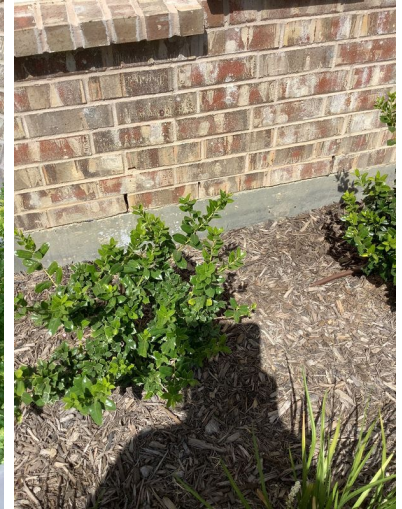
There were areas of excessive/Insufficient exposure of the foundation wall. Preferably 6 to 8 inches of foundation exposure should be present around the perimeter of the home. The higher the soil level the more inviting it is for wood destroying insect activity and moisture intrusion.

Recommendation: Contact a qualified grading contractor.

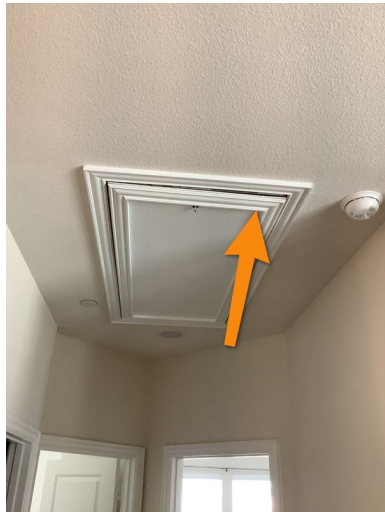
4: Attic Door Gapped

Attic cover door is gapped when shut. The attic access door should be sealed when shut to prevent energy loss.

Recommendation: Contact a qualified professional.

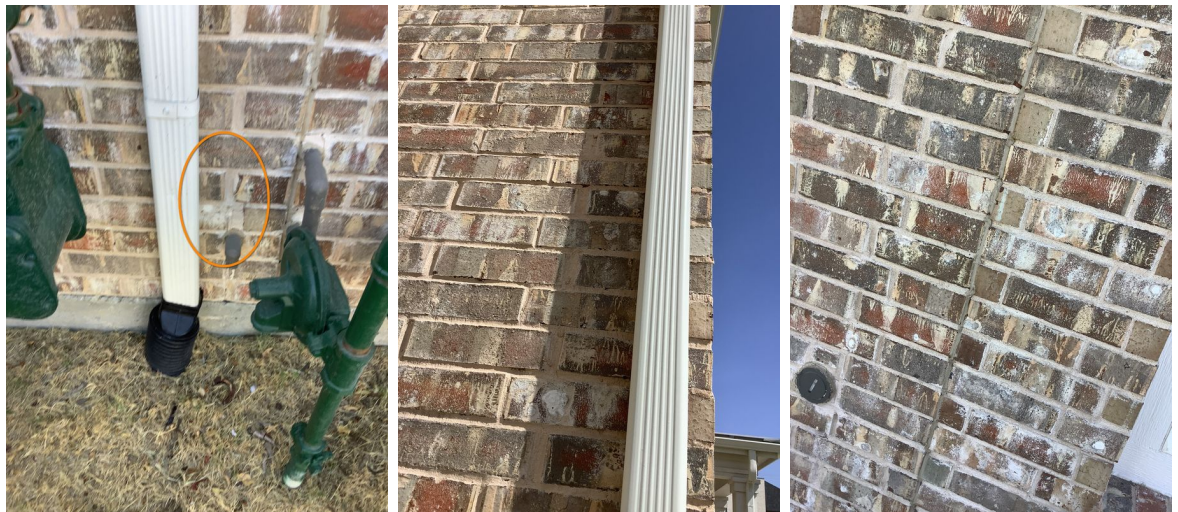
2: Mortar Separation

Areas of mortar and/or joint separation were observed at the exterior walls.

Recommendation: Contact a qualified masonry professional.

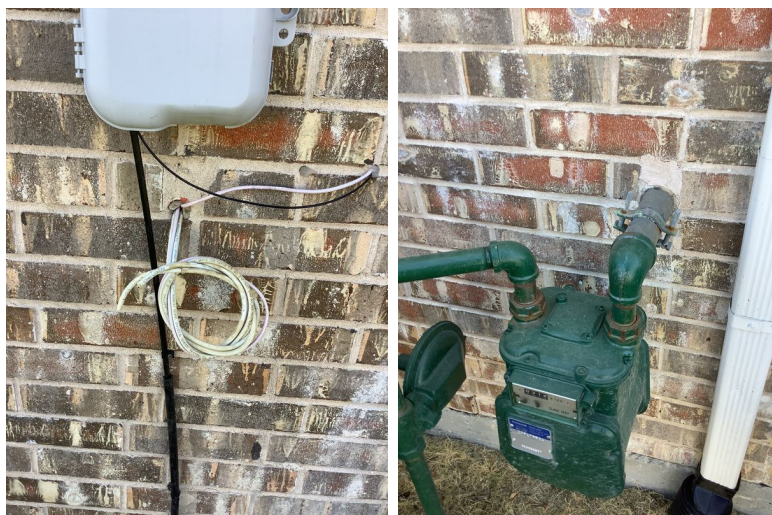
3: Lack of Sealed Penetrations

It is recommended that all protrusions through the siding and fixtures mounted on the exterior be sealed in order to prevent moisture incursion. Using a quality exterior caulk type sealant around pipes, wires, light fixtures etc. can prevent moisture related failure of electrical components and siding materials.

Recommendation: Contact a qualified professional.

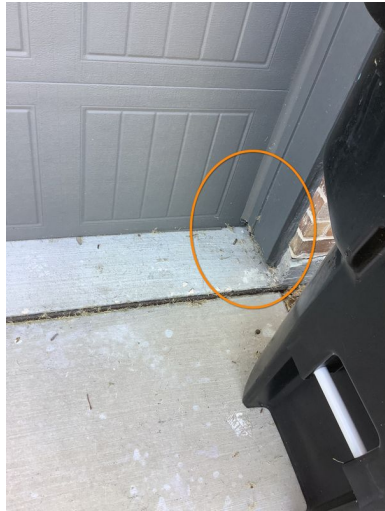
4: Separation - Exterior Trim

Areas of trim were separating and lacked proper caulking. These areas are conducive for water penetration into the home.

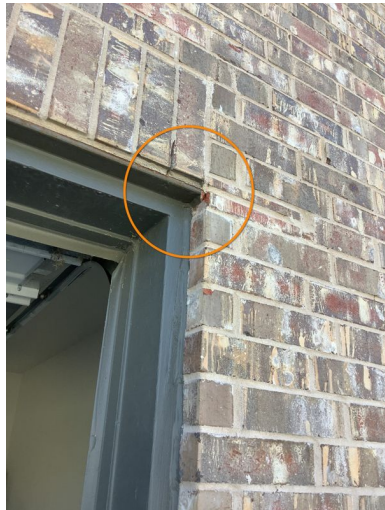
5: Spalling

Spalling was observed at the exterior veneer. Various areas of cracking and damage were observed. Veneer materials were flaking, and missing portions of material.

Recommendation: Contact a qualified masonry professional.

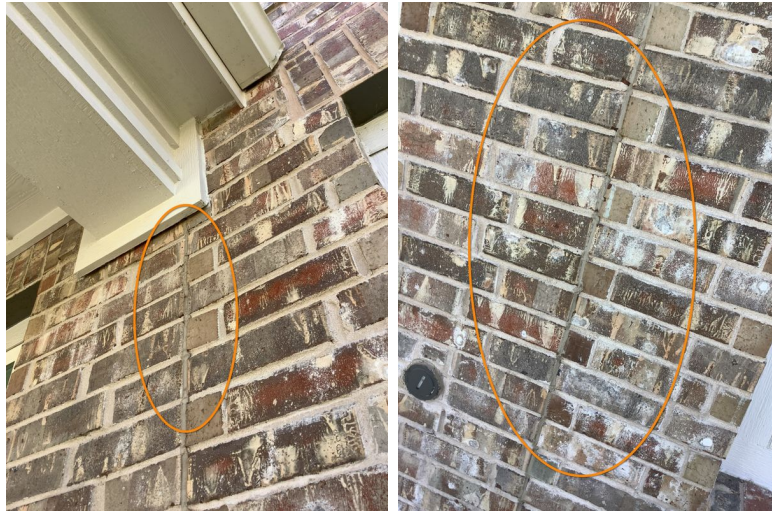
6: Caulking - Exterior wall joints

There was separated caulking at the exterior wall joints. All wall joints should water tight and sealed. Repair is recommended.

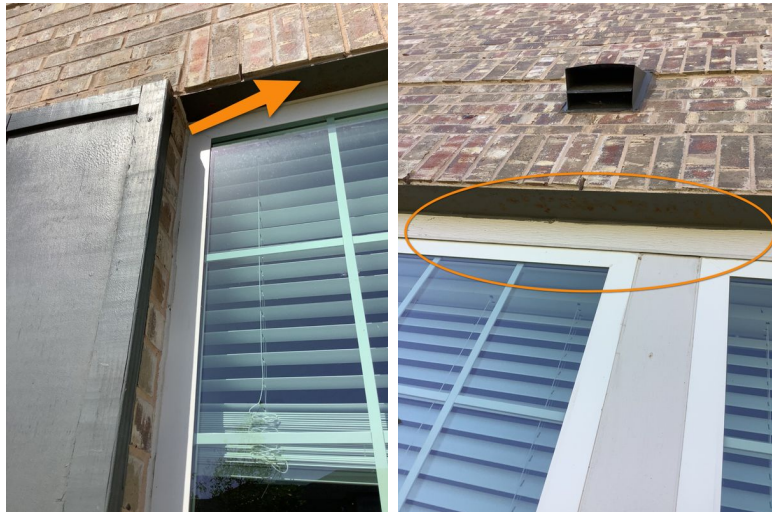
Some of the brick lintels need to be painted.

Recommendation: Contact a qualified painting contractor.

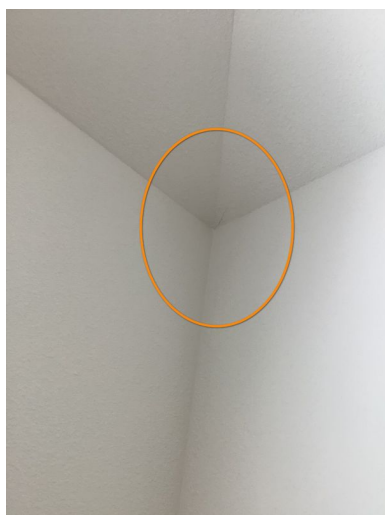
Interior wall cracks were observed at the time of inspection.

Recommendation: Contact a qualified drywall contractor.

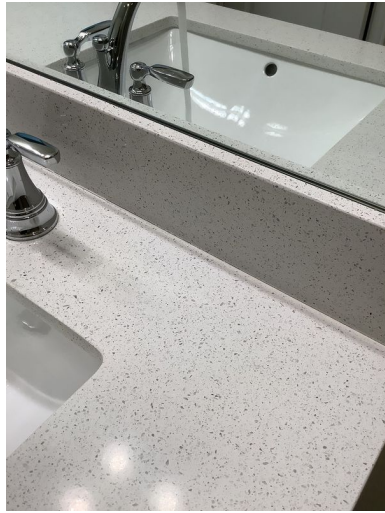
2: Caulking Counter Connection

Caulking is needed at the wall / counter connection point.

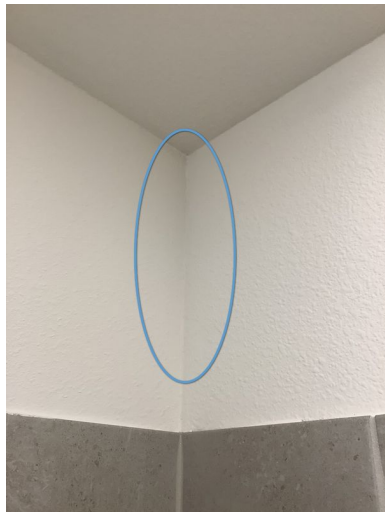
There are joint separations in various areas.

Recommendation: Contact a qualified drywall contractor.

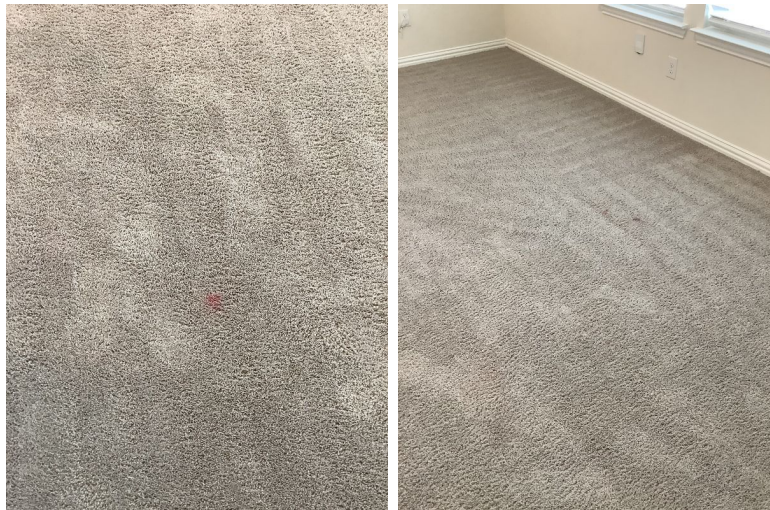
2: Carpet Stains

Carpet had areas of staining or discoloration. Recommend a thorough steam clean by a qualified carpet cleaning company

Recommendation: Contact a qualified cleaning service.

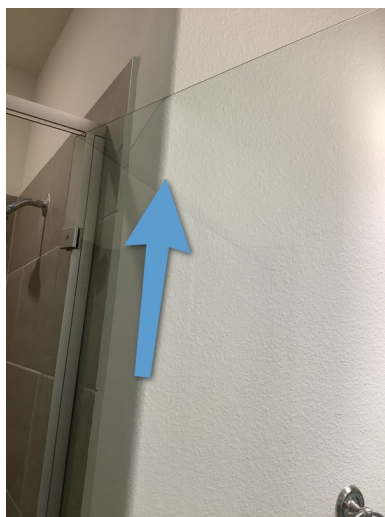
The shower door collides with another surface in the bathroom. Risk for damage is high and adjustment or stopper installation is recommended.

Recommendation: Contact a handyman or DIY project

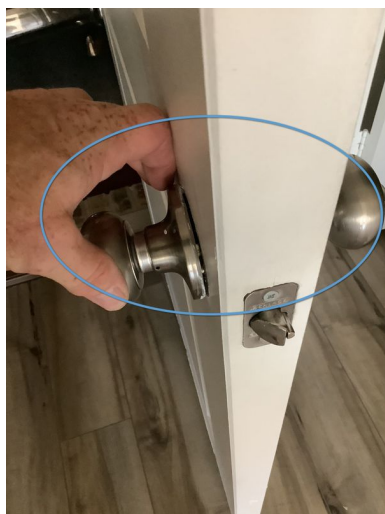
2: Loose Door Knobs

There were loose doorknobs in areas of the home.

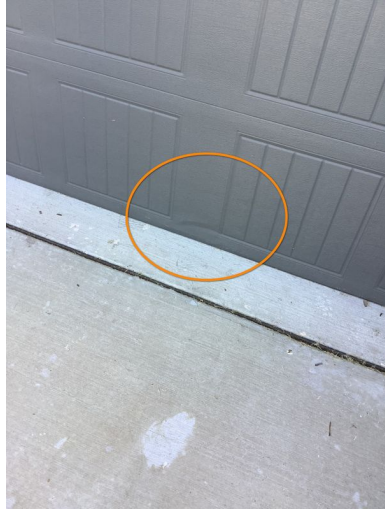
There is denting and damage to the overhead garage door.

Recommendation: Contact a qualified door repair/installation contractor.

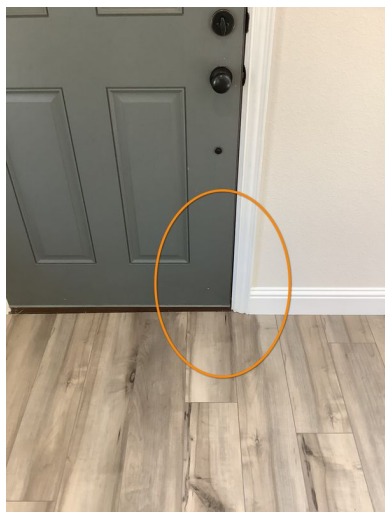
5: Exterior Doors - Air and Light

Light and air gaps were present at the exterior doors. This can result in significant energy loss and moisture intrusion. Recommend installation of additional weatherstripping.

Recommendation: Contact a qualified door repair/installation contractor.

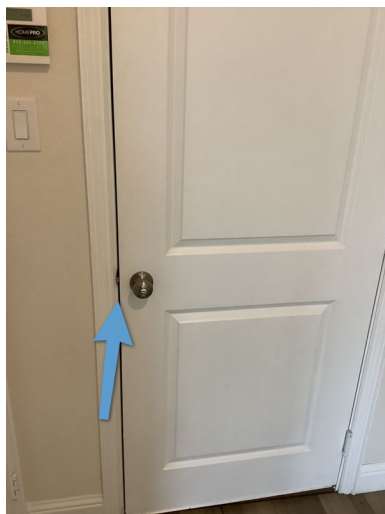
6: Self-Closing Garage Door

The house to garage door does not self-close and latch. A self-closing, house to garage door is recommended for safety and fire protection.

Recommendation: Contact a qualified door repair/installation contractor.

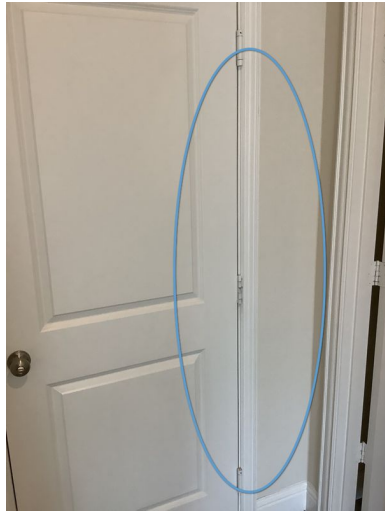
7: Self-Closing Garage Door - Adjustment

Self-closing hinges are installed but require adjustment to close properly.

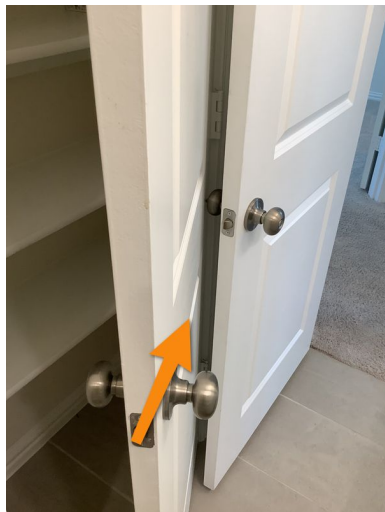
8: Doors Collide

The doors collide when opening and closing.

Recommendation: Contact a qualified professional.

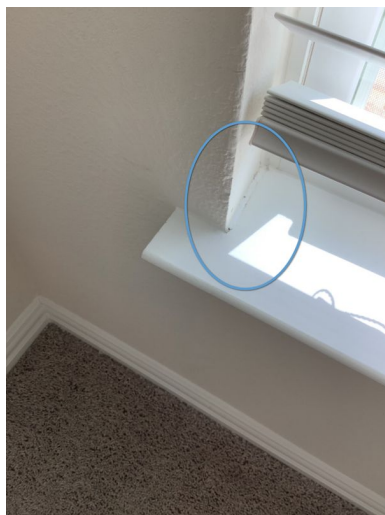
The interior caulk is missing, cracked, or separated around the windows in the home.

Recommendation: Contact a handyman or DIY project

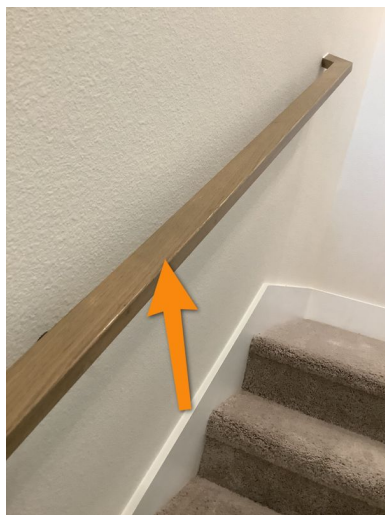
The stairway railing is loose. This is a safety concern. Recommend a qualified professional evaluate and repair.

Recommendation: Contact a qualified professional.

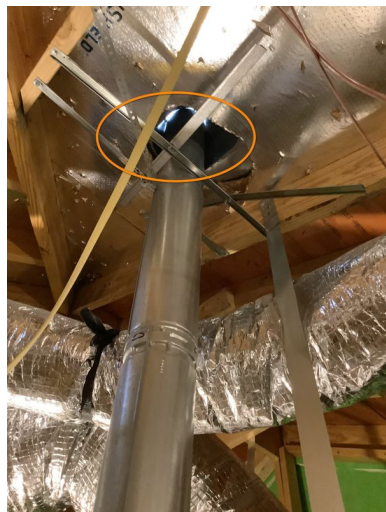
Light gaps were observed around the vent flue at the roof penetration. This can lead to water penetration. Repair is recommended.

Recommendation: Contact a qualified HVAC professional.

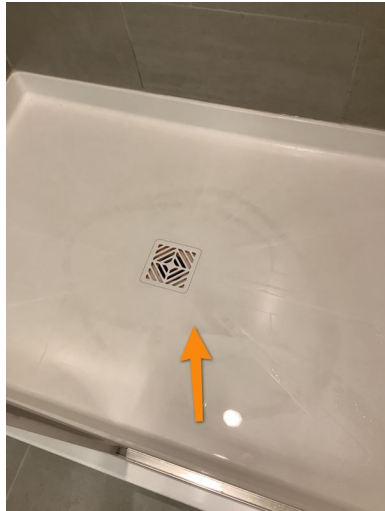
Surface staining was observed at the bathroom shower.

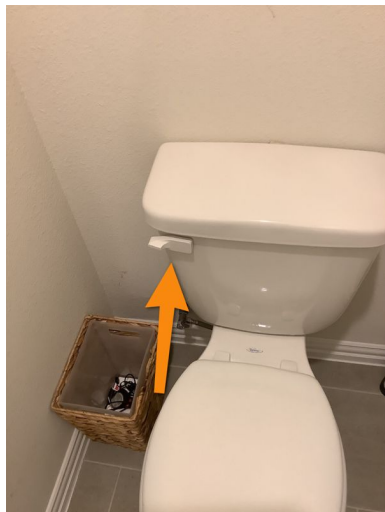
3: Bad Toilet Chain

The chain does not lift the flapper properly at the bathroom toilet.

Recommendation: Contact a qualified plumbing contractor.

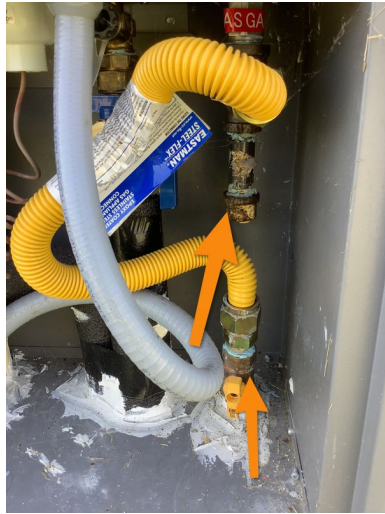
There was rusting at the gas lines at the home. Rusted lines can lead to gas leaks.

Recommendation: Contact a qualified plumbing contractor.

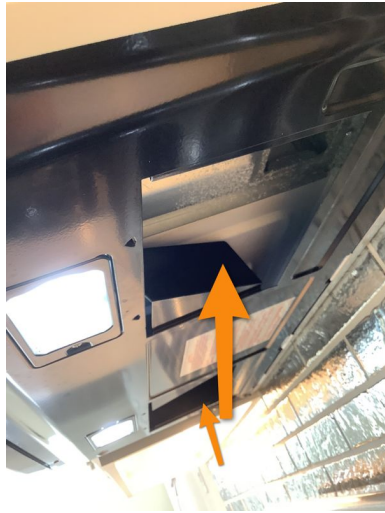
1: Missing Filter

The range exhaust vent filter is missing.

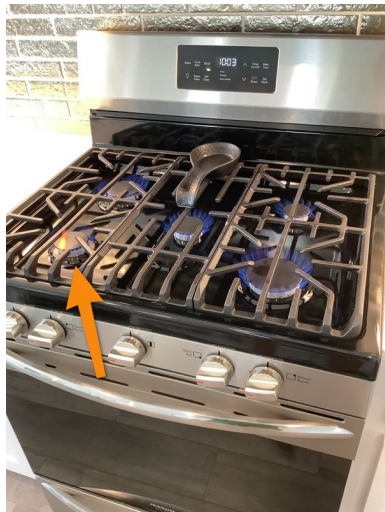
1: Orange Flames

There were orangey flames at the cooktop. Adjustment and repair by qualified technician is recommended.

Recommendation: Contact a qualified professional.

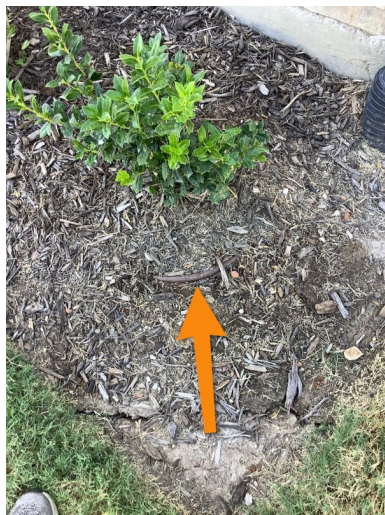
Sprinkler lines were exposed in various areas. These should be covered to prevent damage to the lines.

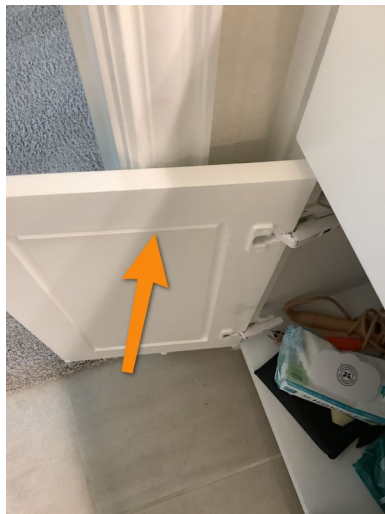
Cabinet door collided with another surface when operated.

Recommendation: Contact a qualified professional.
