GREENWORKS SERVICE COMPANY

GW STANDARD HOME INSPECTION

PROPERTY INSPECTION REPORT FORM

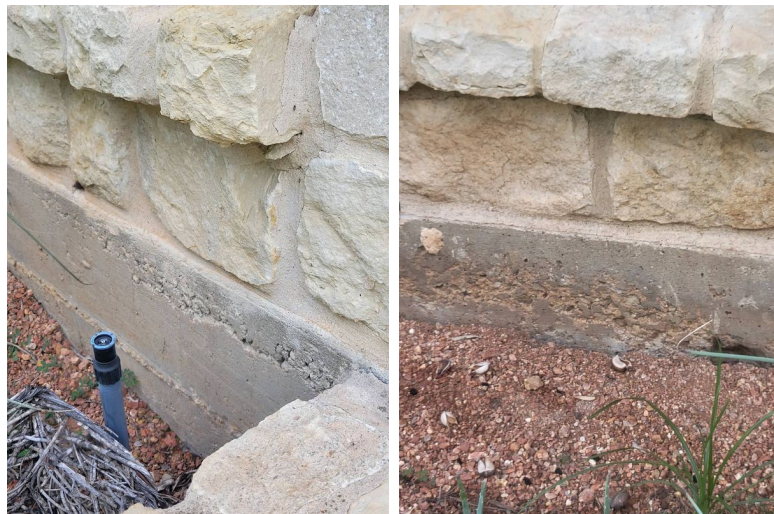
Honeycombing was present at the foundation wall. These areas should be monitored.

Recommendation: Recommend monitoring.

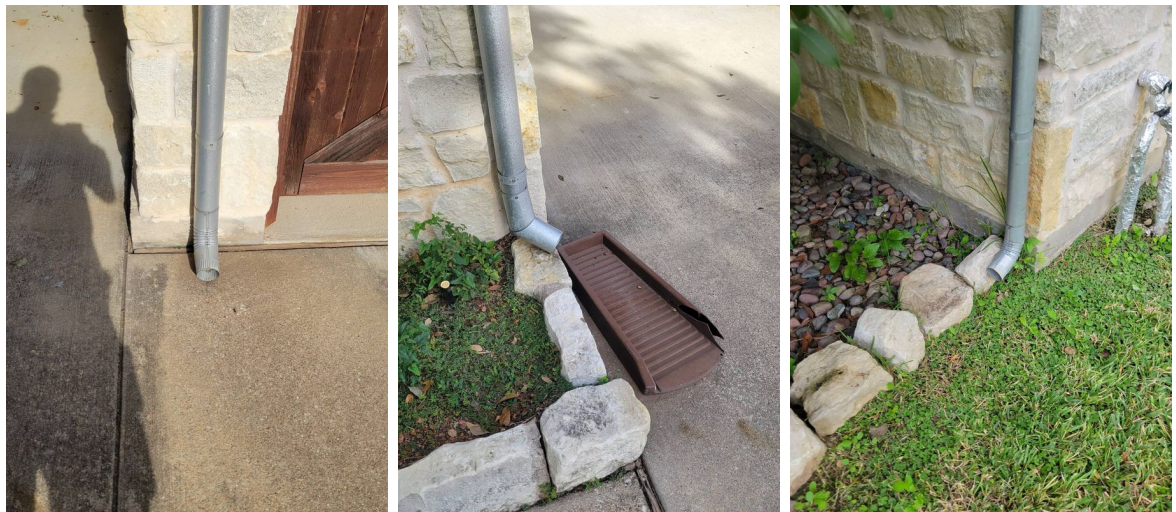
One or more downspouts drain too close to the property foundation. This can result in excessive moisture in the soil at the foundation, which can lead to foundation/structural movement. Recommend a qualified contractor adjust downspout extensions to drain at least 6 feet from the foundation.

Recommendation: Contact a qualified gutter contractor

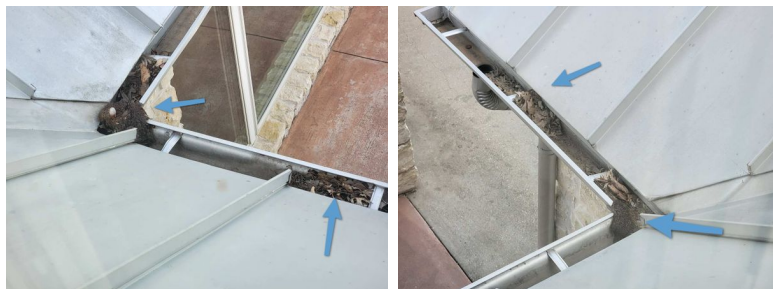
Debris has accumulated in the roof drainage system. Recommend cleaning to facilitate water flow.

Recommendation: Contact a qualified professional.

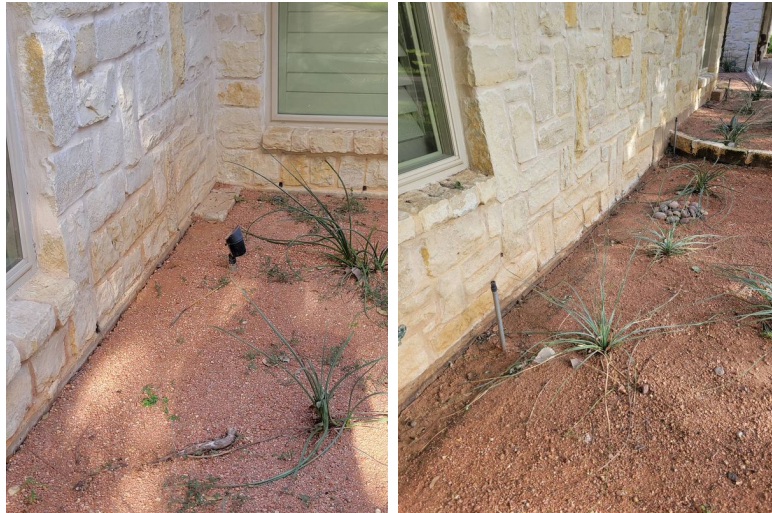
4: Over/Under-Exposure

There were areas of excessive/Insufficient exposure of the foundation wall. Preferably 6 to 8 inches of foundation exposure should be present around the perimeter of the home. The higher the soil level the more inviting it is for wood destroying insect activity and moisture intrusion.

Recommendation: Contact a qualified grading contractor.

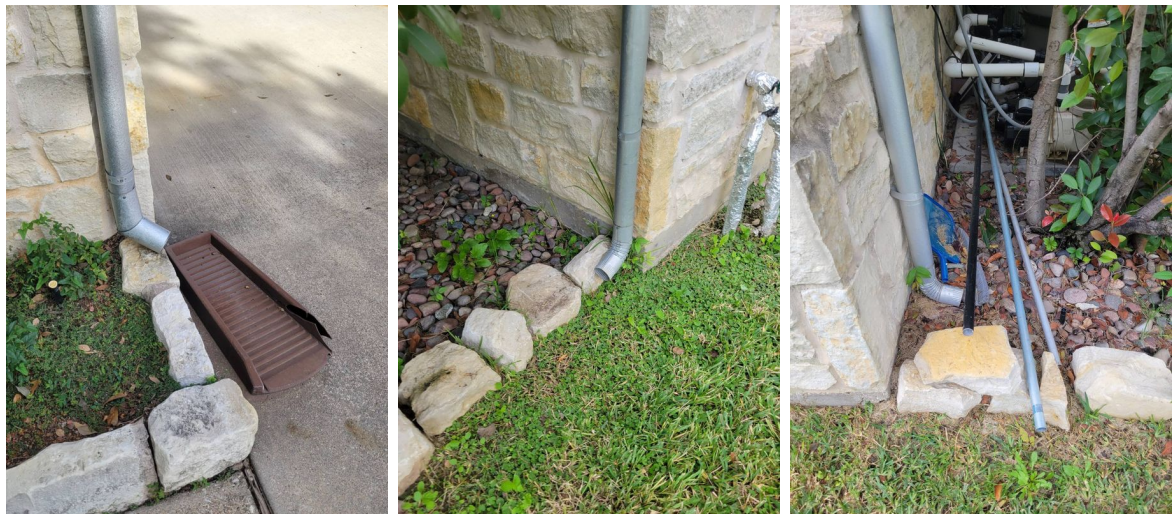
5: Splash blocks - Damaged/Missing

There were damaged or missing downspout splash blocks present at the time of the inspection. it is recommended to have installed or repaired.

Recommendation: Contact a handyman or DIY project

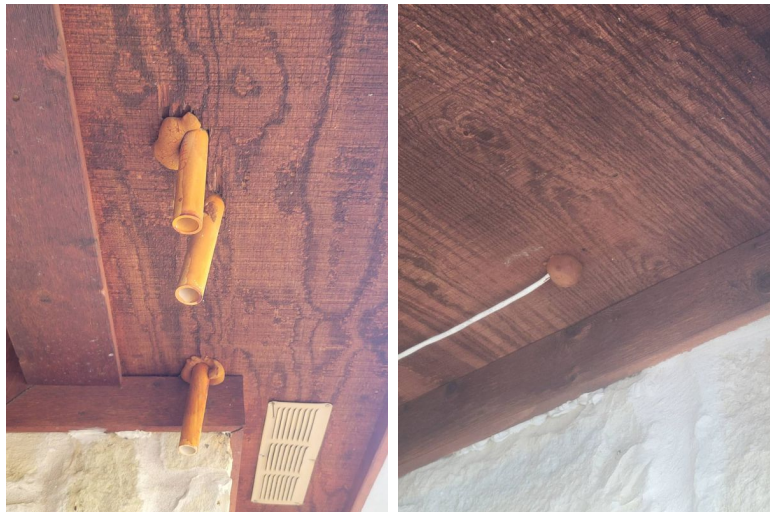
Expanding foam gap filler has been used at some of the exterior penetrations. Gap filler will deteriorate over time and should be monitored.

Recommendation: Recommend monitoring.

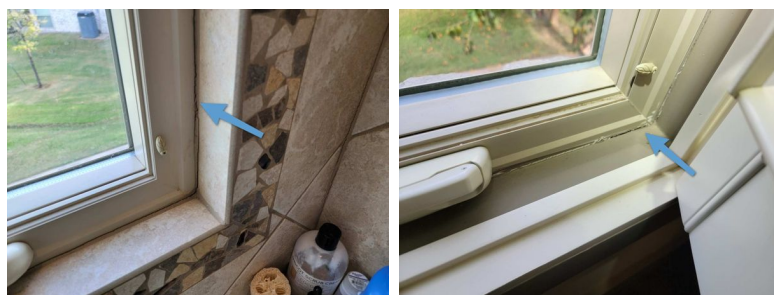
The interior caulk is missing, cracked, or separated around the windows in the home.

Recommendation: Contact a handyman or DIY project

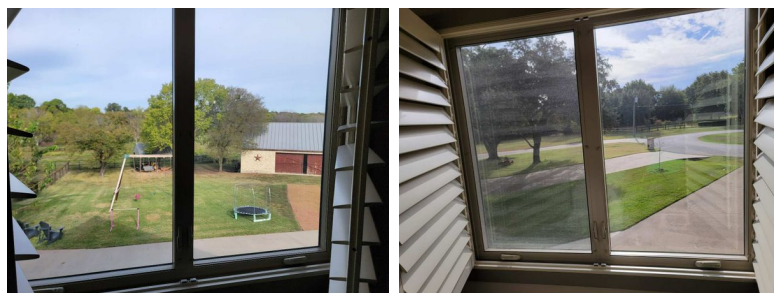
2: Missing Screens

Window screens were not installed at some windows at the time of inspection. It is recommended that screens be installed to prevent insects from coming in if windows are left open.

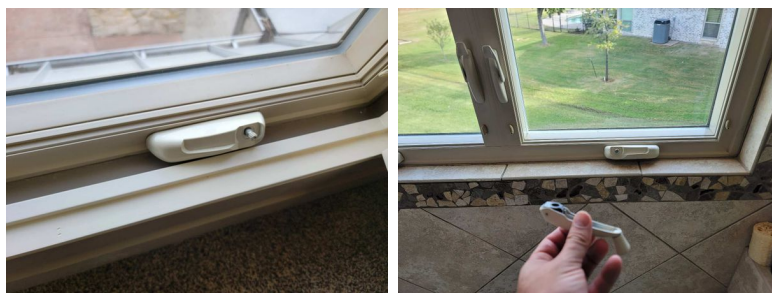
5: Loose/Missing Window Crank Handle

The crank handle is loose/missing at the casement window.

Recommendation: Contact a qualified window repair/installation contractor.

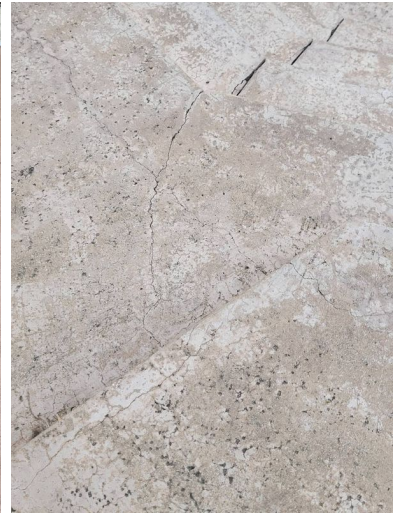
2: Patio/Porch Cracking - Cosmetic

There is cracking noted at the patio/porch surfaces.

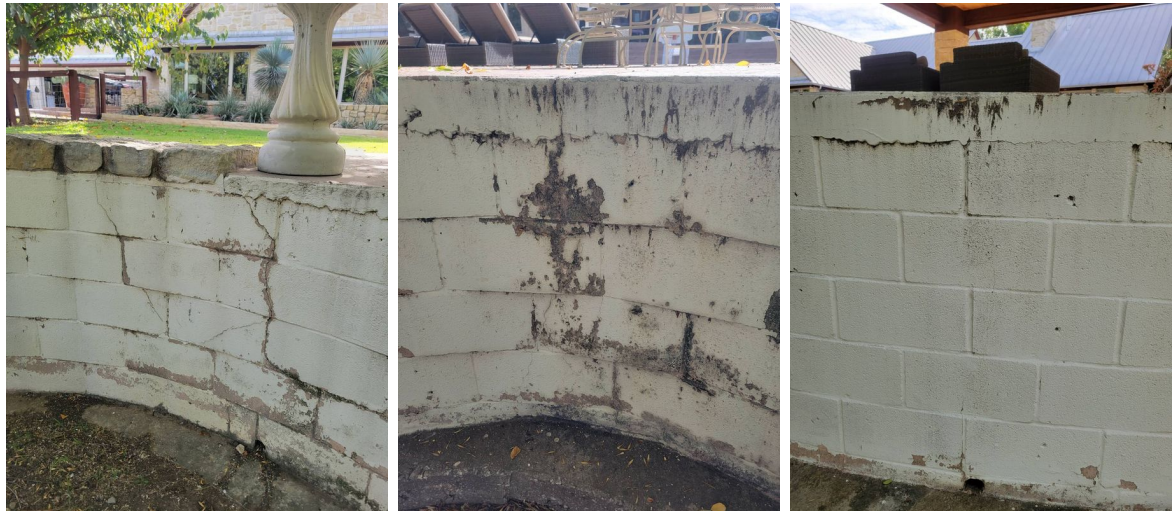
2: Retaining Walls - Cracks

There were cracks and repaired cracks in the retaining walls.

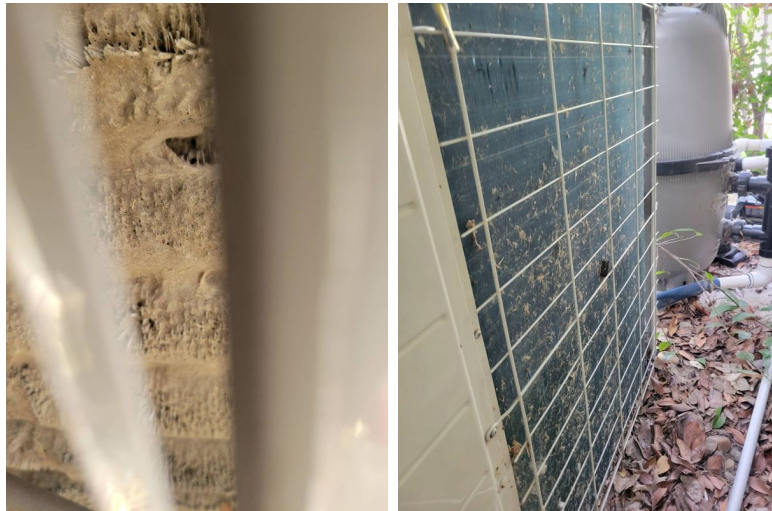
The condensing coils on the air conditioning compressor need to be cleaned.

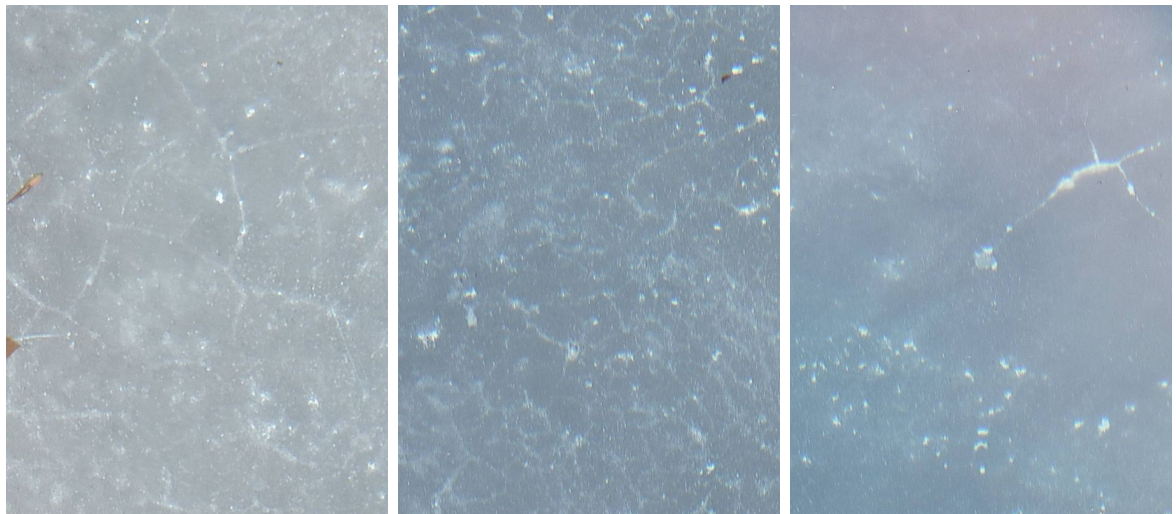
6: Pool Surface/Gunite Cracks

There were areas of cracking and damage at the pool surface. Recommend a qualified professional evaluate and repair.

Recommendation: Contact a qualified Swimming Pool Contractor

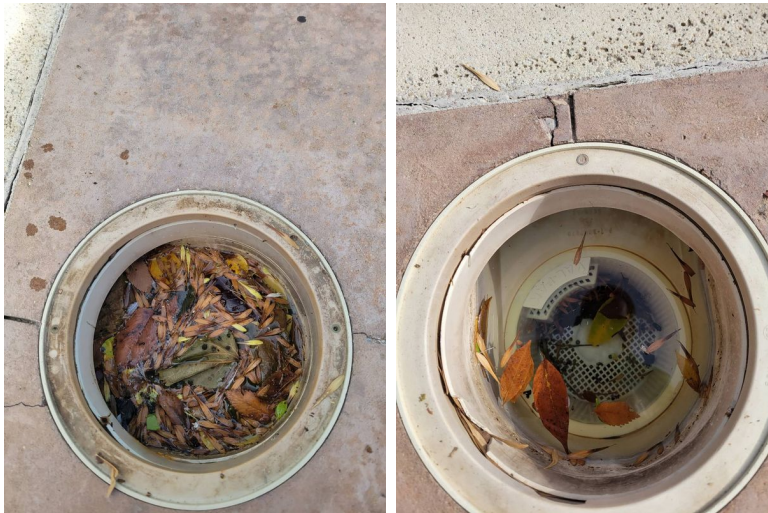
The skimmer baskets are full of debris.

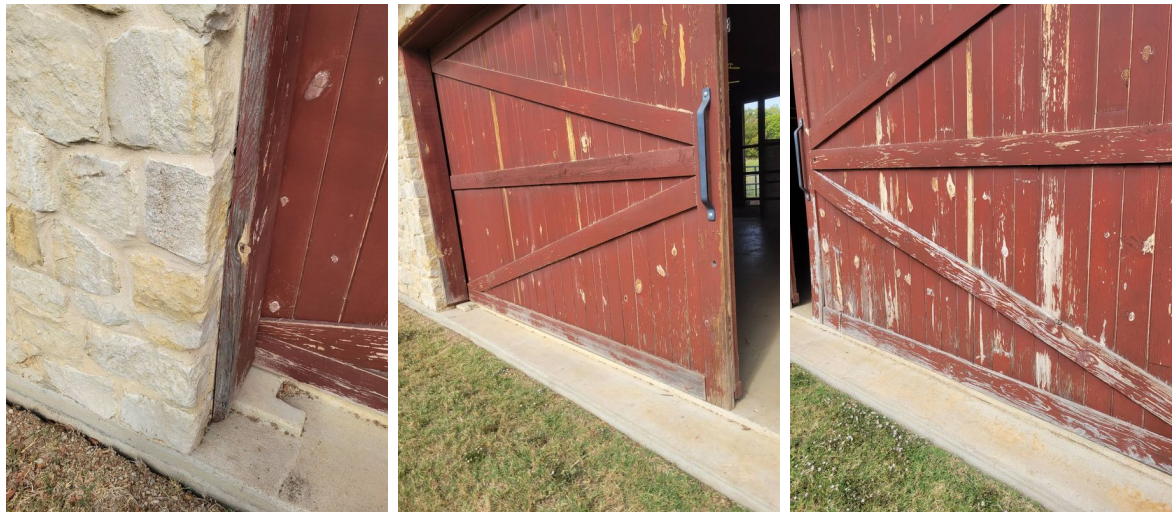
3: Rot/Exposed Wood - Discoloration

There were various areas of damage to the siding and trim. Rot, chipped, and missing paint were noted at time of inspection. Areas of discoloration. Repair/Replacement is recommended.

Recommendation: Contact a qualified professional.
