GREENWORKS SERVICE COMPANY

GW STANDARD HOME INSPECTION

PROPERTY INSPECTION REPORT FORM

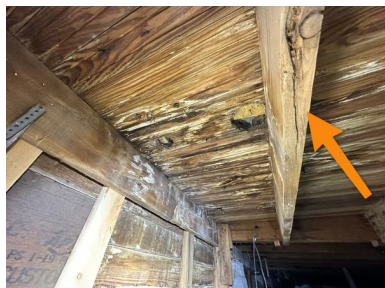
There were cracked and damaged floor joists within the crawlspace.

Recommendation: Contact a foundation contractor.

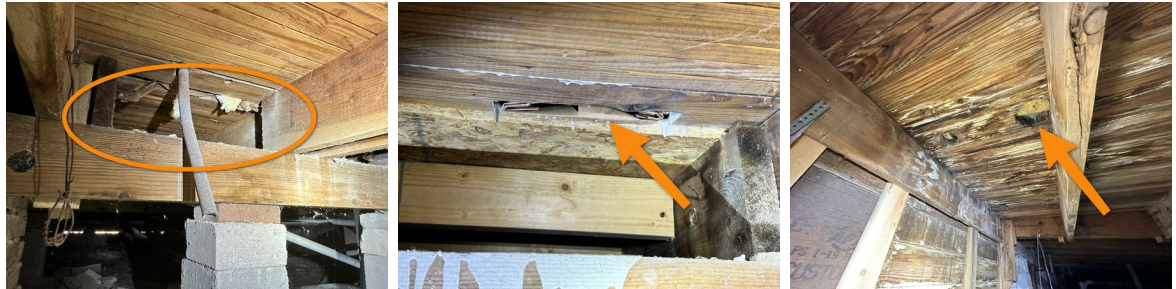
5: Subfloor - Rot Damage

There were areas of rot damage present at the subfloor.

Recommendation: Contact a foundation contractor.

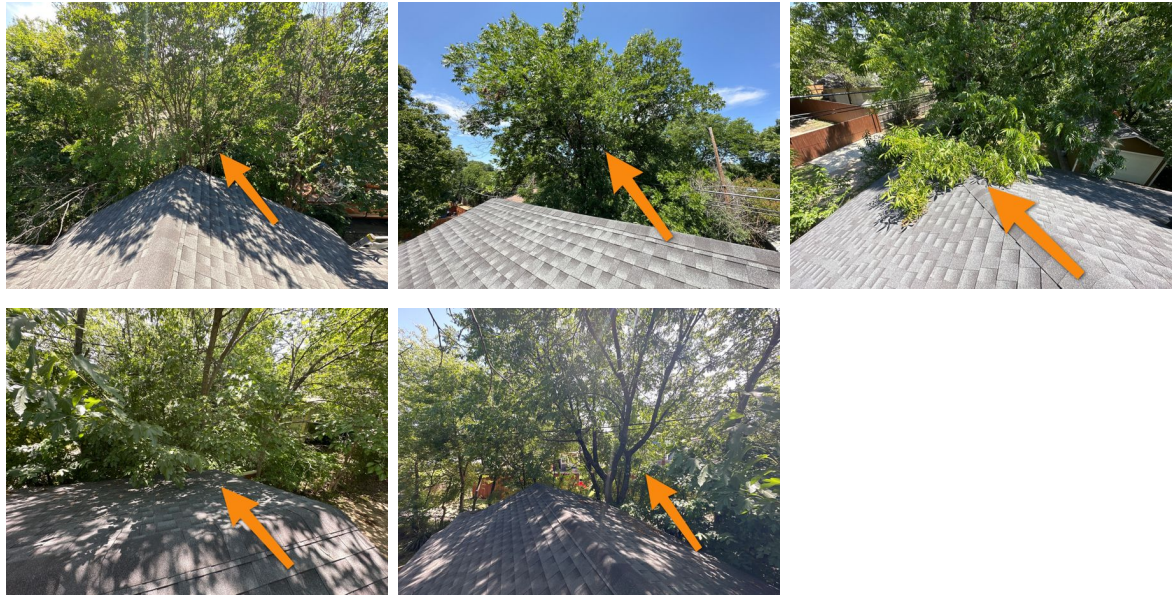
Trees observed overhanging the roof. This can cause damage to the roof and prevent proper drainage. Recommend a qualified tree service trim to allow for proper drainage.

Recommendation: Contact a qualified tree service company.

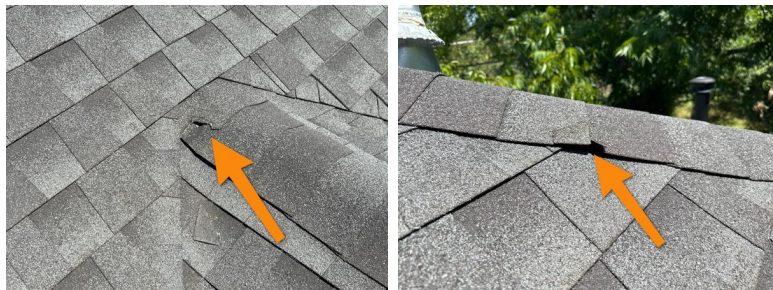
2: Damaged Shingles

Damaged shingles were observed at the time of inspection. Repair or replacement is recommended.

Recommendation: Contact a qualified roofing professional.

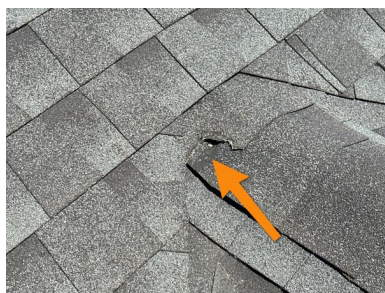
3: Fasteners - Exposed

Exposed fasteners. Fasteners should be sealed to prevent water penetration.

Recommendation: Contact a qualified roofing professional.

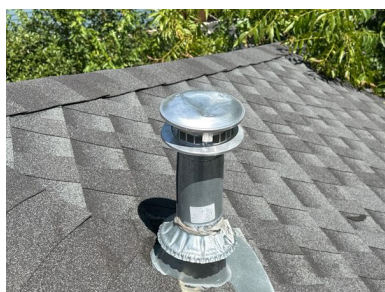
4: Possible Hail Damage - Further evaluation

There were areas of spotty damage. Possible hail exposure. Further evaluation is recommended.

Recommendation: Contact a qualified roofing professional.

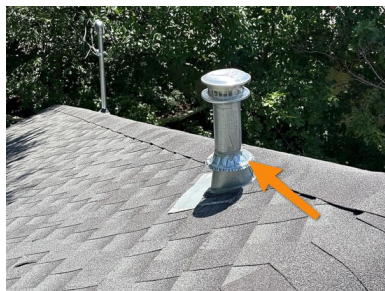
6: Metal Vent/Chimney Paint Peeling

The metal vent or chimney has missing or damaged paint. These should be painted for weather protection.

Recommendation: Contact a qualified roofing professional.

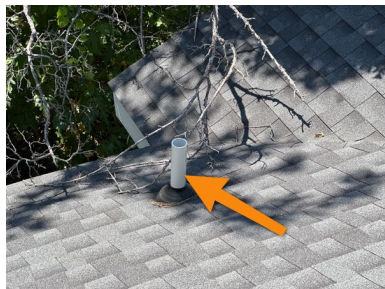
7: Plumbing Vent Paint

The PVC vent pipes at the roofline have missing or damaged paint. Vent pipes should be painted for weather protection.

Recommendation: Contact a qualified roofing professional.

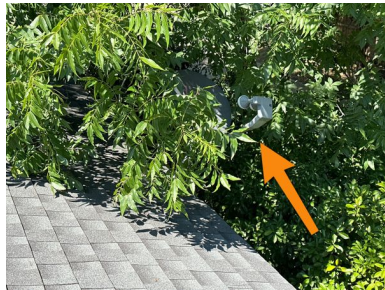
9: Satellite Dish

There was a satellite dish installed on the roof. Due to the penetrations in the roof this area is prone to future leaking.

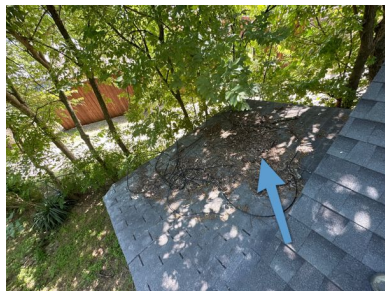
10: Roof Debris

There is buildup of debris on the roof. Removal is recommended for proper drainage.

Recommendation: Contact a handyman or DIY project

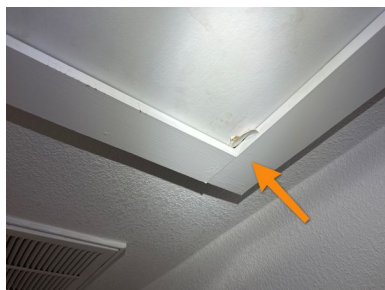
The attic access cover was damaged at the time of inspection.

Recommendation: Contact a qualified professional.

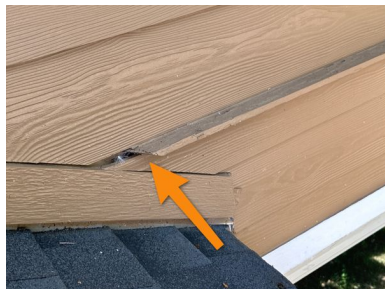
3: Damaged Siding/Trim

There were areas of cracked and damaged siding and trim materials. Repair or replacement is recommended.

Recommendation: Contact a qualified siding specialist.

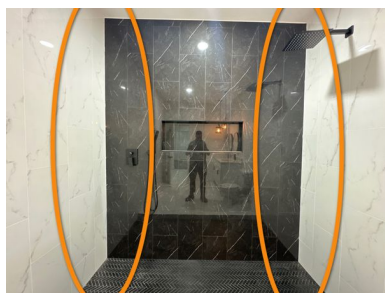
There were various areas of missing and damaged caulking and grout at the shower walls. All enclosures should be completely water tight and sealed.

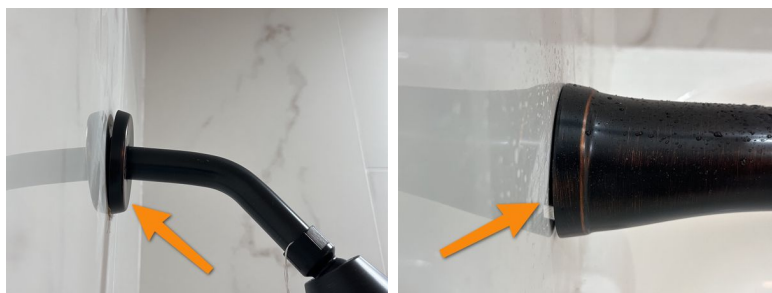
2: Escutcheon Plates - Seal at Plumbing Fixtures

The escutcheon plate and/or plumbing fixtures need to be sealed at the wall connection to prevent water from entering the wall when the water is on.

Recommendation: Contact a qualified professional.

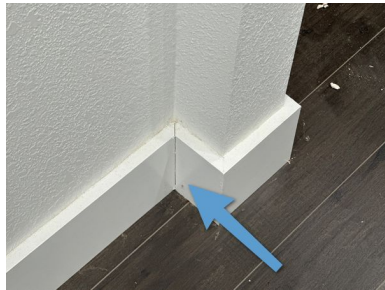
4: Trim Separation/Gapping

Trim separation was observed at areas of the interior trim materials.

Recommendation: Contact a qualified professional.

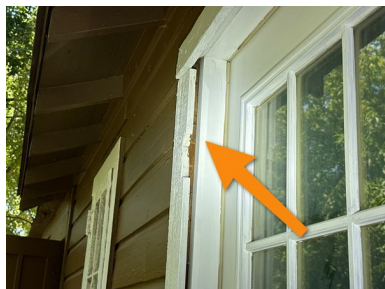
Observed door frame separation at the home.

Recommendation: Contact a qualified professional.

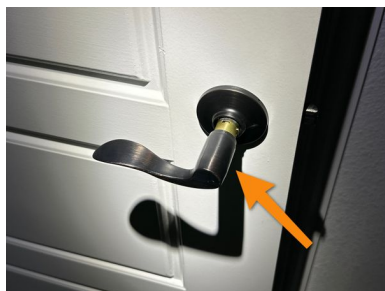
The doorknob was damaged. Repair replacement is recommended.

Recommendation: Contact a qualified door repair/installation contractor.

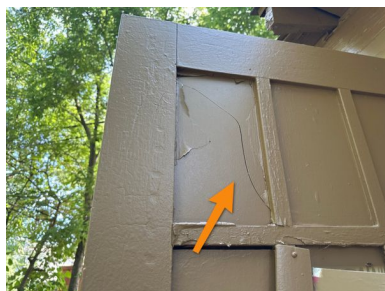
5: Broken Glass

The glass is broken at the door.

Recommendation: Contact a qualified door repair/installation contractor.

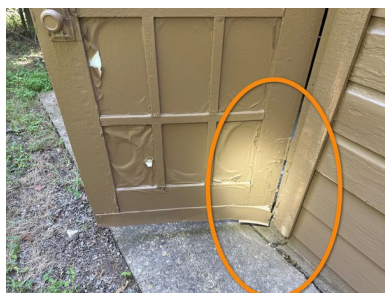
7: Door Rot/Water Damage

Rot/water damage was noted at the exterior door. Recommend a qualified professional evaluate and repair or replace.

Recommendation: Contact a qualified professional.

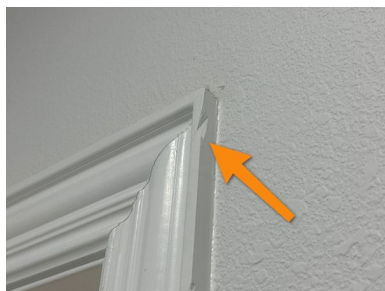
8: Door Frame Damage

The door frame is damaged. Repair is recommended.

Recommendation: Contact a qualified door repair/installation contractor.

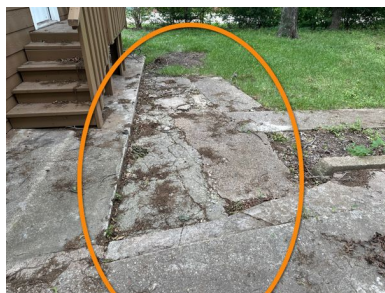
The patio surface was cracked and damaged.

Recommendation: Contact a qualified concrete contractor.

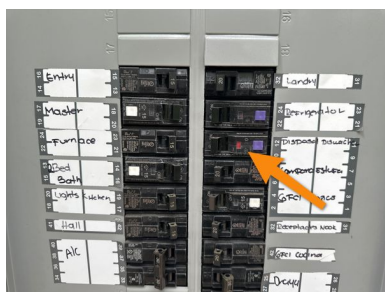
The test breaker did not trip when tested. Repair or replacement is recommended.

Recommendation: Contact a qualified professional.

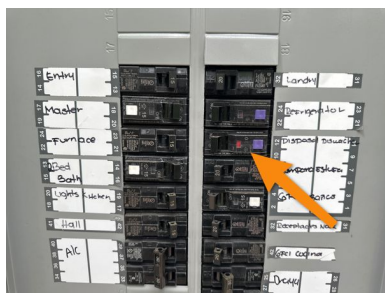
3: Damaged Breaker

Damaged breaker was observed in the electrical panel. Replacement is recommended.

Recommendation: Contact a qualified professional.

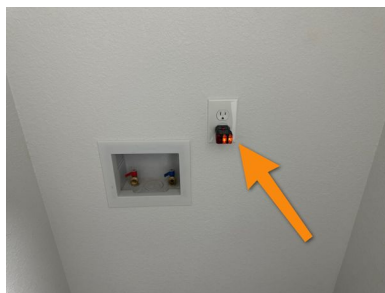
Not all TREC required areas were GFCI protected. Required areas include, but are not limited to the Kitchen, all Bathroom/Restrooms, Garage, Exterior, Crawlspace, Unfinished Basements, Laundry Rooms, and Bar areas.

Recommendation: Contact a qualified electrical contractor.

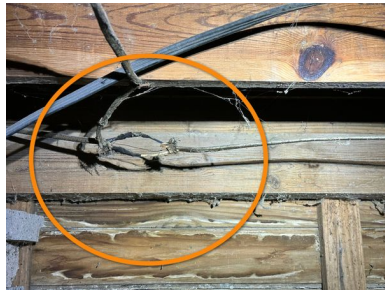
3: Exposed Wire Terminations

Exposed wire terminations were present.

Recommendation: Contact a qualified electrical contractor.

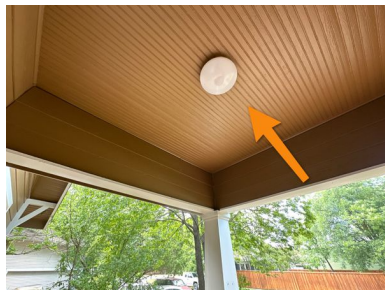
Some lights did not respond to testing.

Recommendation: Contact a qualified electrical contractor.

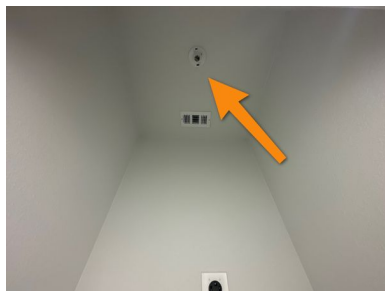
7: Missing/Damaged Pull Chain

The pull chain was missing/Damaged at the fixture.

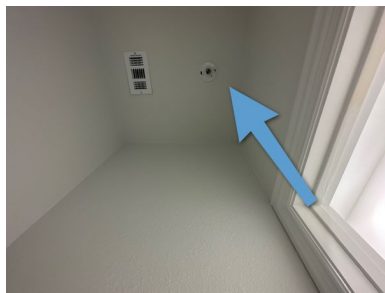
Some light bulbs were missing at the time of inspection. Inspector was unable to check the function of these fixtures.

Recommendation: Contact a qualified professional.

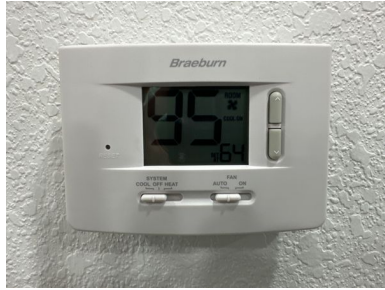
The temperature in the house at the time of inspection was higher than the maximum allowed temperature setting for the heat. Heat was not able to be tested due to this condition.

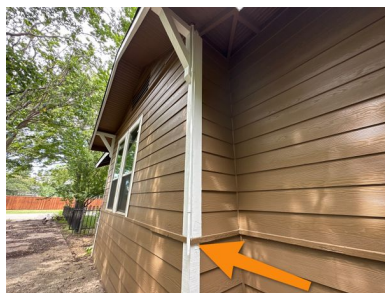
The secondary drain line was not properly terminating at the soffit. The secondary drain line should be installed in a conspicuous location so if a backup is present, it can be rectified before damage occurs. Repair is recommended.

Recommendation: Contact a qualified heating and cooling contractor

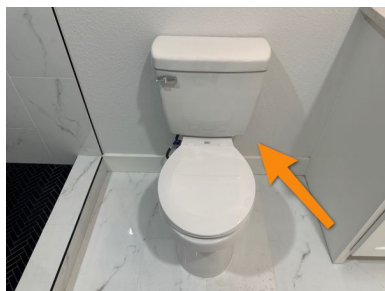
The toilet tank is loose at the tank/bowl connection point, which can result in possible leakage.

Recommendation: Contact a qualified plumbing contractor.
