GREENWORKS SERVICE COMPANY

GW STANDARD HOME INSPECTION

PROPERTY INSPECTION REPORT FORM

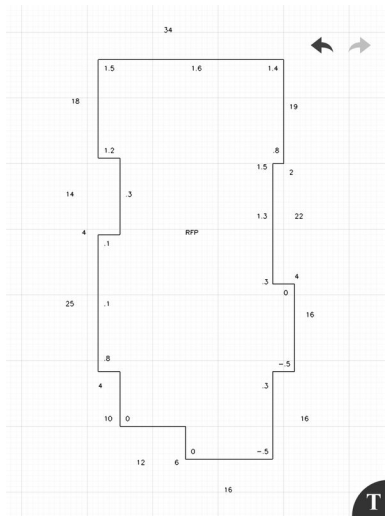
Elevation Map:

Based on the elevation survey taken at the time of inspection there were areas of the home that had a higher or lower elevation than the rest of the home. These areas should be monitored for continued movement. If you have any concerns about the foundation life expectancy, insurability, or the potential for future problems, a professional engineer should be consulted.

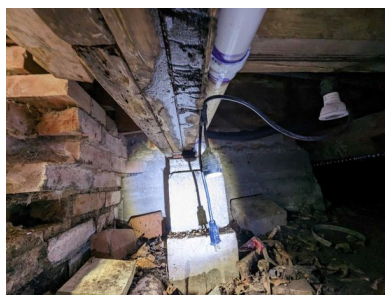
3: Crawlspace - Active water leak

Active water leak was observed within the crawl space. Moisture penetration was confirmed with a moisture meter. Repair is recommended.

Recommendation: Contact a qualified plumbing contractor.

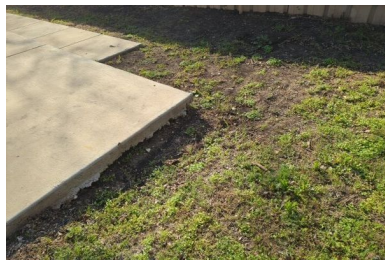
3: Washout

Washout was noted around the perimeter of the home. Repair is recommended.

Recommendation: Contact a qualified landscaping contractor

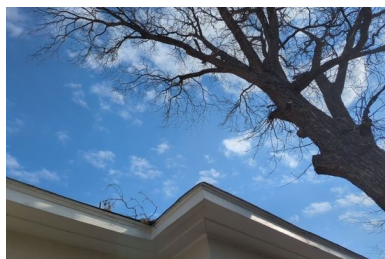
Trees observed overhanging the roof. This can cause damage to the roof and prevent proper drainage. Recommend a qualified tree service trim to allow for proper drainage.

Recommendation: Contact a qualified tree service company.

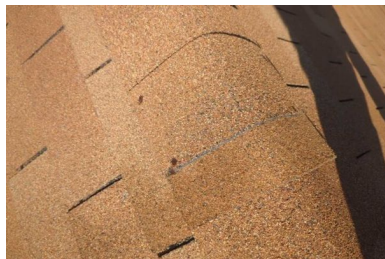
Exposed fasteners. Fasteners should be sealed to prevent water penetration.

Recommendation: Contact a qualified roofing professional.

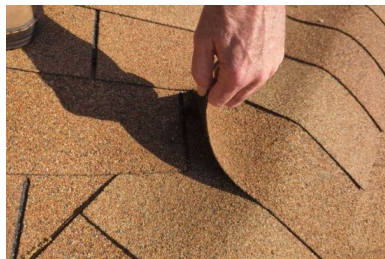
6: Shingle Uplift - Lack of Bonding

Some of the upper shingles have not bonded sufficiently to the shingles located beneath them at the sealing strip. This could have been caused by installation of the shingles during cold weather, or that dust/dirt covered the sealing strip. These shingles should be monitored.

Recommendation: Recommend monitoring.

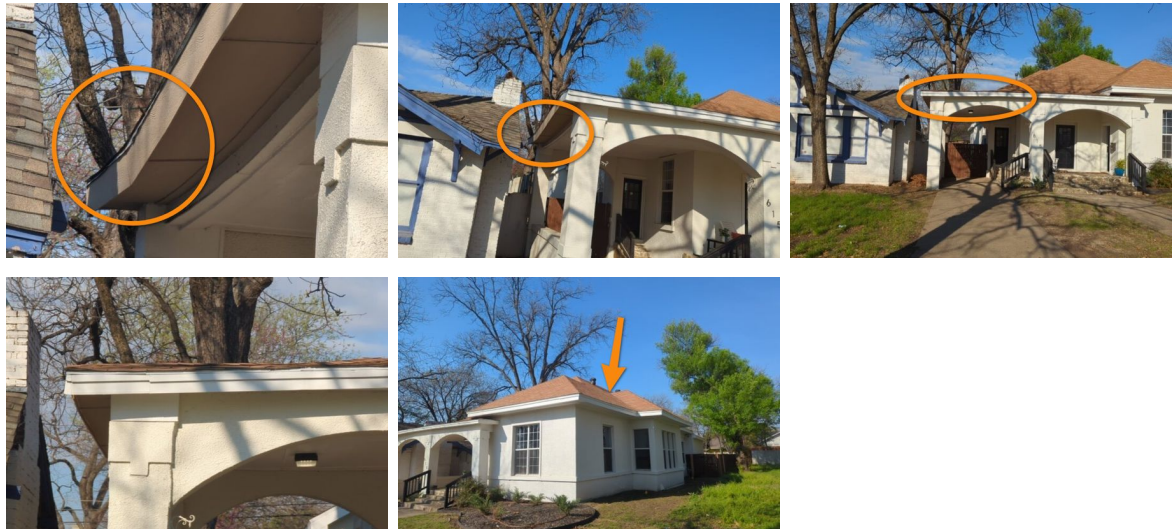
7: Sagging Roof

There were sags or unlevel areas in the roof line. This is common and can be caused by several factors. Further evaluation is recommended, if so desired.

Recommendation: Contact a qualified professional.

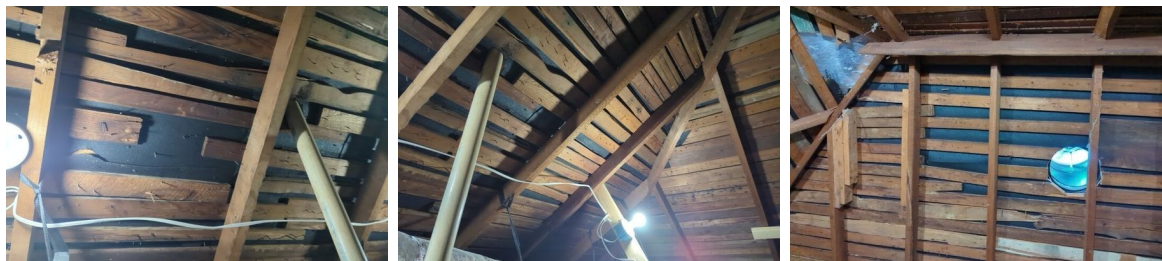
7: Insufficient roof decking

There were areas void of any structural r

Recommendation: Contact a qualified professional.

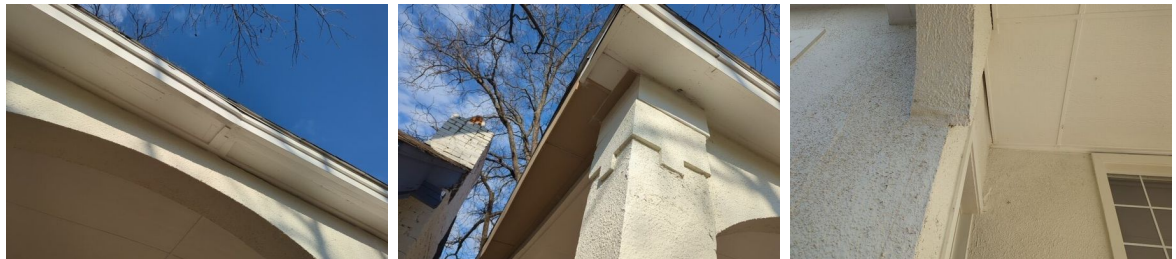
There were repaired cracks and separations present at the exterior wall. Repairs cannot be verified for proper installation and any hidden areas were not visible and may contain further damage.

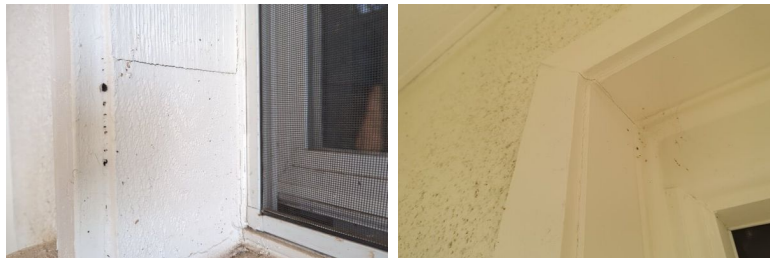
1: Separation - Exterior Trim

Areas of trim were separating and lacked proper caulking. These areas are for conducive for water penetration into the home.

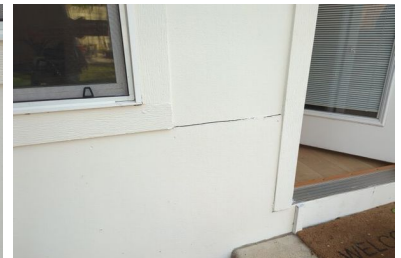
There were gaps at the exterior surfaces. These areas can allow water penetration into the structure. It is recommended these areas be sealed.

Recommendation: Contact a qualified professional.

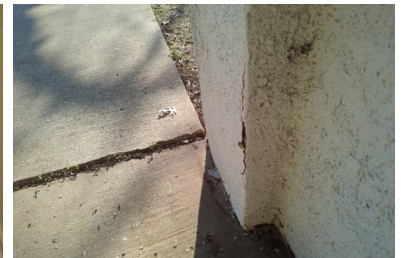
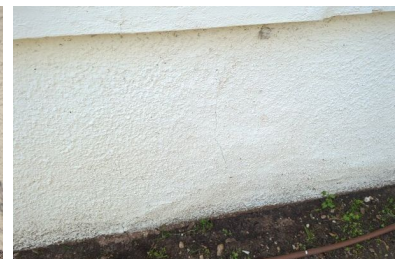
5: Veneer damage

Various areas of cracking and damage noted to the exterior veneer materials. Repair is recommended.

Recommendation: Contact a qualified professional.

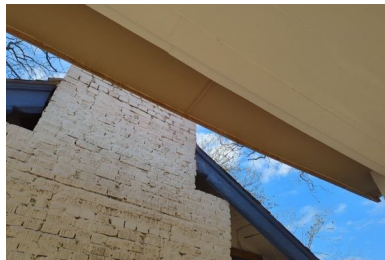
6: Unfinished Area at Exterior

Unfinished area noted at the exterior of the home.

Recommendation: Contact a qualified professional.

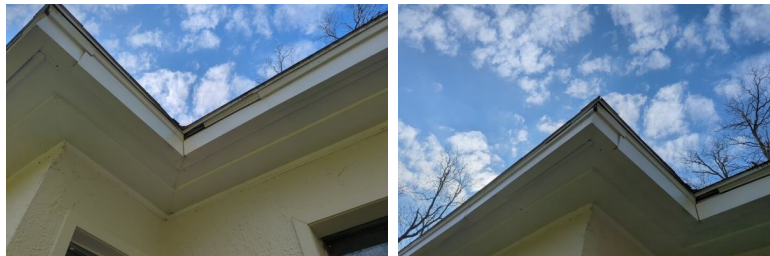
7: Missing Trim

Observed missing trim material. Water and/or pests can enter these areas. Repair is recommended.

Recommendation: Contact a qualified professional.

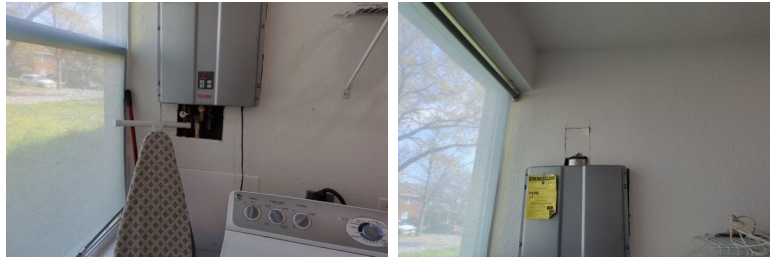
5: Wall Damage

There was damage to the walls within the home. Repair is recommended.

Recommendation: Contact a qualified general contractor.

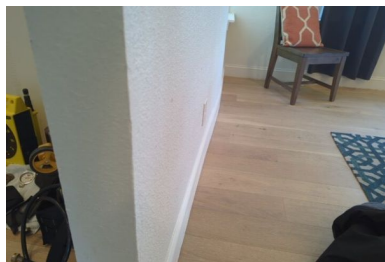
6: Bowing or Bulging Wall

Areas of bowing or bulging were observed at the wall.

Recommendation: Contact a qualified professional.

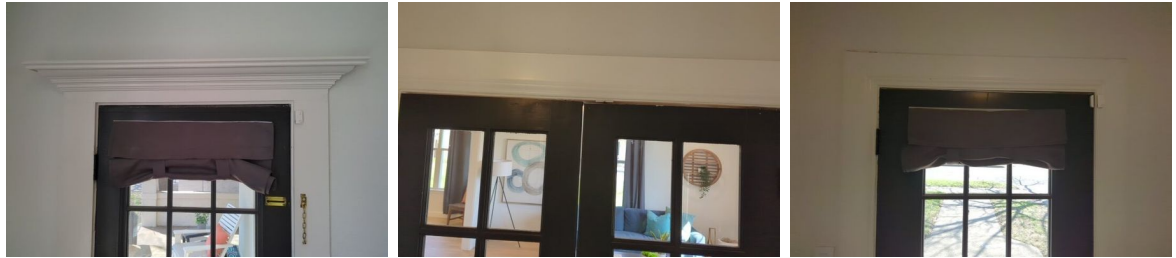
2: Out of Square

Some doors are out of square.

Recommendation: Contact a qualified door repair/installation contractor.

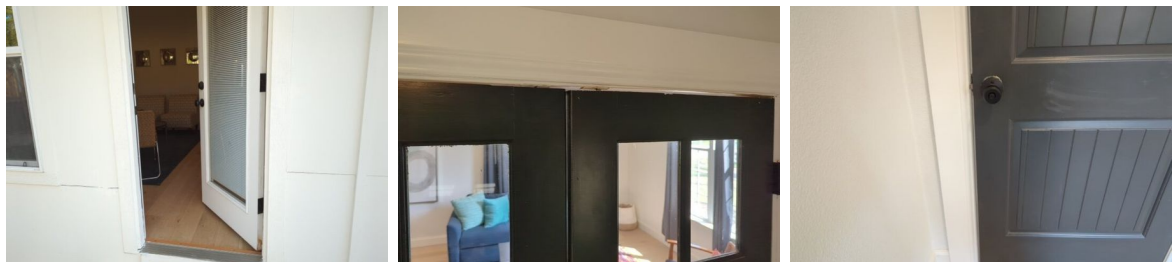
3: Not Latching

There were doors present that did not latch when shut.

Recommendation: Contact a qualified door repair/installation contractor.

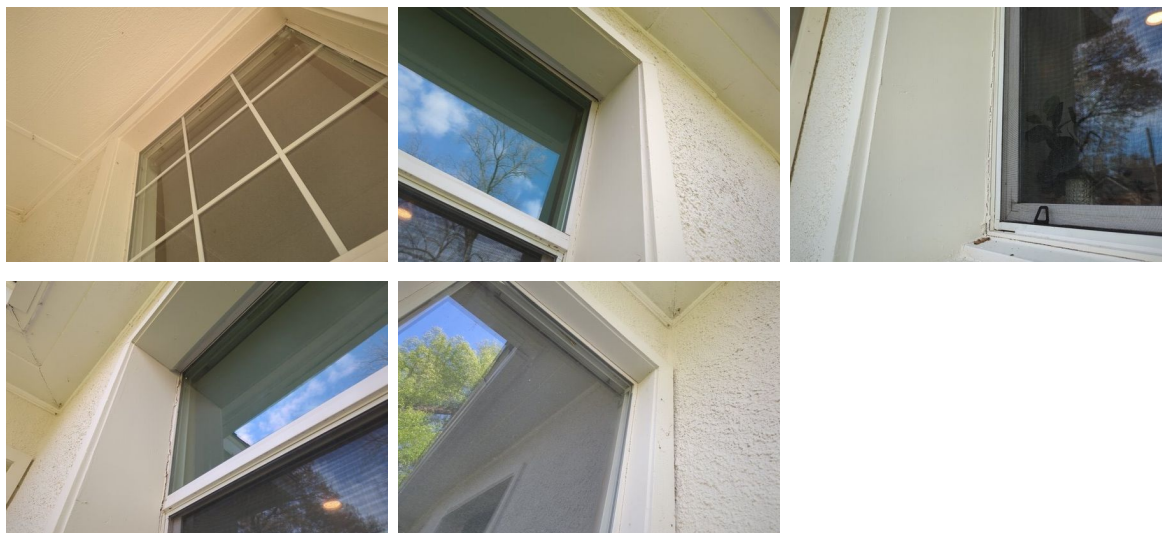
The caulking was separated and/or missing around some windows at the exterior.

Recommendation: Contact a handyman or DIY project

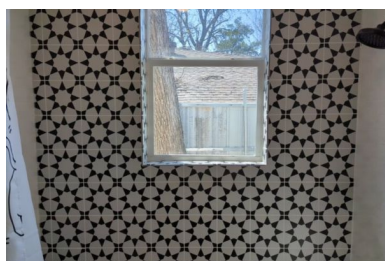
Safety glass should be present within 5 feet of the tub edge. Markings were not found.

Recommendation: Contact a qualified professional.

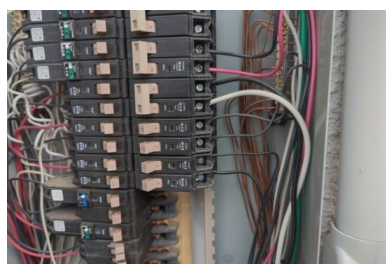
The panel had neutral (white) wires being used as hot (black) wires and were not taped to indicate the same.

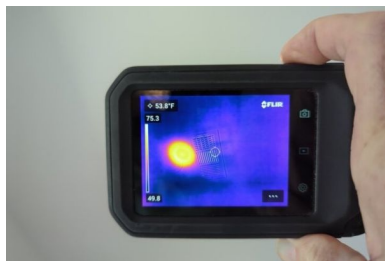
The register does not appear to be connected to the unit.

Recommendation: Contact a qualified professional.

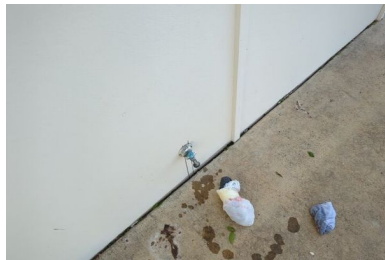
The exterior faucet was loose at the wall connection point.

Recommendation: Contact a qualified plumbing contractor.

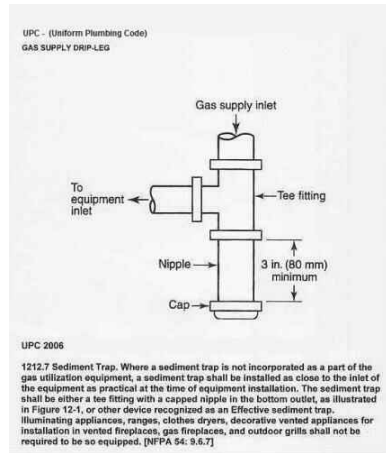
Drip leg or sediment trap was not observed on the gas line at the unit.

Recommendation: Contact a qualified plumbing contractor.

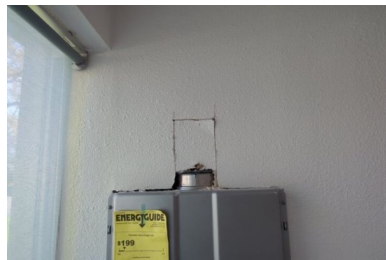
2: Flue Insufficient Clearance

The vent pipe had insufficient clearance to combustible materials. Gas flues should have a clearance of 1.5" from building materials surrounding the flue pipe.

Recommendation: Contact a qualified plumbing contractor.

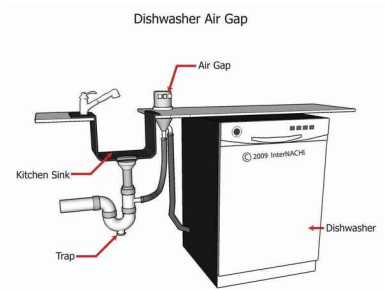
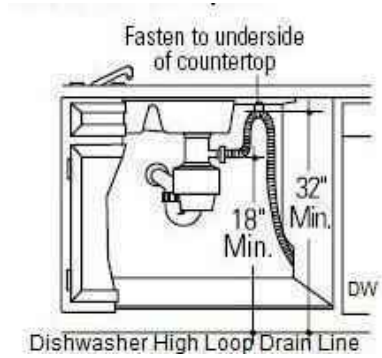
The dishwasher drain line needs backflow prevention. A check valve, air gap or high loop could be installed on the drain line.

Recommendation: Contact a qualified appliance repair professional.

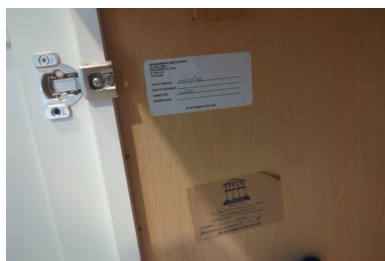
Previous WDI Treatment:

Evidence of a previous wood destroying insect treatment was observed.

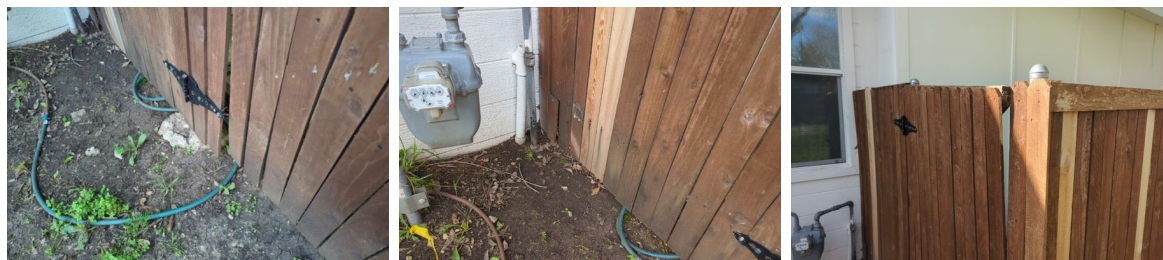
Damage noted to the fence around the home. Recommend a qualified fence contractor evaluate and repair.

Recommendation: Contact a qualified fencing contractor

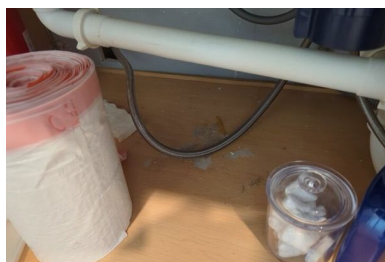
Observed damage to some cabinets within the property. Recommend a qualified professional evaluate and repair.

Recommendation: Contact a qualified cabinet contractor.

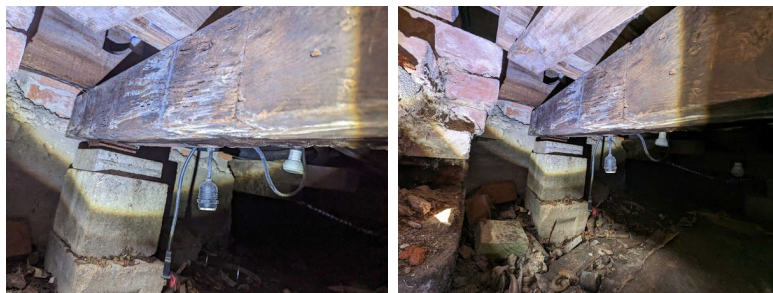
4: Wood Destroying Insect (WDI) Activity Observed

There were areas of wood destroying insect activity at the home. It is recommended that a treatment be performed.

Recommendation: Contact a qualified pest control specialist.

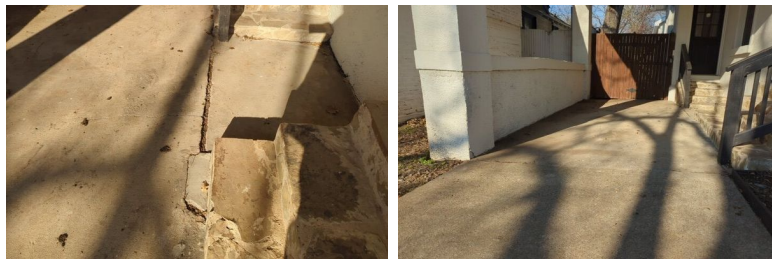
6: Driveway Settle

The driveway has settled away from the house.

Recommendation: Contact a qualified professional.
