GREENWORKS SERVICE COMPANY

GW STANDARD HOME INSPECTION

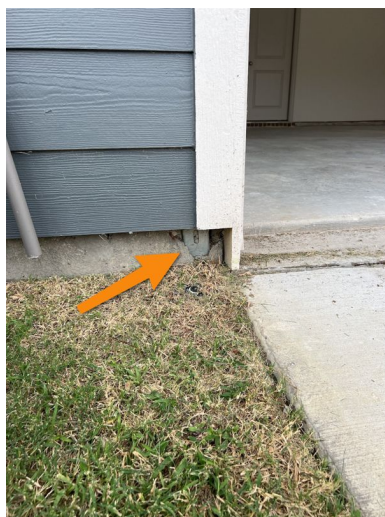
Back left

1: Missing Foundation Wall Material

There was an area of missing concrete material at the foundation wall and plumbing was exposed in this area.

Recommendation: Contact a qualified concrete contractor.

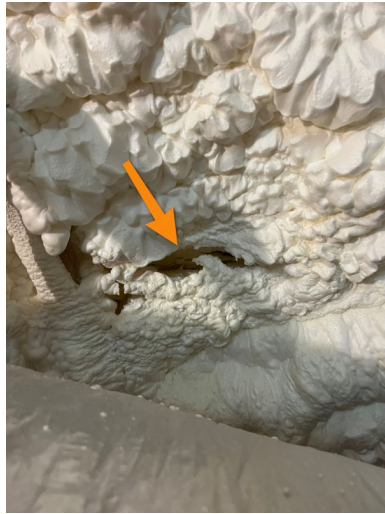
There were gaps in the foam in the attic. These areas should be sealed from the exterior.

Recommendation: Contact a qualified professional.

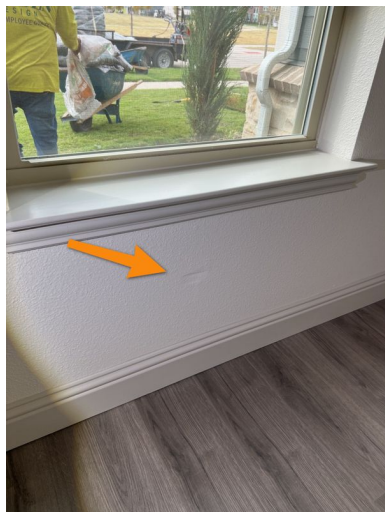
Living Room

1: Wall Damage

There was damage to the walls within the home. Repair is recommended.

Recommendation: Contact a qualified general contractor.

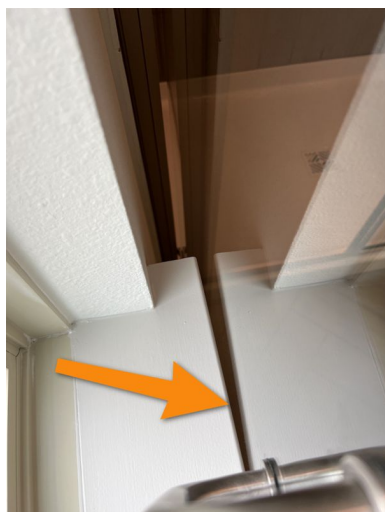
Master/Primary shower

Observed door(s) in the home that collide with other doors/objects when in use. Recommend further evaluation and repairs as necessary.

Recommendation: Contact a qualified professional.

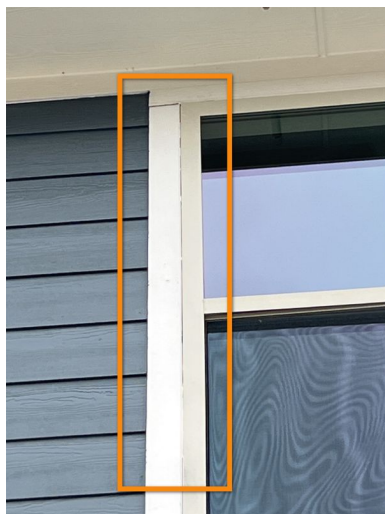
Back

The caulking was separated and/or missing around some windows at the exterior.

Recommendation: Contact a handyman or DIY project

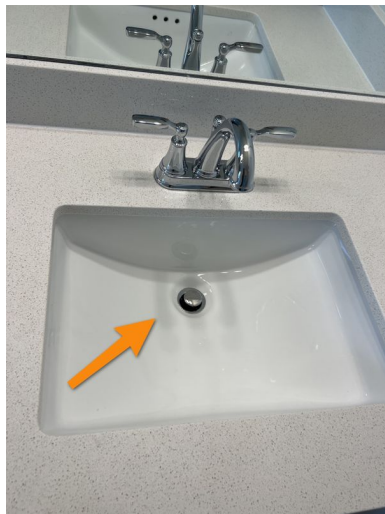
Master/Primary Bathroom

The sink stopper did not hold water when engaged.
