## STRUCTURAL ENGINEERING INSPECTION

### General: Purpose - Roof Framing Review

As requested, personnel of GreenWorks Engineering and Consulting have completed a structural review of the address referenced above. The purpose of the observation was to collect information necessary to assess the condition and performance of the new roof framing supporting the new RTUs. Structural drawings from Wright Structural Engineers, project number 230764, dated May 18, 2023 were provided by the client.

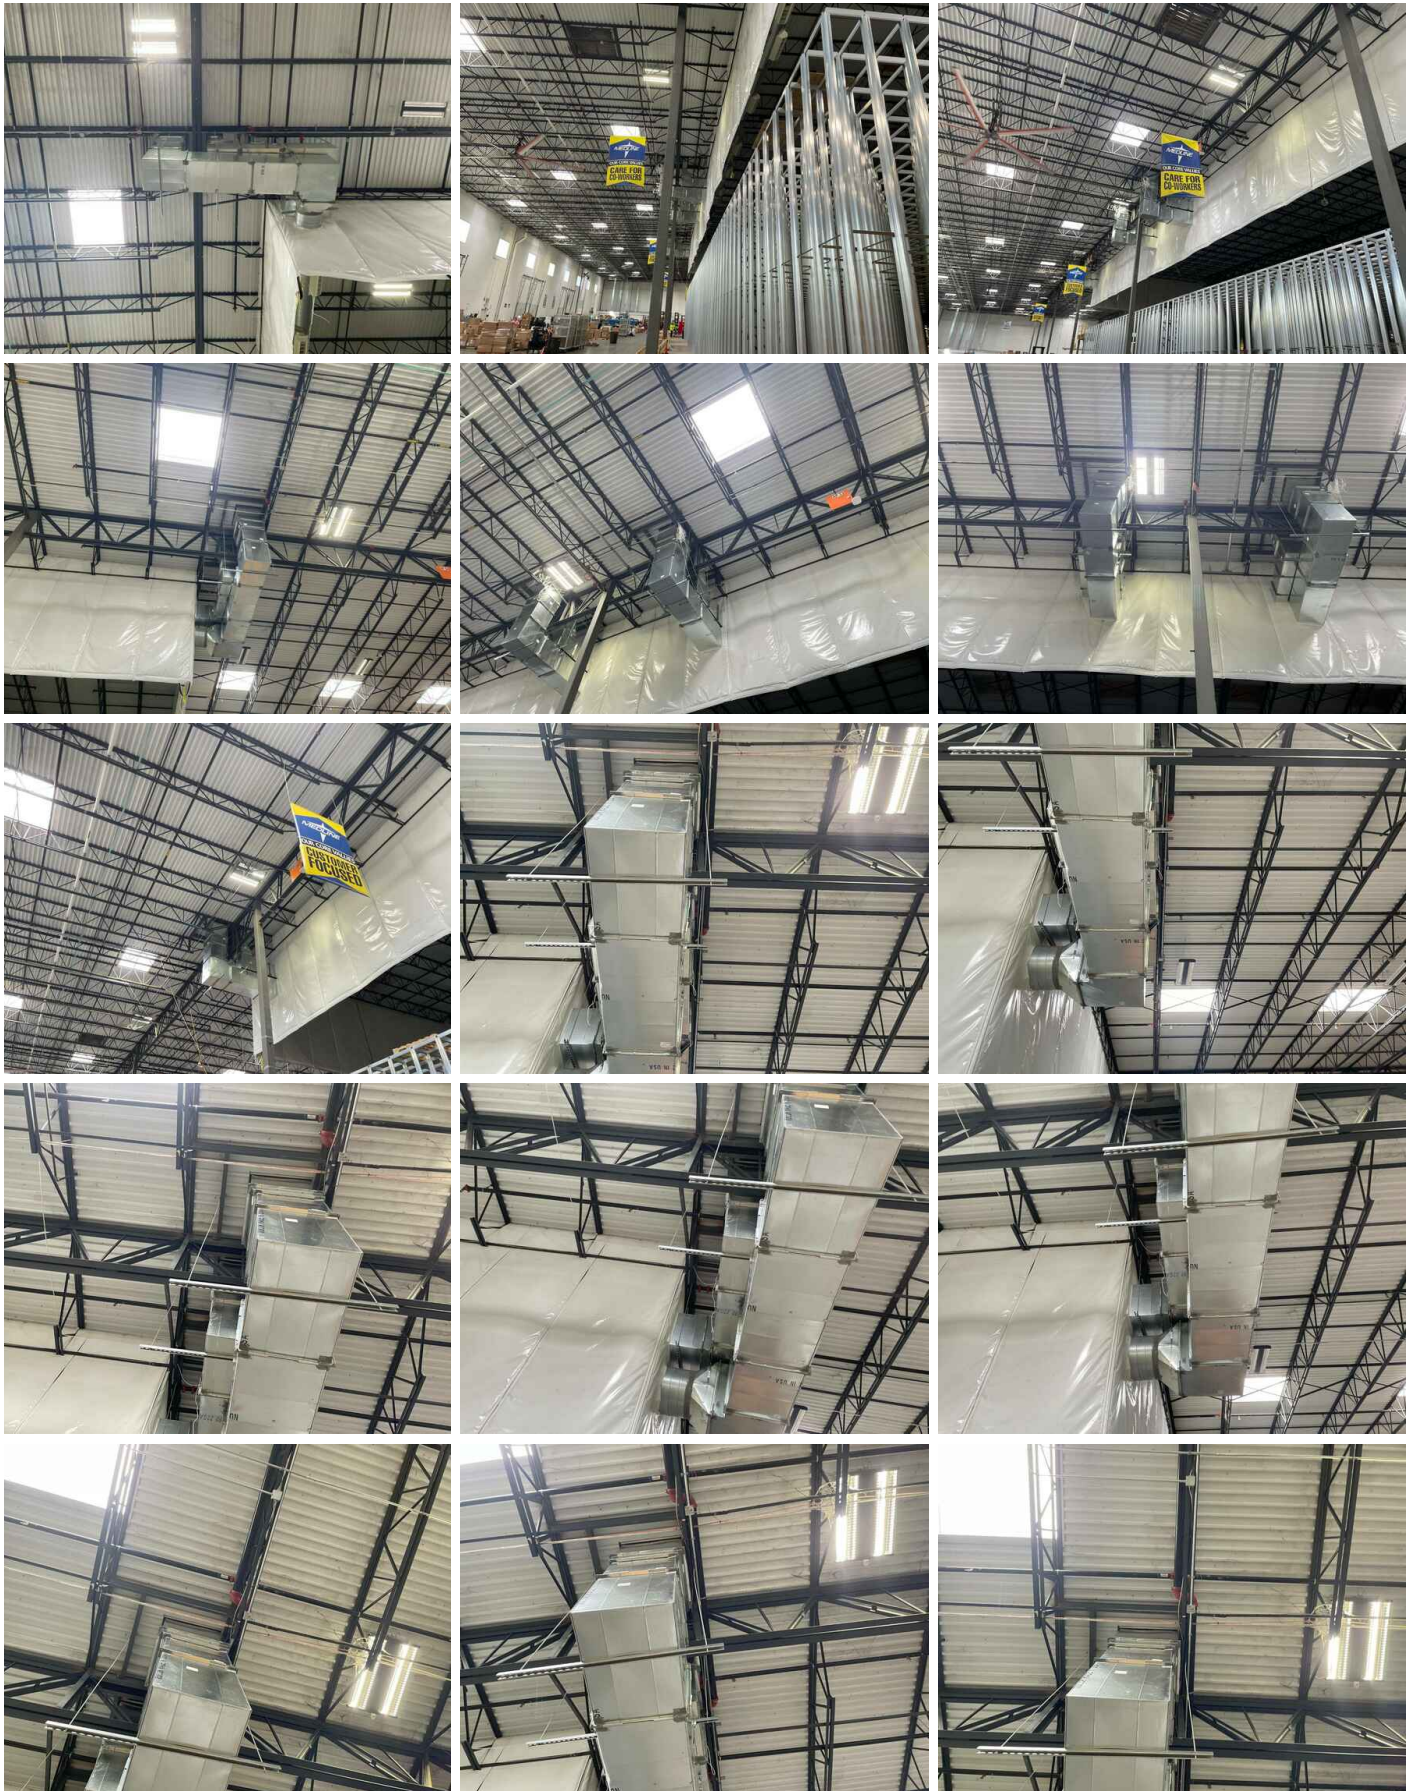
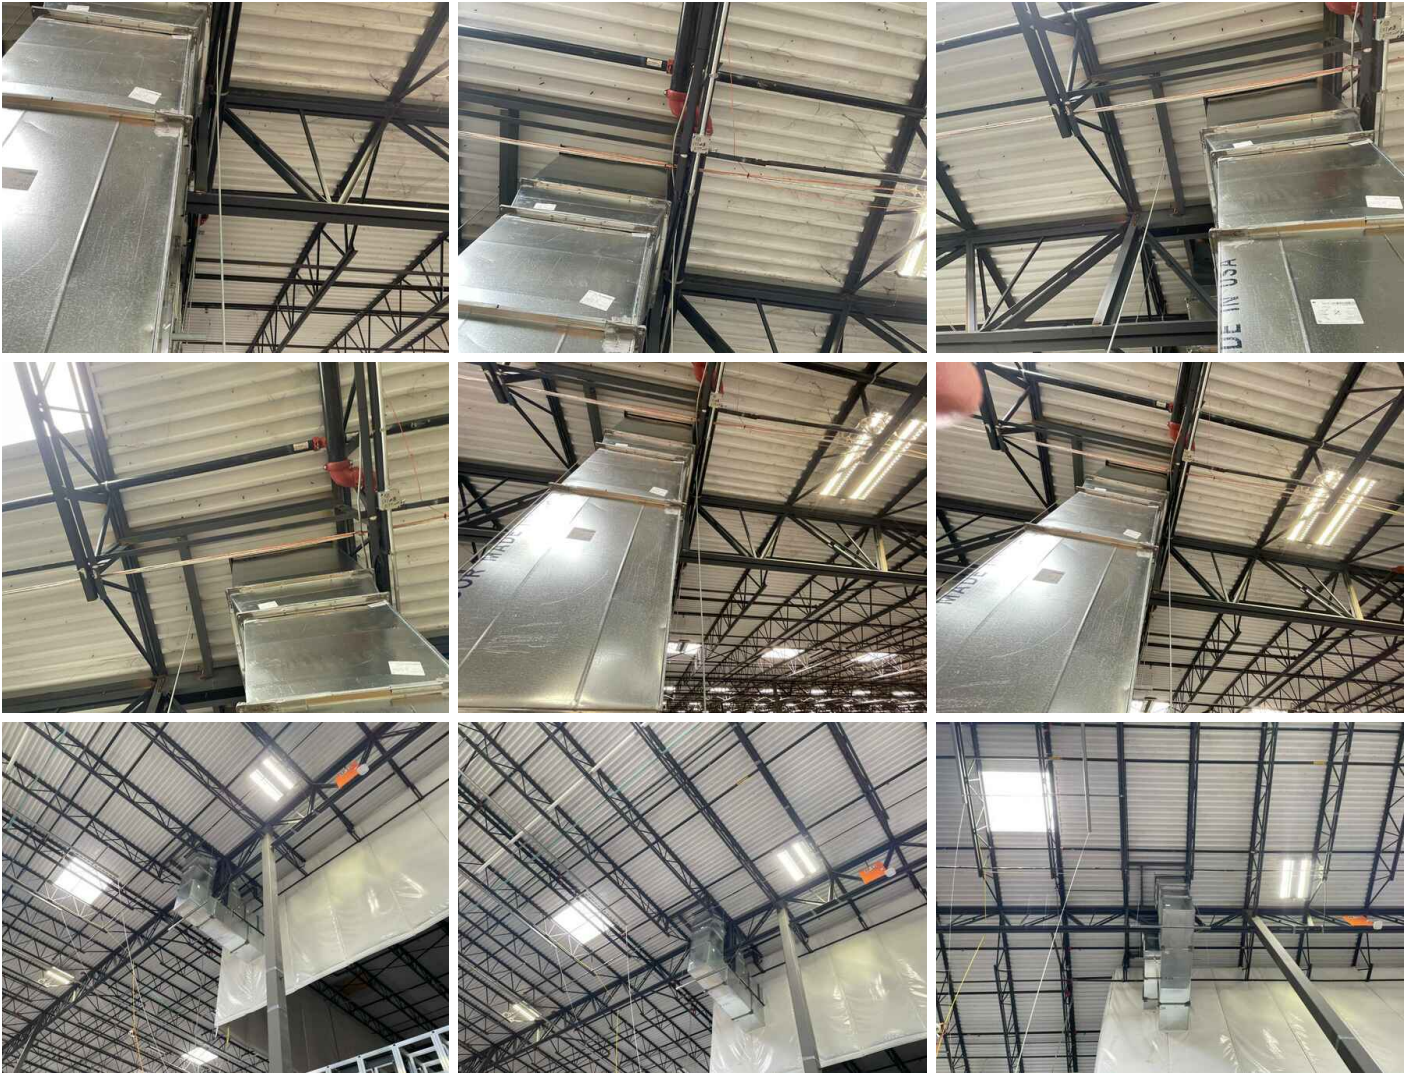
Per the client, four new RTUs were installed along column line J (furthest south bay) of the structure. New RTU framing was supported by C8x11.5 along all supporting edges of the RTU. All C8x11.5 were welded all around to the existing steel joist with additional (2) L2-1/2"x2-x1/2"x3/16 angles added to the steel joists web vertically.

Based on our observations, the subject framing appeared to be in good condition and in substantial compliance with the referenced documents. No apparent structural distress was observed. It is our opinion that the subject framing is adequate to support the current loads and does not require structural mitigation.
