STRUCTURAL ENGINEERING INSPECTION

APRIL 8, 2024

Project Information: GreenWorks Project Information: Inspection		Project Information: Report Issue
Project Number	Date	Date
106936	04/08/2024	04/16/2024

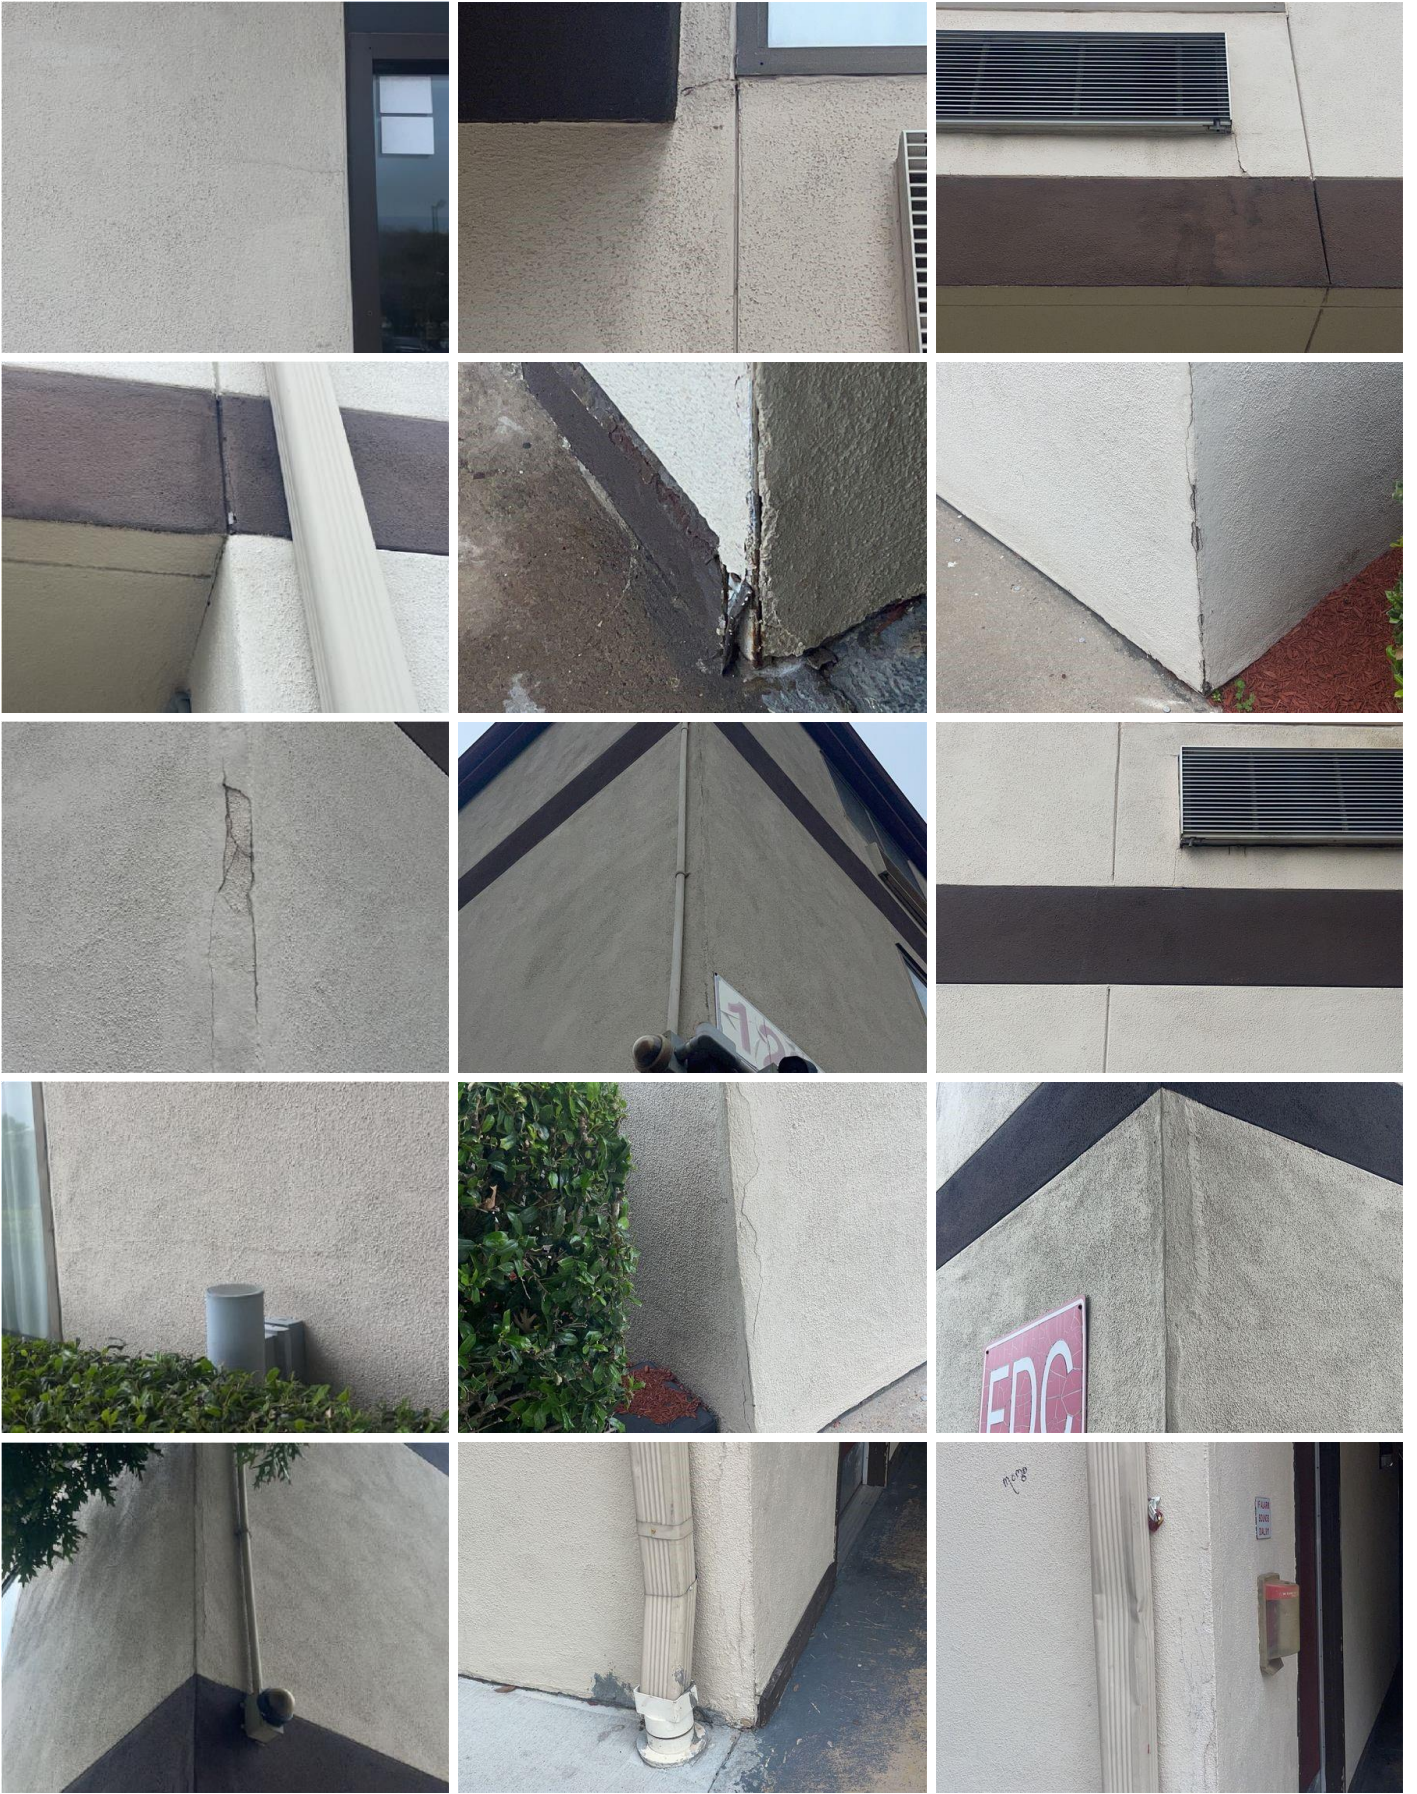
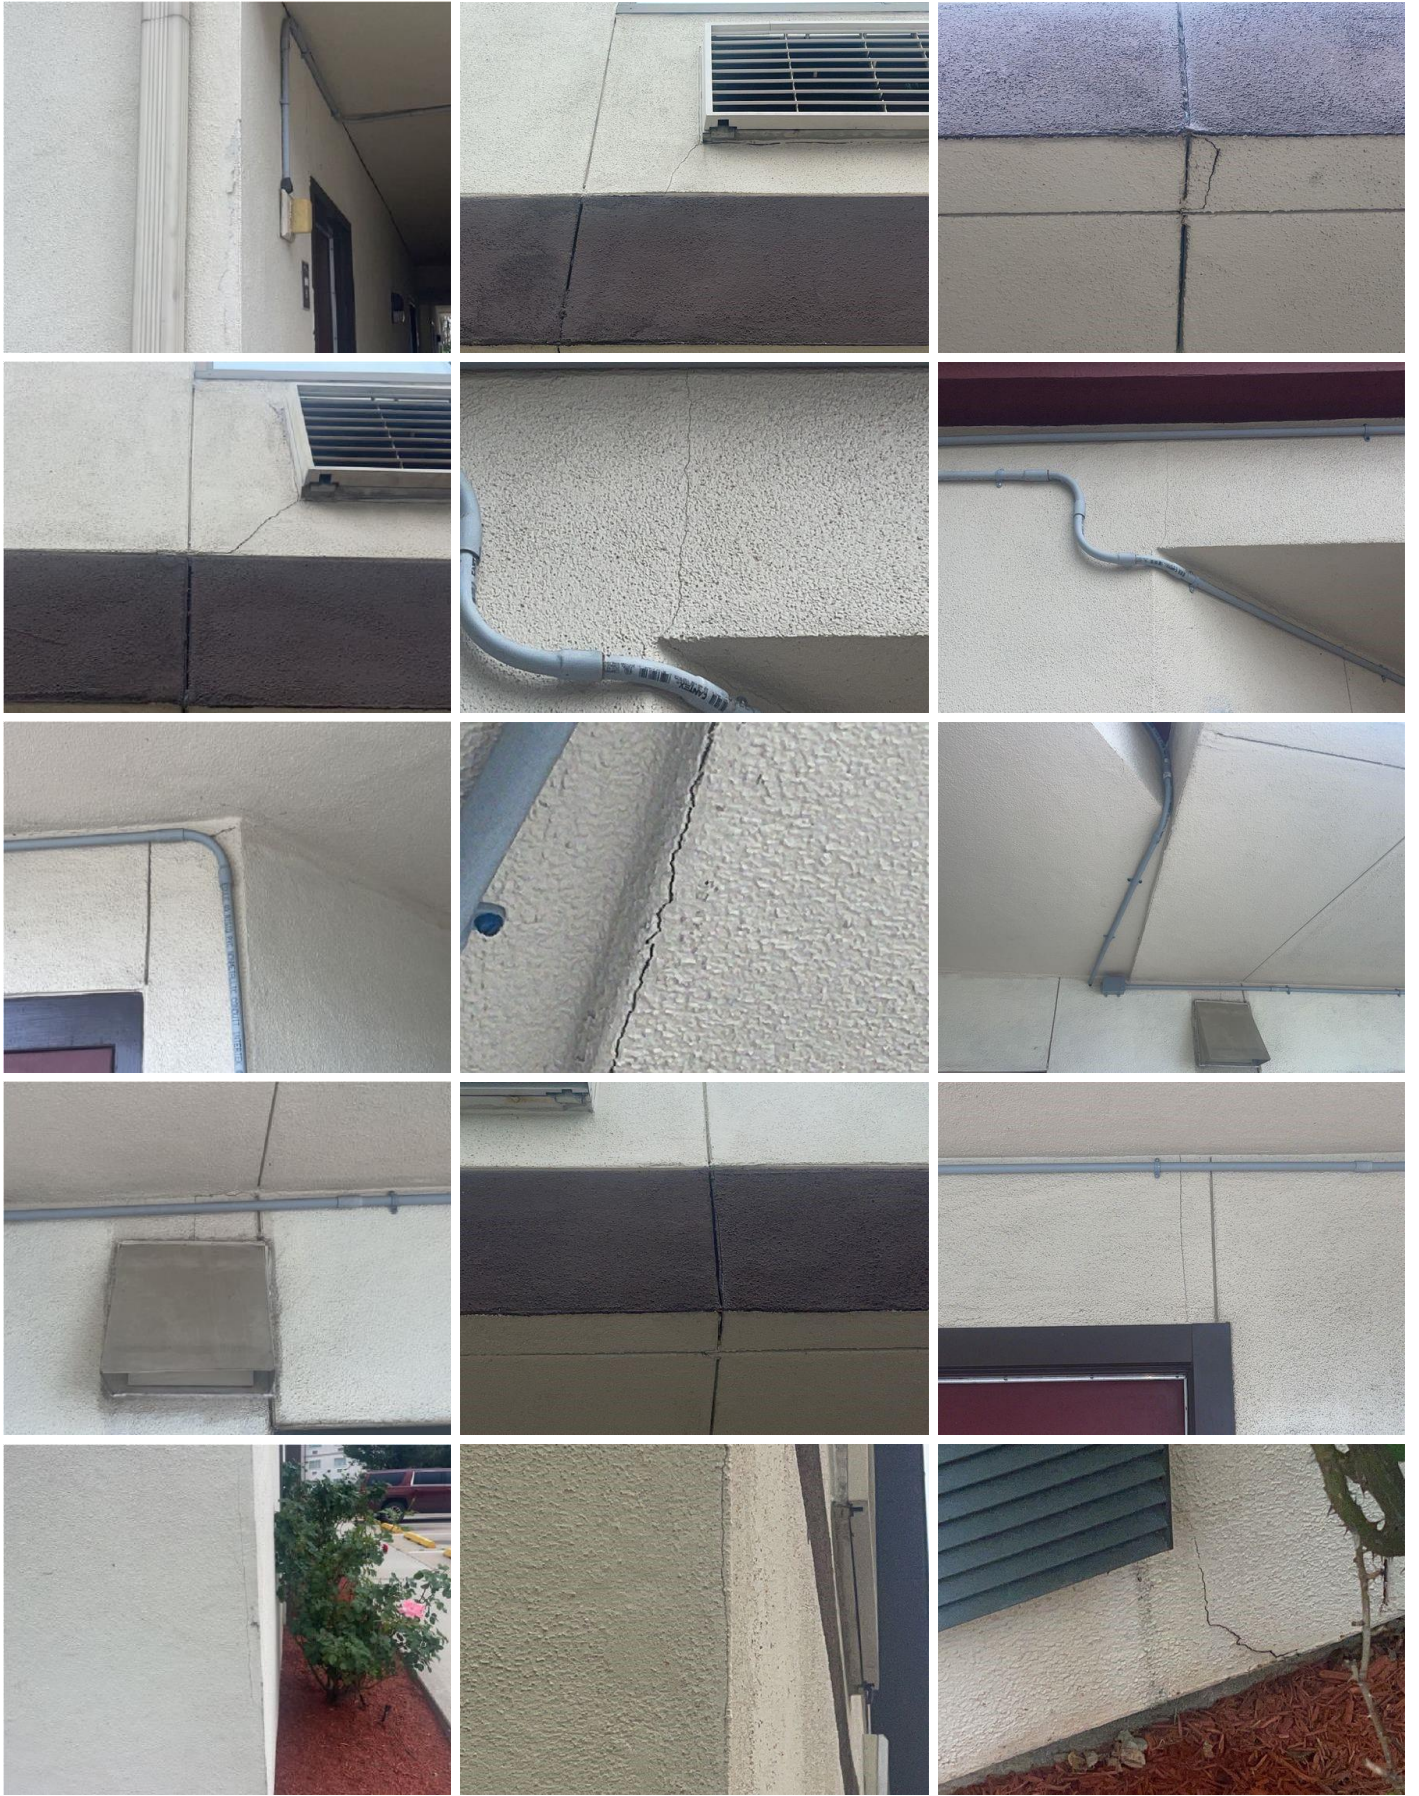
Exterior Distress: Stucco Veneer Cracks

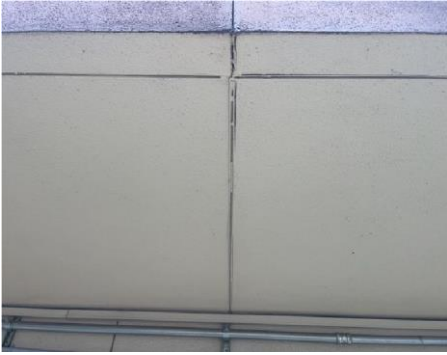
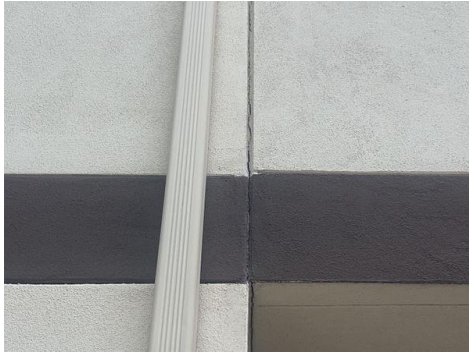
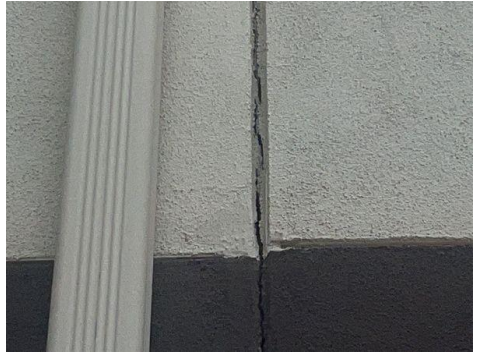
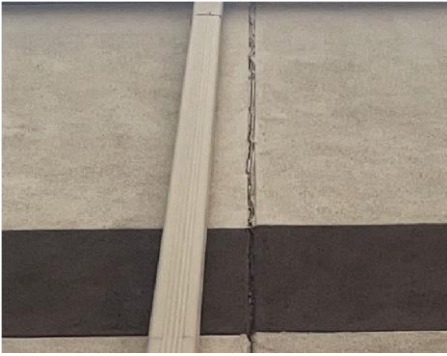
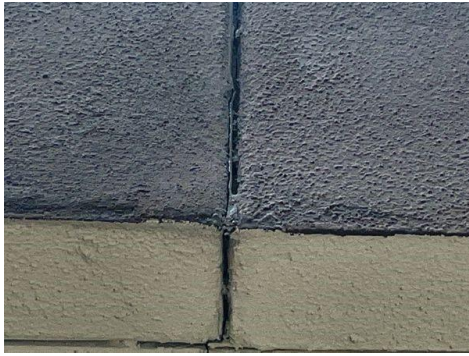
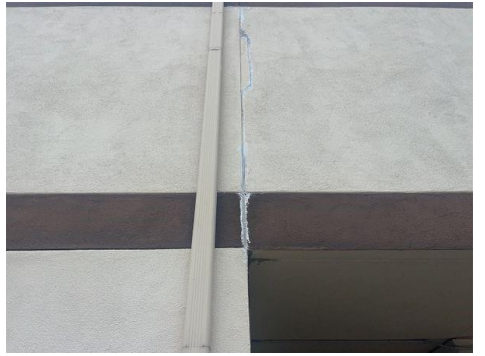
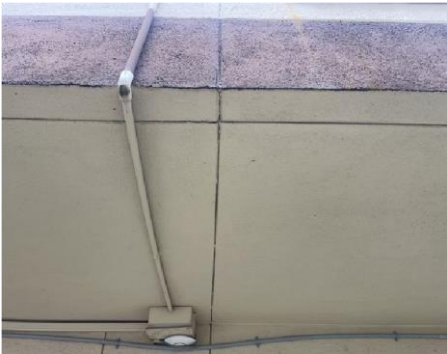
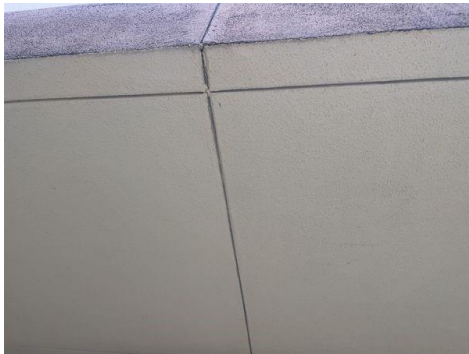
Exterior Distress: Expansion Joint Separation

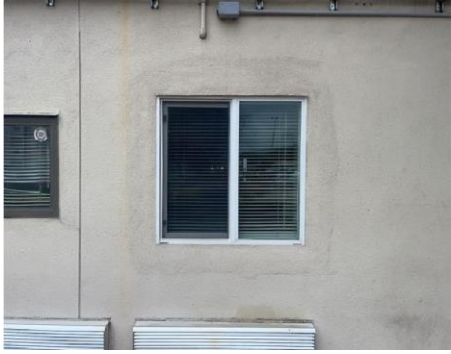
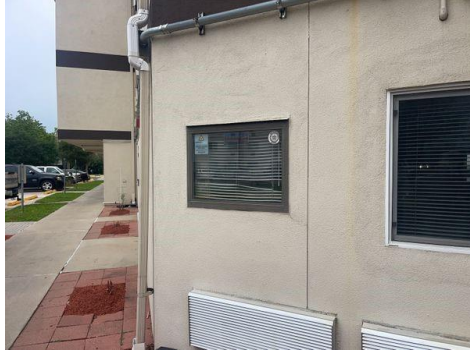
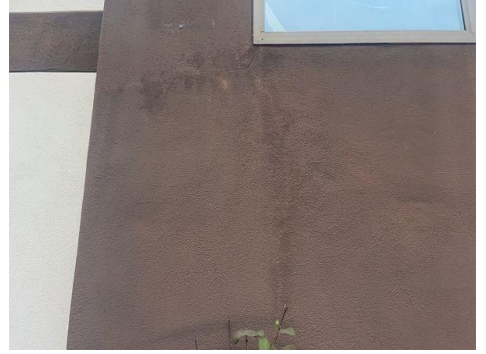
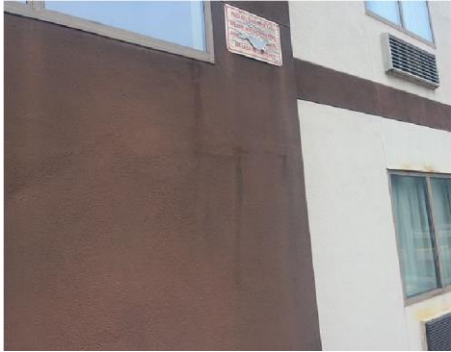
Exterior Distress:

Previous Repair

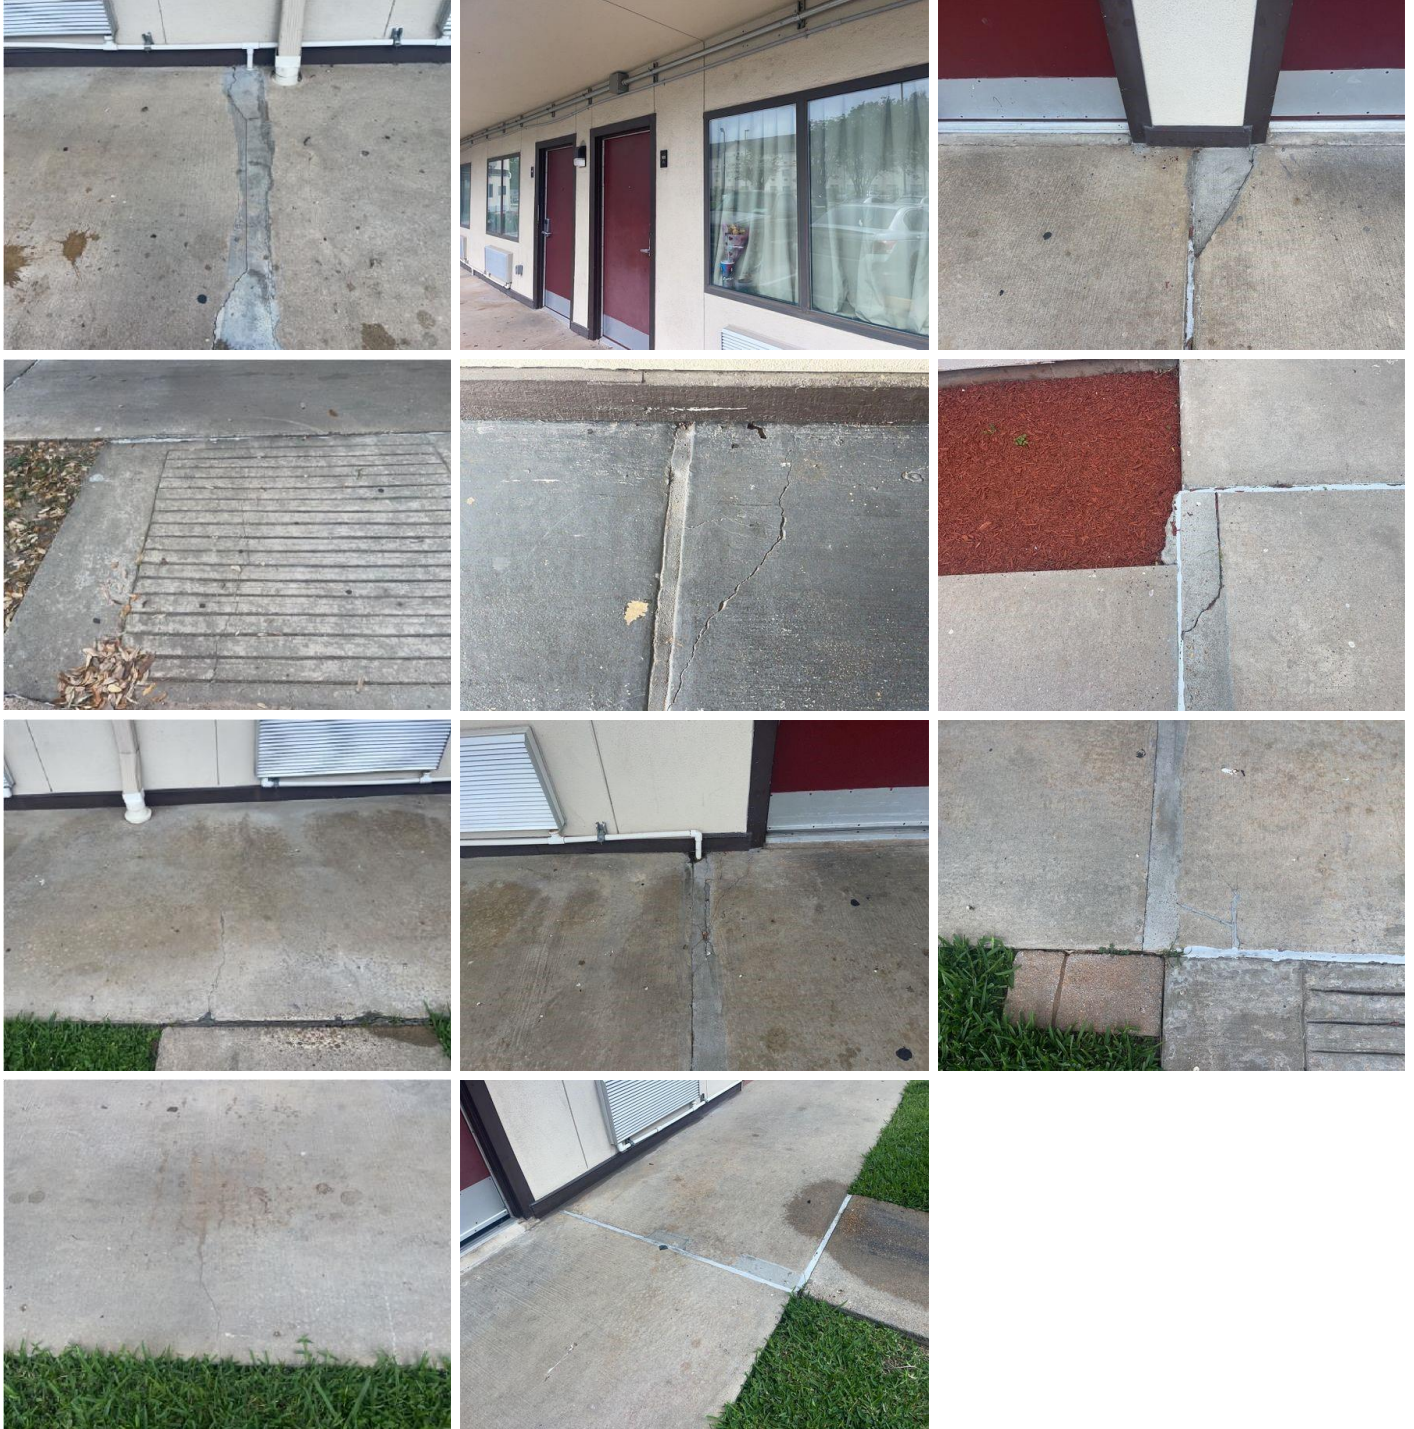
Exterior Distress:

Sidewalk Cracks

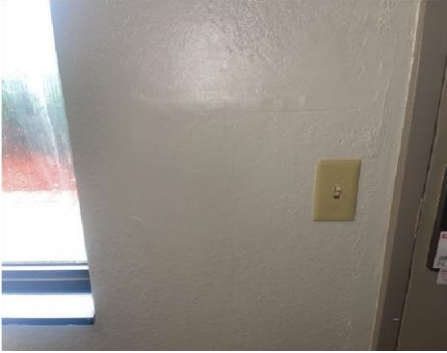
128

Interior Distress: Repaired Cracks

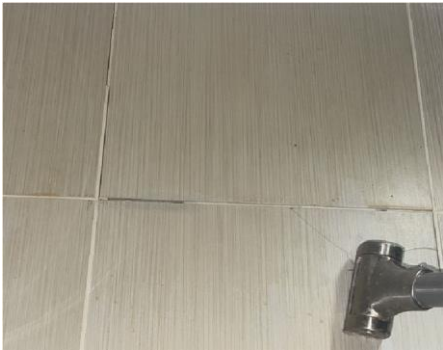
128

Interior Distress: Wall Tile
Cracking

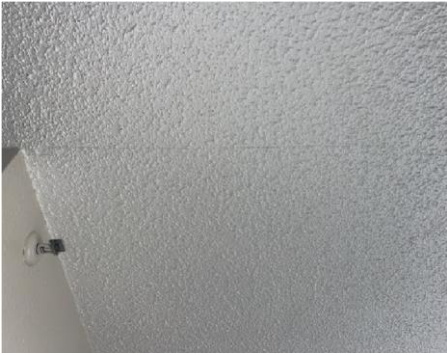
302

Drywall Distress: Ceiling Cracks Present

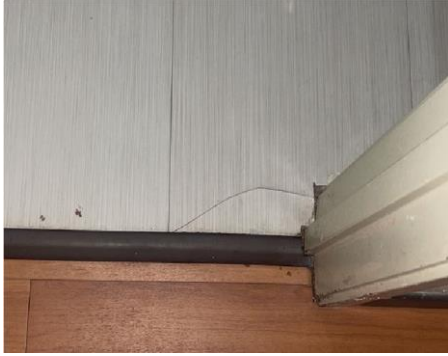
128

Floor Distress: Flooring Cracking

Isolation membranes that meet ANSI A118.12 may be installed under flooring to help resist cracking associated with foundation movement. We recommend contacting a flooring professional to determine which isolation membrane solution is best suited if desired.
