STRUCTURAL 360 INSPECTION

FEBRUARY 17, 2024

Project Information: Purpose - Structural 360

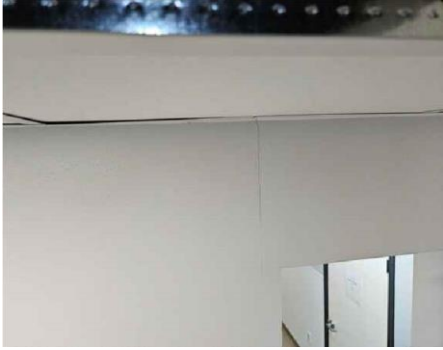
Drywall Distress: Wall Cracks

Present

Wall below 2nd story addition

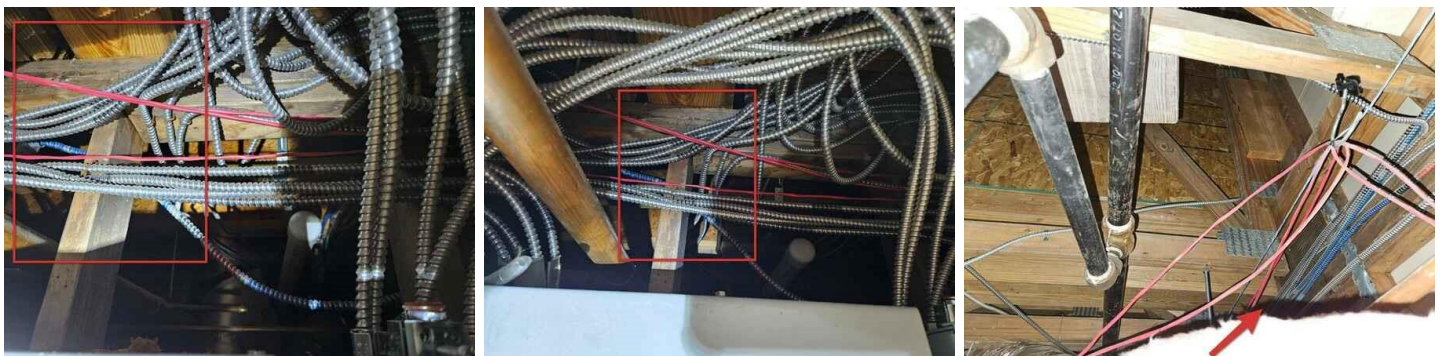
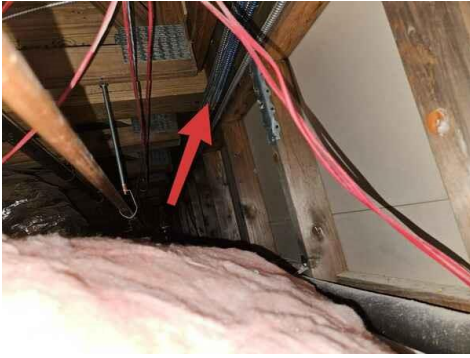
3.2.1 Structural Concerns

INADEQUATE HEADER SUPPORTS

IRC 2021 Table R602.7.5

The beams supporting the walls and roof of the 2nd story addition bear on a single stud at the original interior walls. With a span of approximately 18-feet and an ultimate wind speed that exceeds 130mph, four (4) full-height studs are required at each end of the beam.

We were unable to determine if the exterior wall was reinforced.

Based on our observations, the existing framing appeared to be inadequate to support the current loads and will require reframing to bring the structure to adequacy. We recommend performing the required repairs only according to framing plans that have been stamped and signed by a licensed professional engineer. If requested GreenWorks Engineering can provide the required framing plans. The proposed repair plans will include the following:

- Reinforce framing for lights in Operating Rooms #4 and #5.
- Reinforce framing for lights in Operating Rooms #1, #2, and #3 - additional exploration will be required to verify the existing framing in these areas.
- Reinforce interior wall supporting the 2nd story addition.
- Reinforce exterior wall supporting the 2nd story addition - additional exploration will be required to verify the existing framing in these areas.

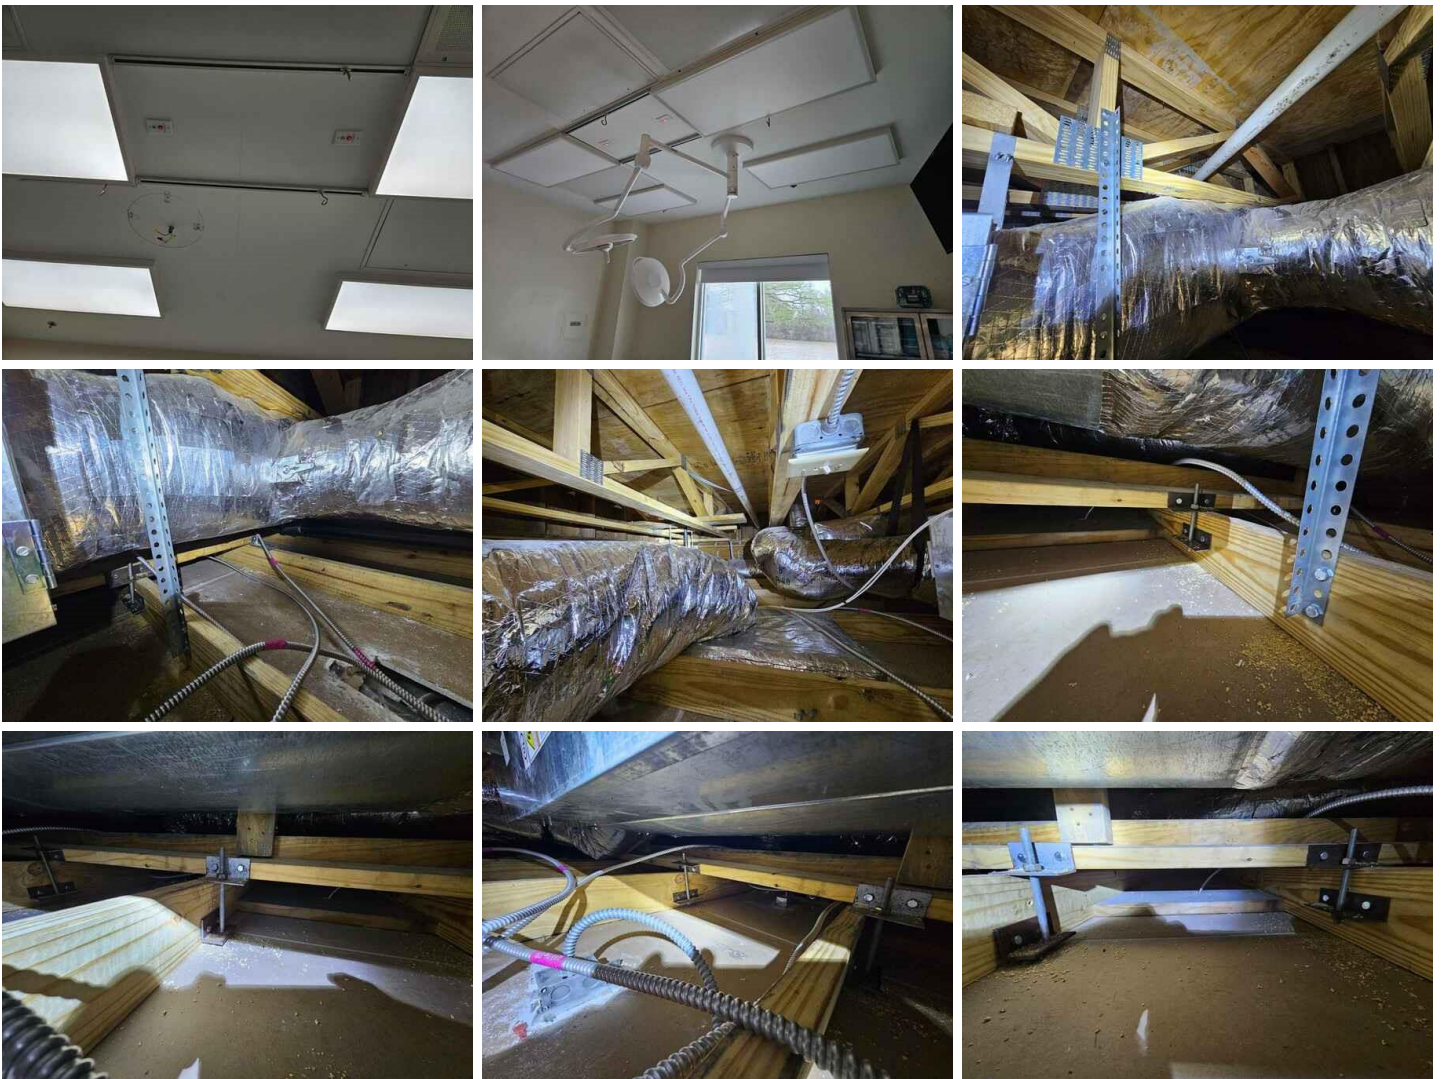
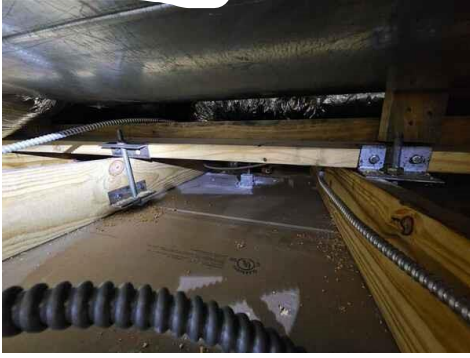
3.2.2 Structural Concerns

INADEQUATE FRAMING FOR OVERHEAD LIGHTS

Overhead lights in Operating Rooms #4 and #5 are improperly supported. Although additional oor joists were apparently installed to provide support for the lights, the extra oor joists were not used to support the lights. Rather, the lights were secured to dropped ceiling framing consisting of 2x6 joists at 24" on center.

The light in Operating Room #4 had already been removed. We recommended that the use of Operating Room #5 also be avoided until the light can be removed and/or the framing reinforced.

We were unable to view the framing supporting the lights in Operating Rooms #1, #2, and #3 and cannot comment on the capacity of the framing in those areas.

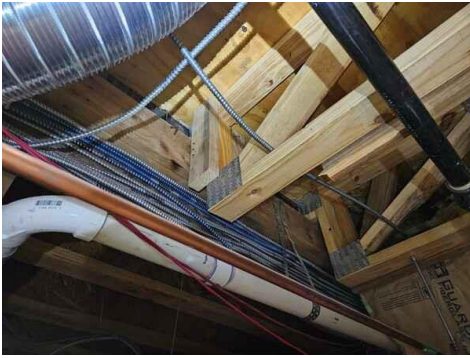
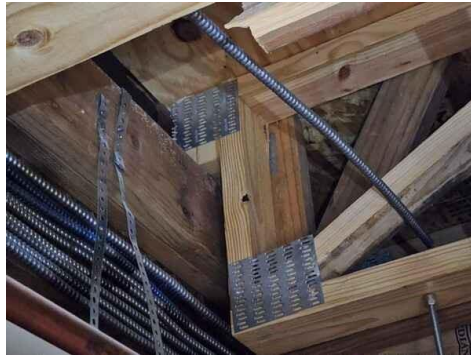
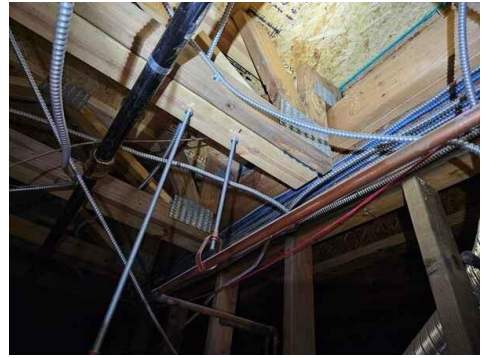
3.2.3 Structural Concerns

PREVIOUS REPAIRS OR MODIFICATIONS

The original roof trusses were cut, and new roof trusses were installed to expand the 2nd floor. The new roof trusses bear on the original interior wall and the original exterior wall.

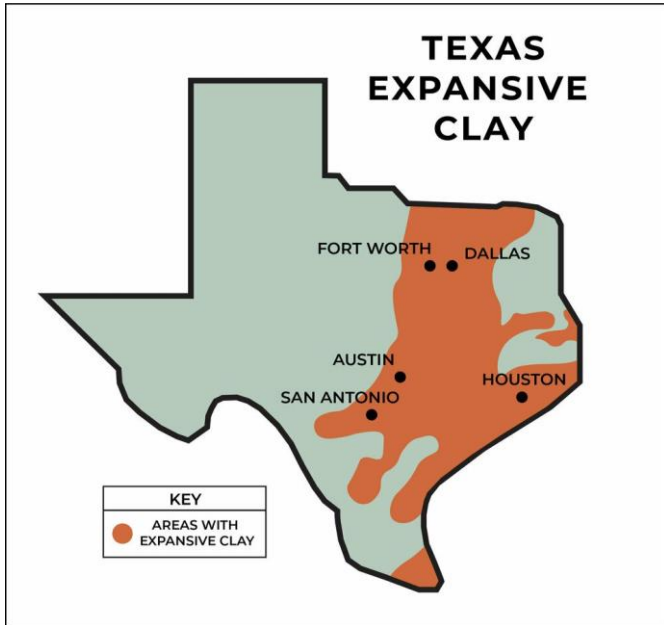
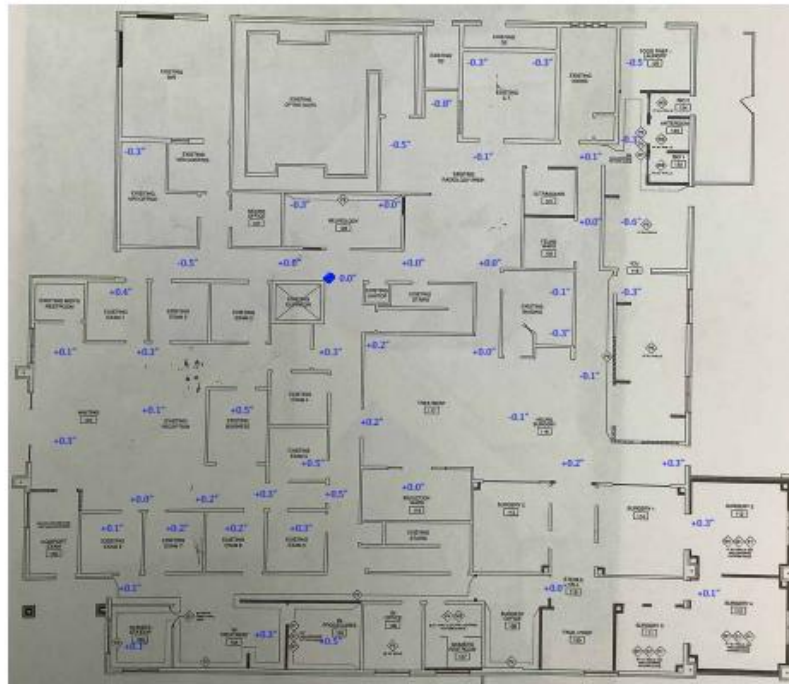
FIGURE 1
NOT TO SCALE

An interior door elevation survey was performed on the ground level of the structure as shown on Figure 1, with the elevations recorded to the nearest 10th of an inch (0.1"). Adjustments were made to account for the thickness of the door coverings. A benchmark elevation of 0.0 inches was established. The benchmark elevation is referential and its location will not alter the net elevation differentials - location of it was based on the inspector's best judgement.

Based on our observations of the interior and exterior cosmetic distress, the floor elevations, and calculations, it is our opinion that the foundation appears to be in relatively good condition. The maximum differential deflection is 0.4 inches and occurred over an approximate distance of 24 feet. This amount of deflection is within the standard allowable deflection of 0.8 inches for a distance of 24 feet.

1. Comprehensively implement the foundation maintenance recommendations.
2. Review the performance of the foundation as a proactive foundation maintenance program every 6 to 12 months. Retain this report as an elevation baseline for the foundation. Compare all future foundation evaluations to this baseline.
3. Once foundation movement has been ruled out with a follow-up foundation evaluation, the interior and exterior cosmetic distress can be repaired.
