GREENWORKS SERVICE COMPANY

STRUCTURAL ENGINEERING INSPECTION

General: Purpose - Framing Review

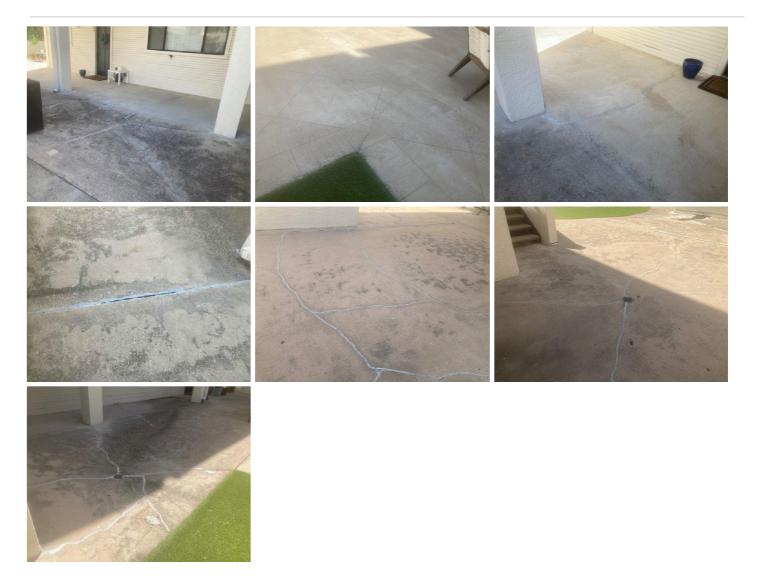
Exterior Distress: Patio Cracks

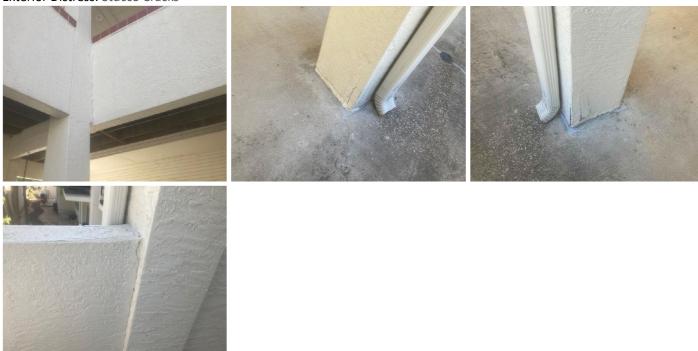
Exterior Distress: Stucco Cracks

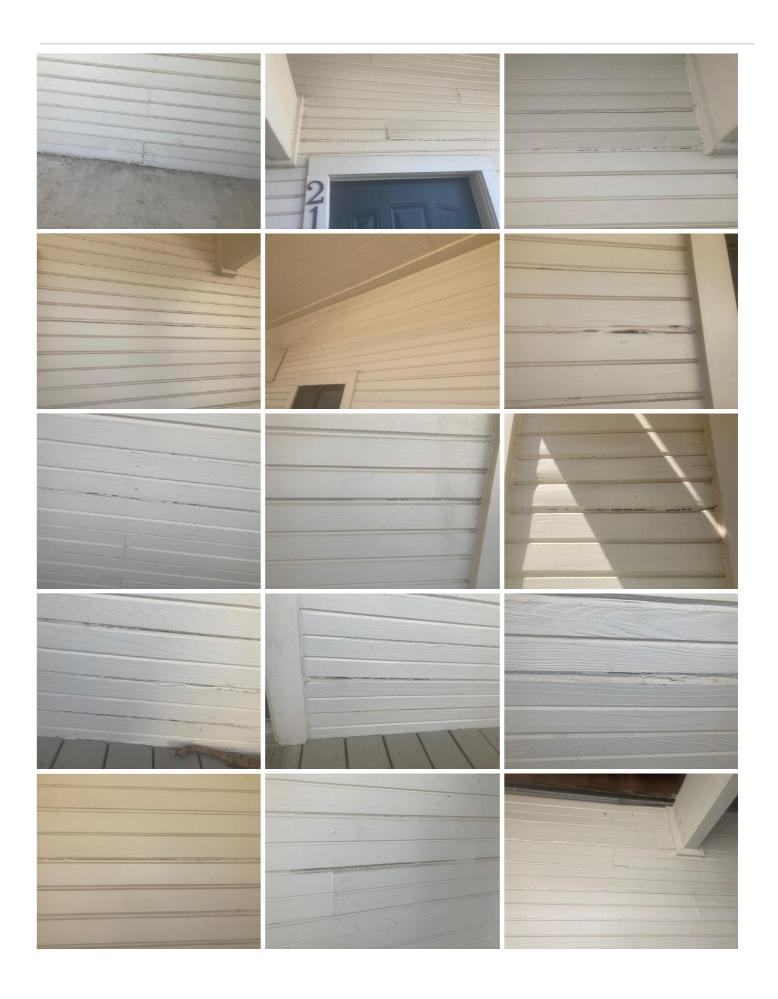
Exterior Distress: Siding separation

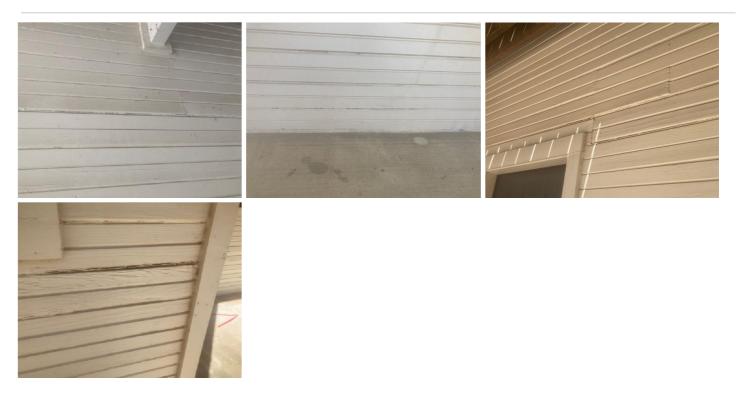
Exterior Distress: Rotted siding Unit 220, 224, 222, 2nd oor laundry, 102

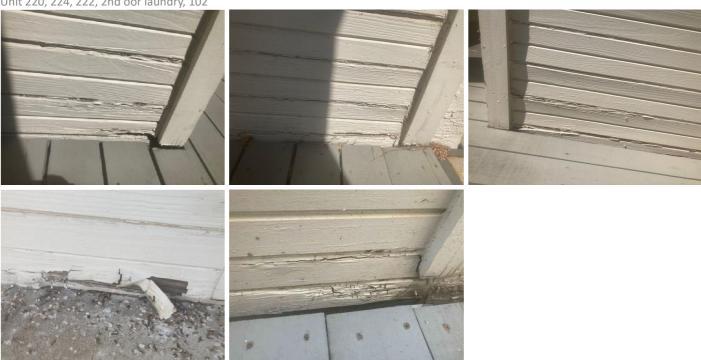
Exterior Distress: Rotted Trim Unit 207, 209, 210

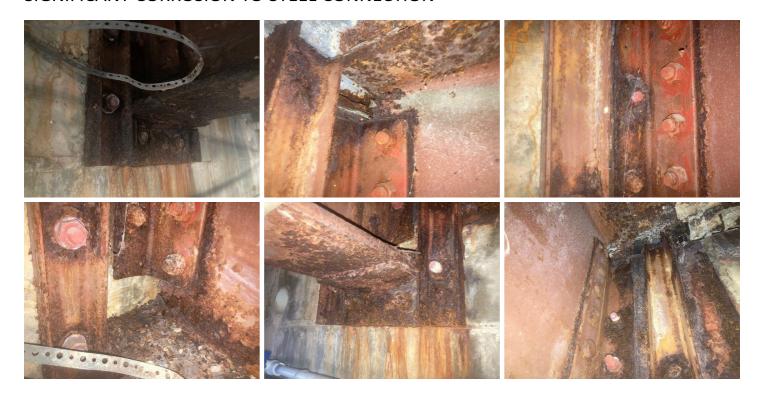
2.1.1 Exterior Distress SIGNIFICANT CORROSION TO STEEL CONNECTION

- ⚠ 2.1.1 Observations Exterior Exterior Distress: Signi cant Corrosion to Steel Connection
- ⚠ 2.1.2 Observations Exterior Exterior Distress: Signi cant Corrosion With Section Loss

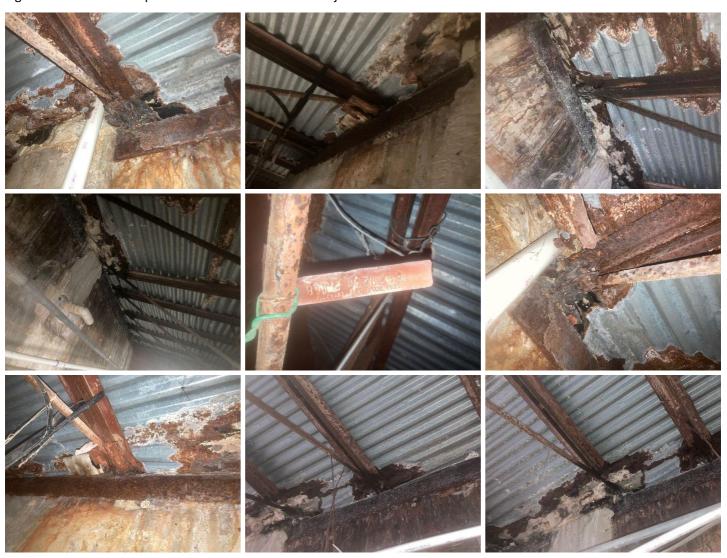
2.1.2 Exterior Distress

SIGNIFICANT CORROSION WITH SECTION LOSS

Signi cant corrosion was present with section loss to steel joists

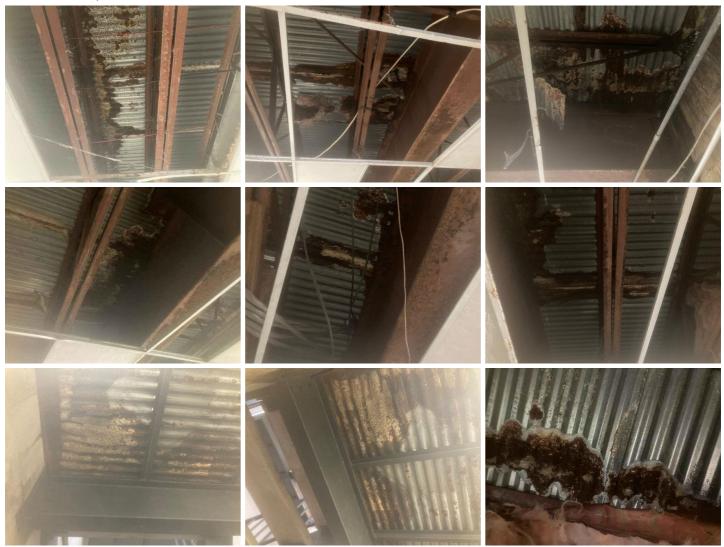
2.1.5 Exterior Distress

A Safety Hazard

SIGNIFICANT CORROSION TO CORRUGATED DECKING

PARKING GARAGE, WEST & EAST STAIRS

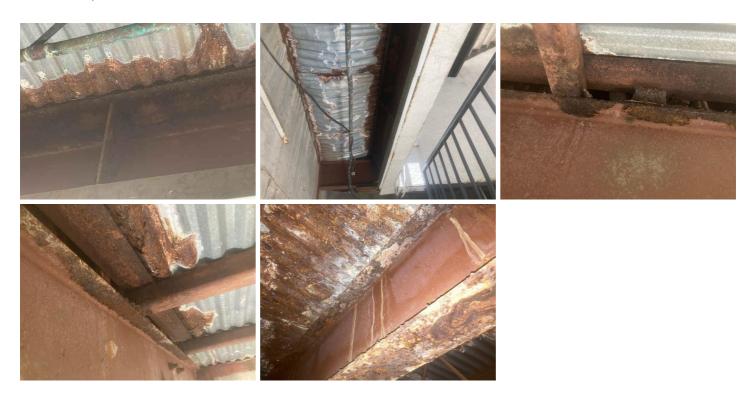
2.1.8 Exterior Distress

MODERATE CORROSION TO STEEL BEAM

EAST STAIRS, PARKING 205
