GREENWORKS SERVICE COMPANY

MOLD PROTOCOL

15940 Great Oaks Dr

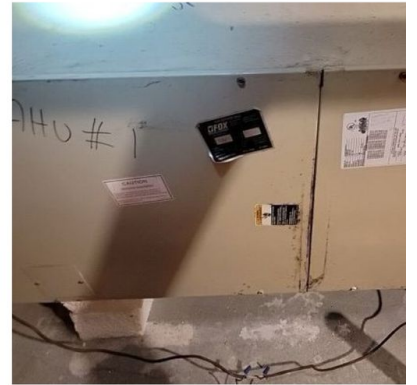
Attic

AHU #1

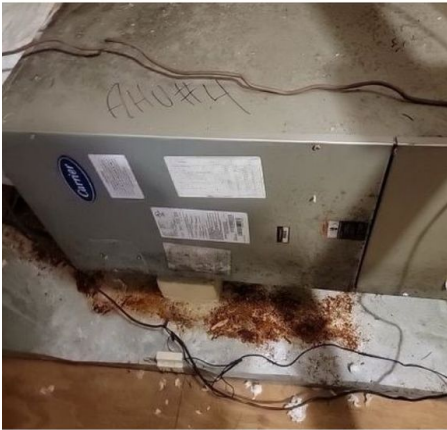
Attic

AHU#4

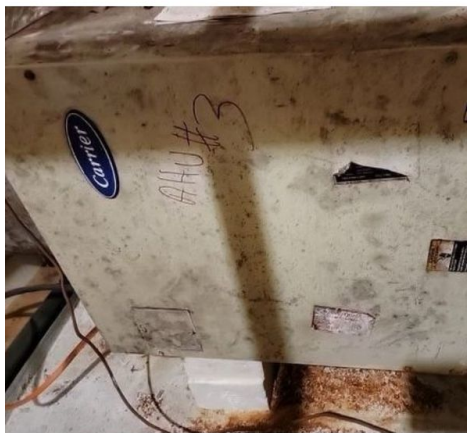
Attic

AHU #3

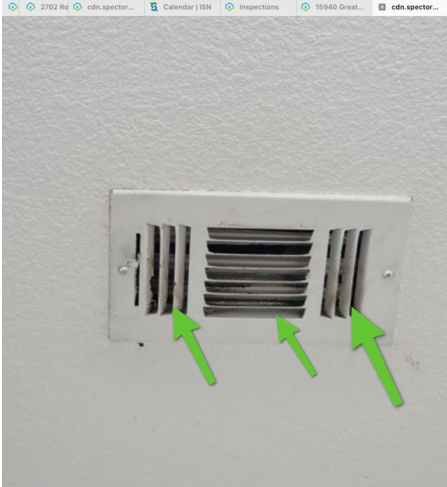
TH1

Sample 10: Location of Sample
Upstairs kennel Return duct

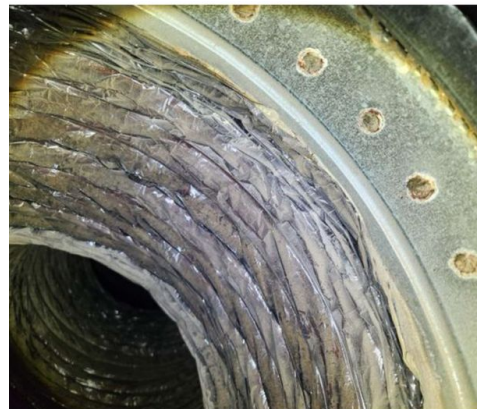
Duct return

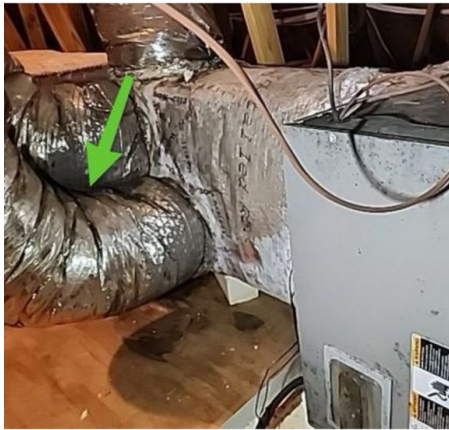
Duct insulation

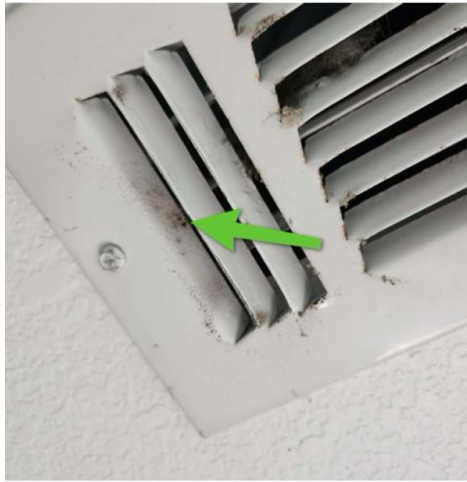
Mold Register

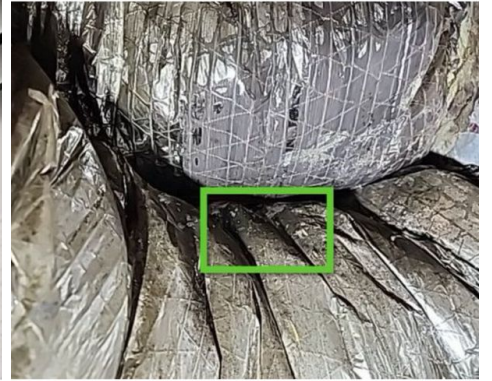
Duct Insulation

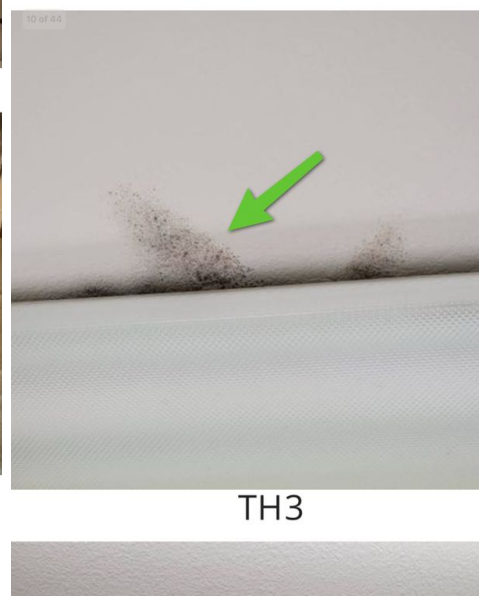
Mold ceiling

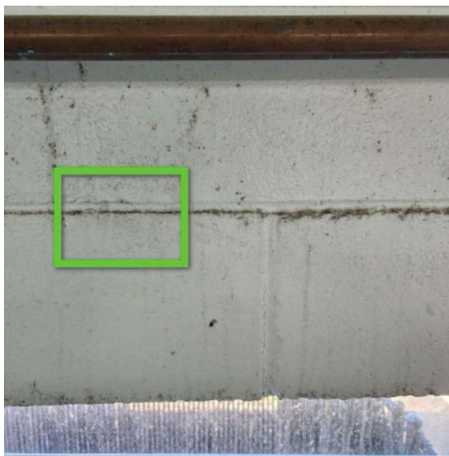
Downstairs kennel middle left side wall

Cinder Block

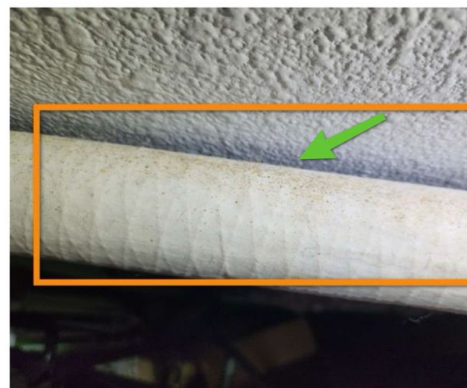
Downstairs Front Right kennel area

Top photo insulation mold on pipe

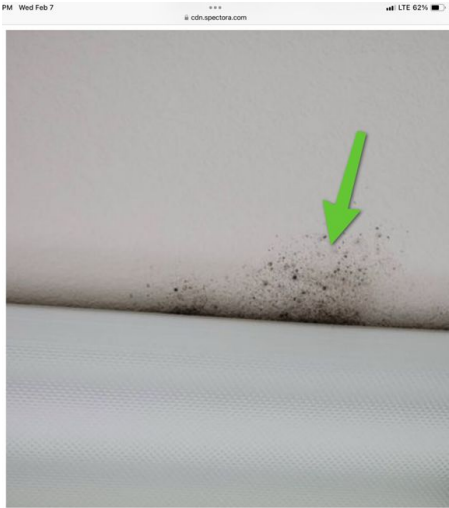
TH17

Mold ceiling

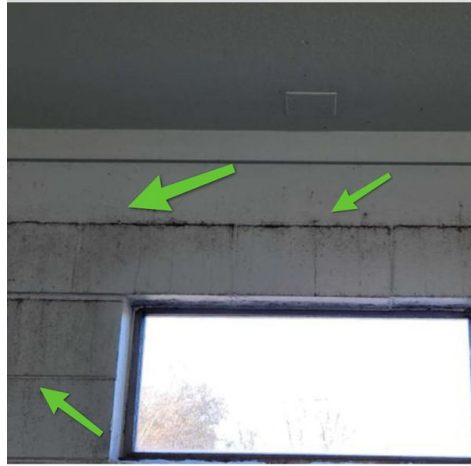
Back Left Side kennel area

Cinder Block
