GREENWORKS SERVICE COMPANY

FOUNDATION INVESTIGATION

MARCH 22, 2025

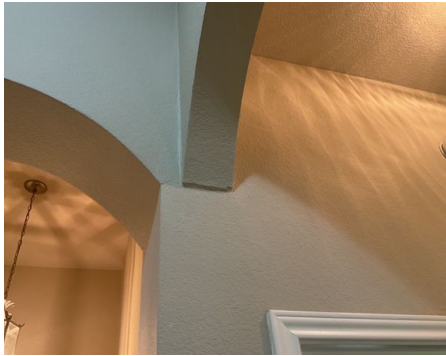
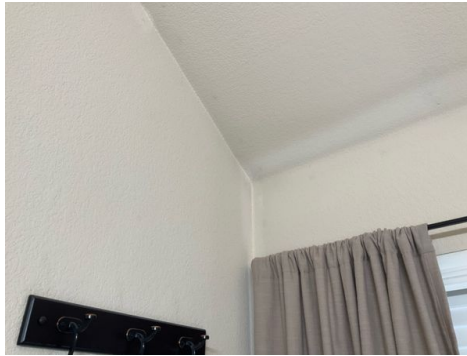
Wall Cracks Present

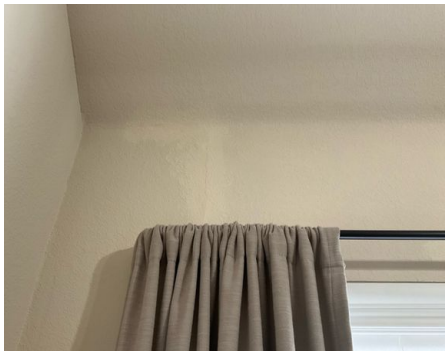
Corner Bead Separation

Separation of the drywall at interior corners

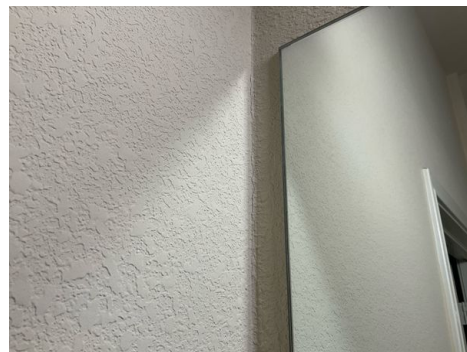
Tape Separation

Separation of the drywall tape from the drywall

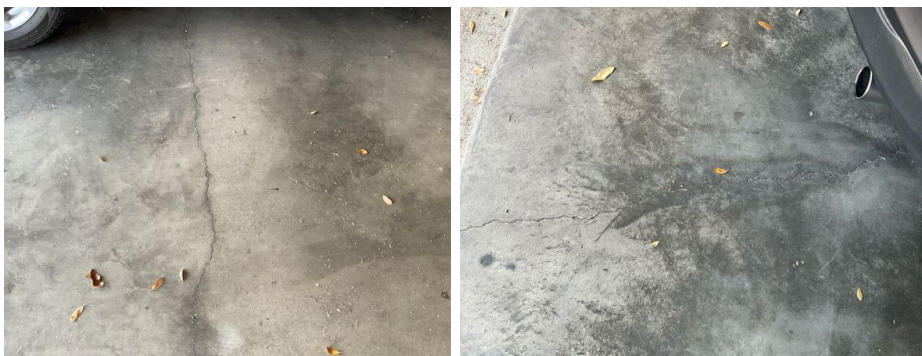
Floor Distress: Flooring Cracking

Isolation membranes that meet ANSI A118.12 may be installed under flooring to help resist cracking associated with foundation movement, though this method requires removal and replacement of the flooring in the desired areas. We recommend contacting a flooring professional to determine which isolation membrane solution is best suited if desired.

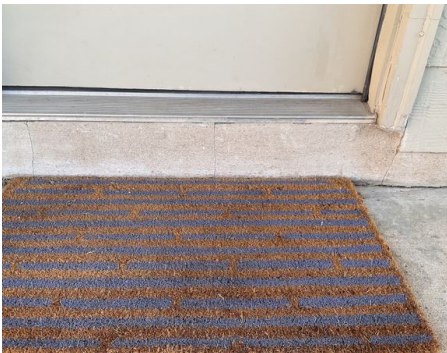
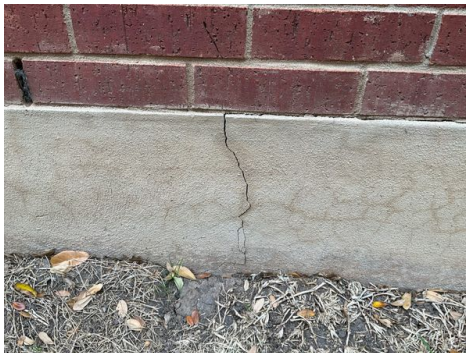
Parge Coat Cracking

Cracks in the parge covering the foundation

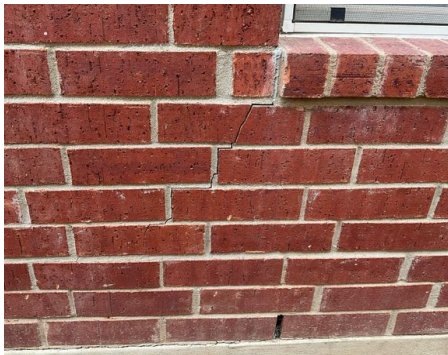
Mortar Separation

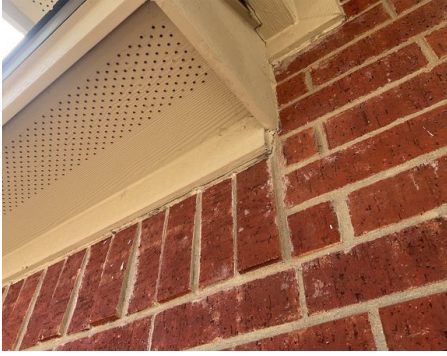
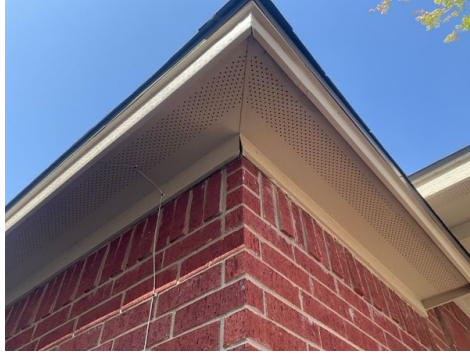
Expansion Joint Separation

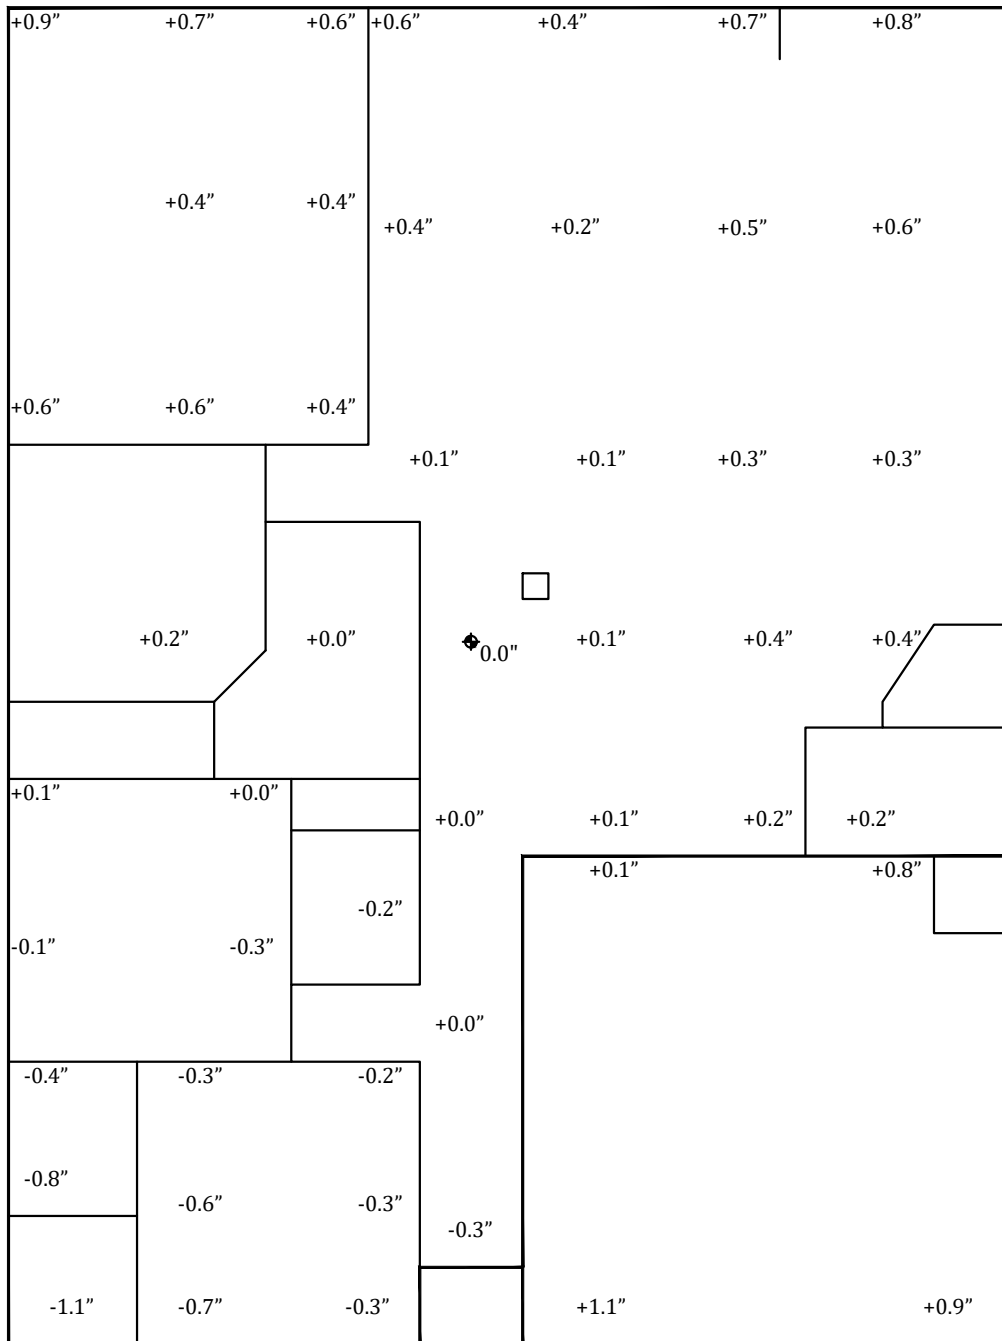
FIGURE 1

Based on our observations of the interior and exterior cosmetic distress, the floor elevations, and calculations, it is our opinion that the foundation appears to be in relatively good condition. The maximum differential deflection is 0.3 inches and occurred over an approximate distance of 22.0 feet. This amount of deflection is within the standard allowable deflection of 0.7 inches for this distance.

The foundation has experienced a mild amount of tilt. Tilt is the percentage of elevation change divided by the length between those elevations. The maximum elevation change measured across the foundation is 2.0 inches over an approximate distance of 31.0 feet for a maximum tilt of 0.3%. This amount of tilt is within the standard allowable tilt of 6.2 inches for this distance.
