GREENWORKS ENGINEERING FOUNDATION REPAIR VERIFICATION

05/07/2025

Project Information: Purpose - Foundation Repair Verification

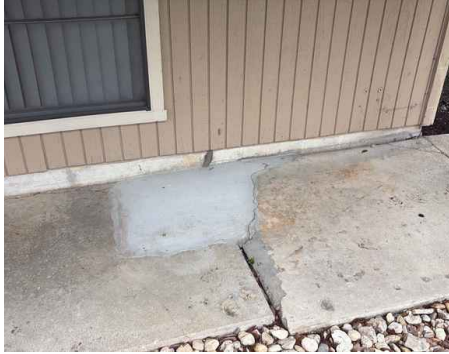
Front

Underpinning: Observed Underpinning
