## ASBESTOS SURVEY

None of the 6 samples taken were identified as asbestos in the limited asbestos survey. The building is a commercial site and is used as a US Post Office. The client limited the survey only to flooring and cove base materials. The survey was conducted by Paul Laman (licensed IAC with Greenworks). The address for this survey is 109 Gordon Rd, Mingus, Tx and the survey date was 1/23/24.

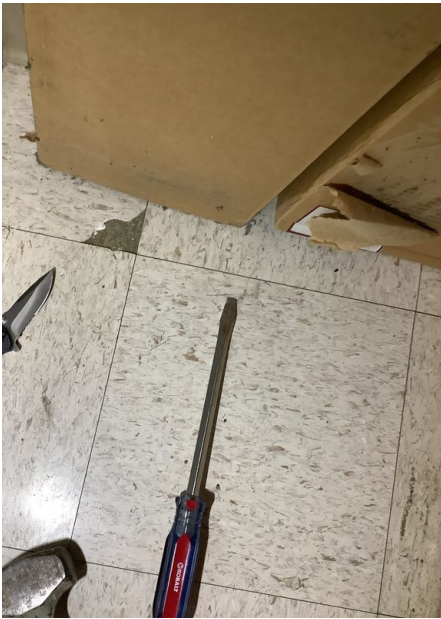
**Sample 1 : Location of Sample**  
Right Hall - Front

Tan floor tile & yellow mastic

4.1.1 Sample 1

No asbestos detected in the sample.

Contact a qualified professional.

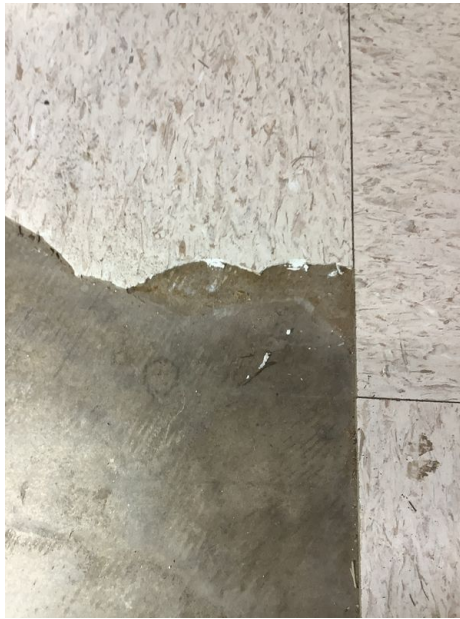
**Sample 2: Location of Sample**  
Central Work Area - Front

Tan Floor Tile & Mastic

4.2.1 Sample 2

No asbestos detected in the sample.

Contact a qualified professional.

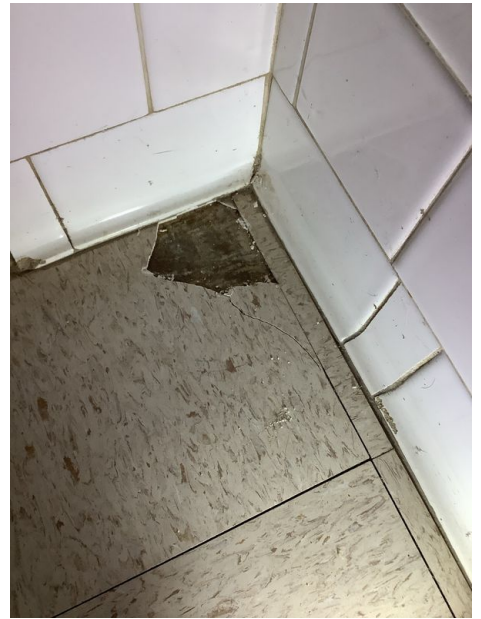
**Sample 3: Location of Sample**  
Restroom - Entry

Tan floor tile & mastic

4.3.1 Sample 3

No asbestos detected in the sample.

Contact a qualified professional.

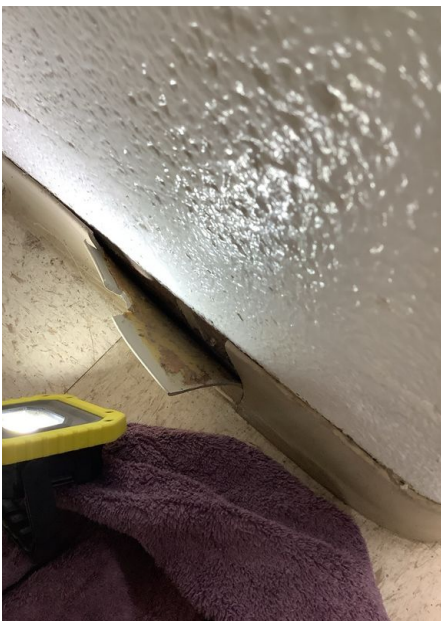
**Sample 4: Location of Sample**  
Work Area - Front

Tan cove base with mastic

4.4.1 Sample 4

No asbestos detected in the sample.

Contact a qualified professional.

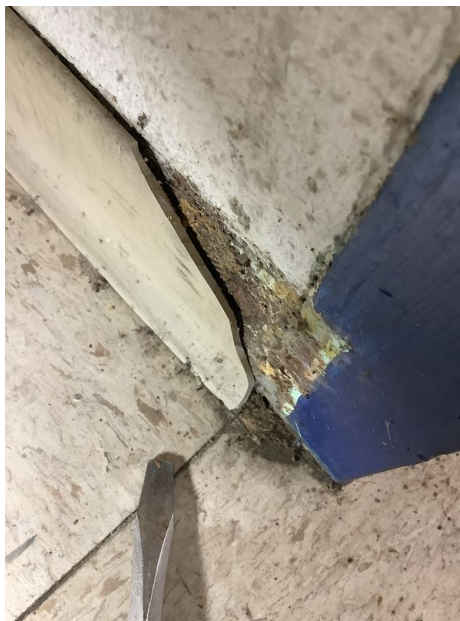
**Sample 5: Location of Sample**  
Rear Exit Room - Front

Tan cove base with mastic

4.5.1 Sample 5

No asbestos detected in the sample.

Contact a qualified professional.

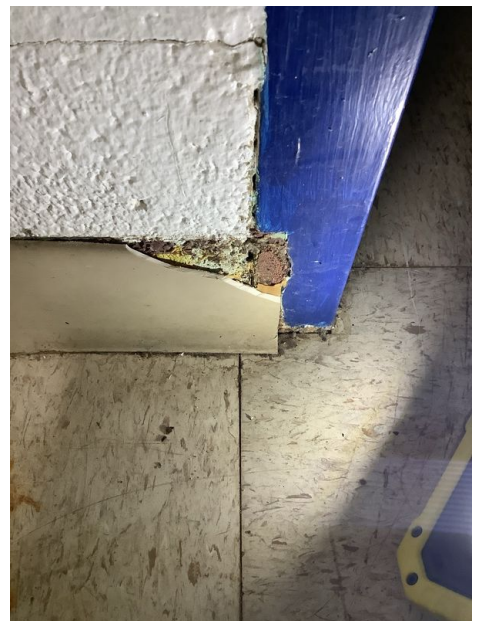
**Sample 6: Location of Sample**  
Storage Room - Entry

Tan cove base with mastic

4.6.1 Sample 6

No asbestos detected in the sample.

Contact a qualified professional.
