GW ASBESTOS SURVEY

1234 Main Street
Dallas, TX 75219

06/17/2025 9:00AM

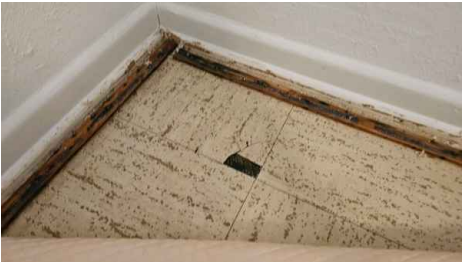
Sample 1 : Sample Material Description Smooth wall texture system	Sample 1 : Condition Of Materials Good	Sample 1 : Homogeneous Areas
Sample 1 : Approx. Square Footage (Includes Homogenous Areas) 100 sq. ft.	Sample 2: Location of Sample Front left bedroom under carpet	Sample 2: Sample Material Description Sand color laminate flooring system

Sample 2: Condition Of Materials Good	Sample 2: Homogeneous Areas	Sample 2: Approx. Square Footage (Includes Homogenous Areas) 122 sq. ft.
Sample 3: Location of Sample Master Bathroom Wall	Sample 3: Sample Material Description Crows feet wall texture system	Sample 3: Condition Of Materials Good

Contact a qualified professional.

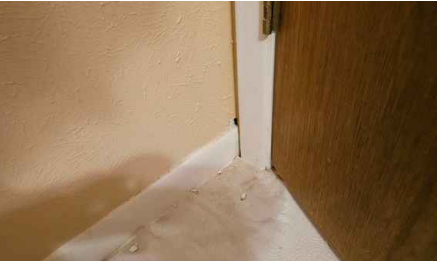
Sample 3: Homogeneous Areas	Sample 3: Approx. Square Footage (Includes Homogenous Areas) 1500 sq. ft.	Sample 4: Location of Sample Master bathroom ceiling

Recommendation
Contact a qualified professional.

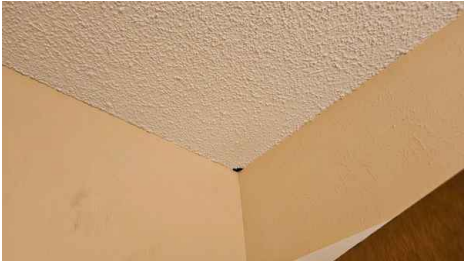
Sample 4: Sample Material Description Popcorn ceiling system	Sample 4: Condition Of Materials Good	Sample 4: Homogeneous Areas

Recommendation
Contact a qualified professional.

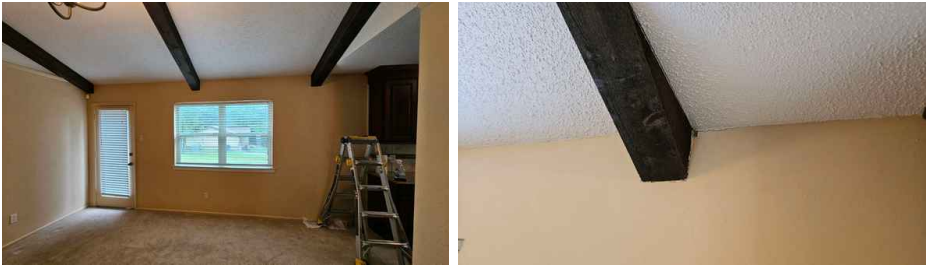
Sample 1 : Location of Sample
Living Room Rear Wall

No asbestos detected in the sample.

Contact a qualified professional.
