PROPERTY CONDITION REPORT

Prepared For: Jane Doe Industries, LLC
(Name of Client)

Concerning: Sample Commercial Inspection Report
(Address or Other Identification of Inspected Property)

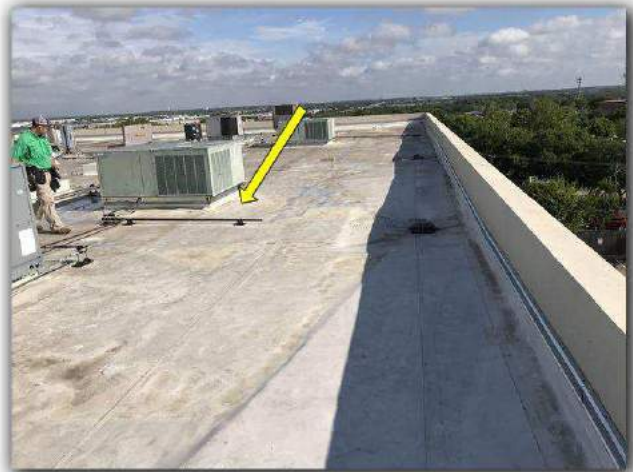
Areas of cracking and damage to the curbs around the drain lines (2nd right picture below)

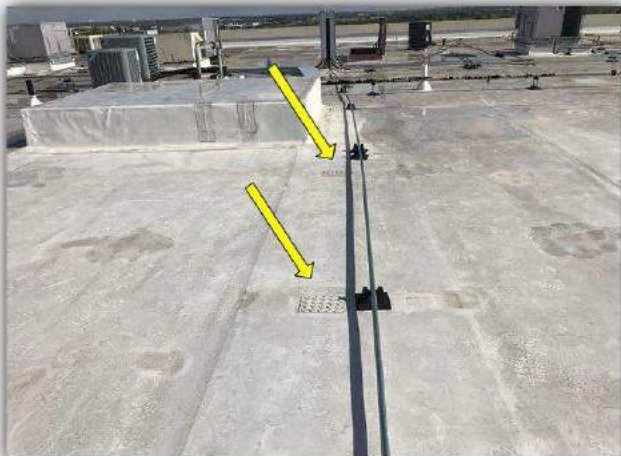
Drain lines should be supported by braces on pads at regular intervals. (5th row picture)

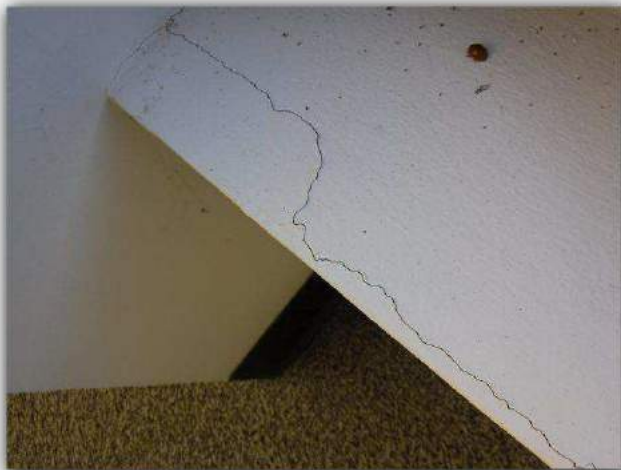
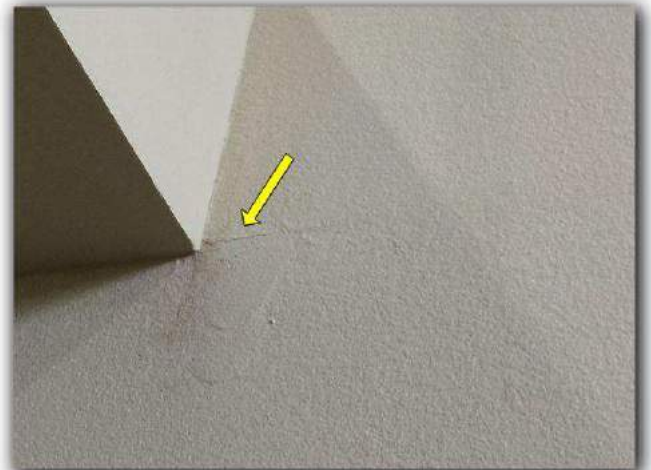
There were minor cracks and small holes in the walls in suite 200.
There was evidence of previous water loss at a wall in suite 205.
There were cracks and repaired cracks at the interior walls near window sills in suites 300, 310 and 400.
There are areas of previous water penetration at and near window sills at the northwest corner office of suite 310.
There are areas of previous water penetration at and near window sills at the east wall windows of suite 320.
The wood backing for the cabinet under the kitchen sink has a large hole in it in Suite 108.
The backsplash at the kitchen sink needs to be re-caulked in Suite 108.
There is a hole cut out of the wall in one of the offices in the suite next to the admissions office.
There was wet areas at the cove base and inside the exterior walls in Suite 112 as observed by the infrared camera.(Bottom Pictures Below)
There is joint separation at the balcony wall connection in the first floor main hallway left side. (Top Right Picture Below)

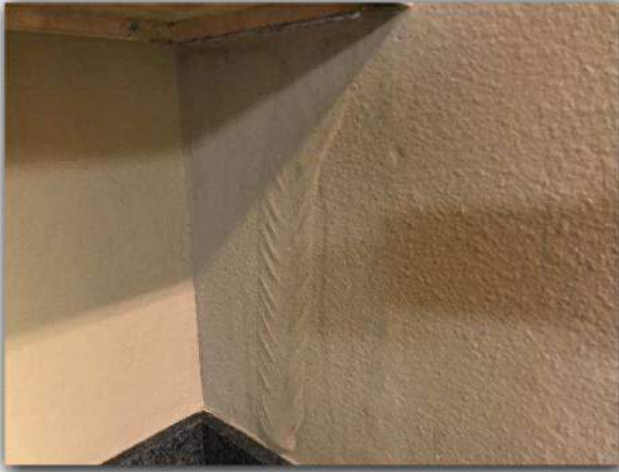
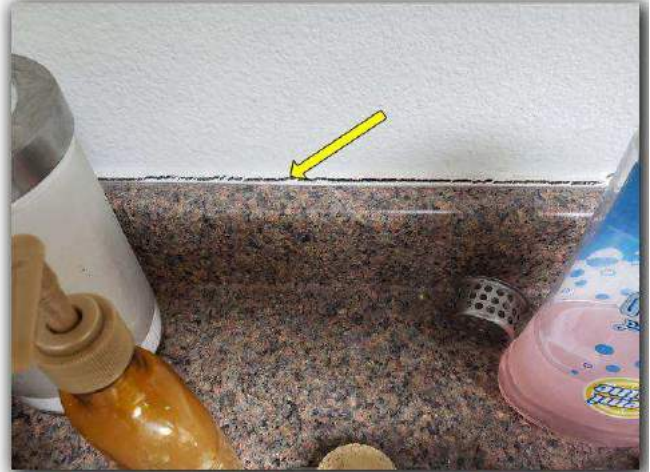
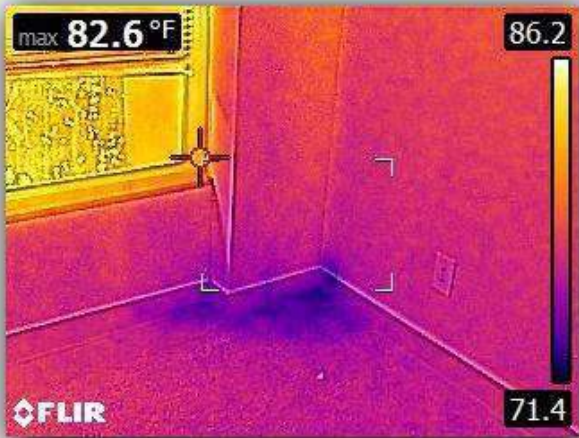
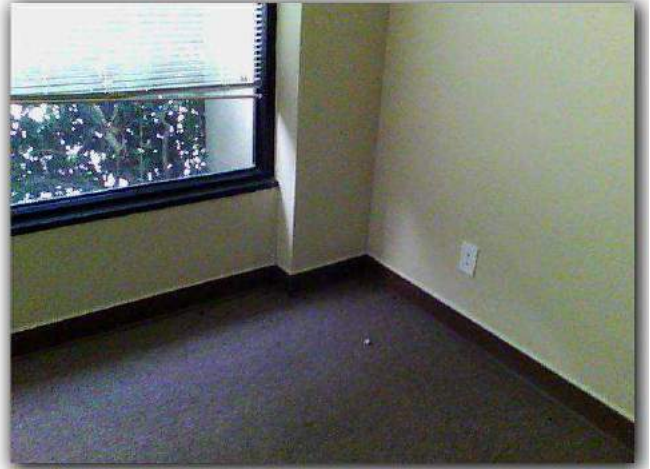
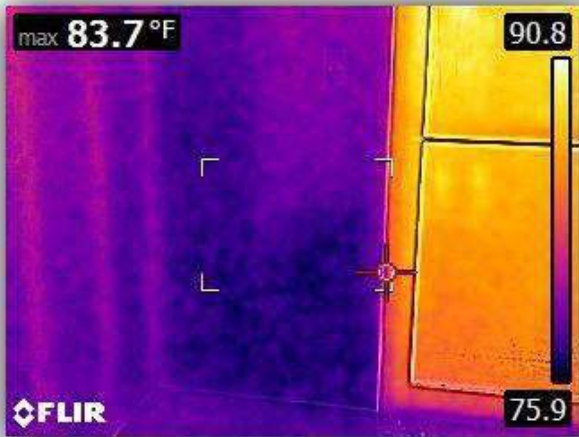
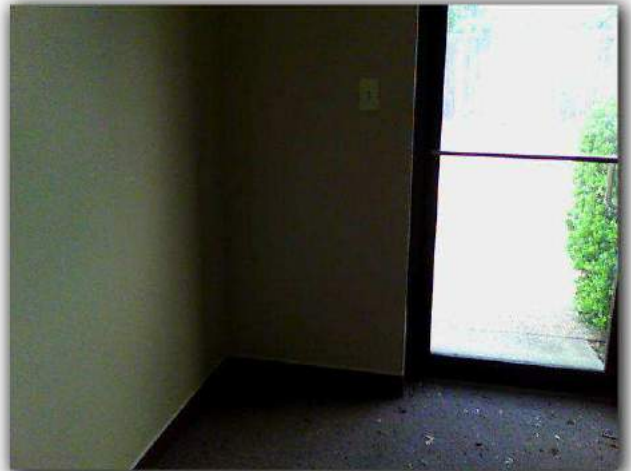
There are nicks and missing paint in various areas.
There were cracks and repaired cracks at the 1st floor hall interior wall.

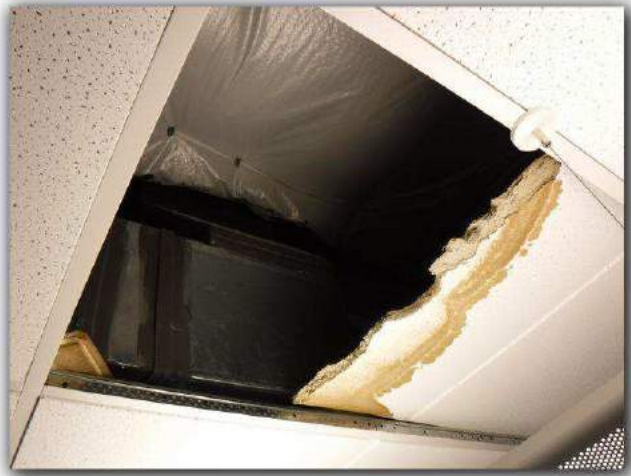
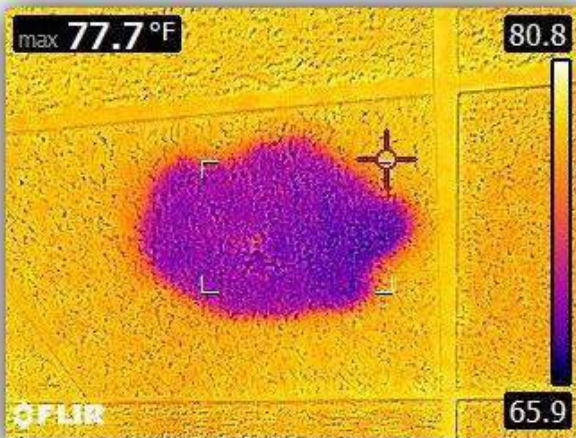
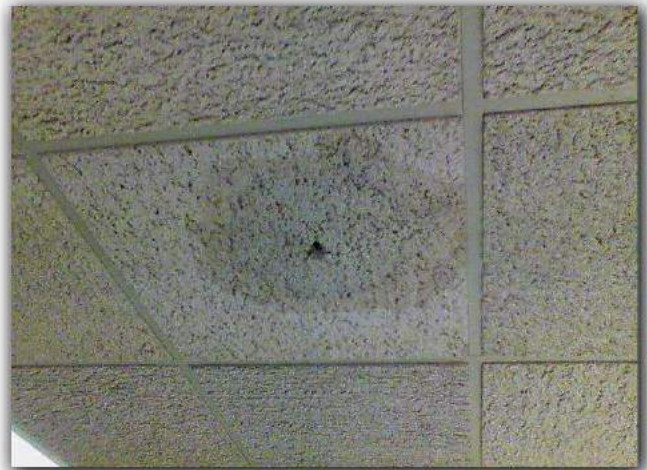
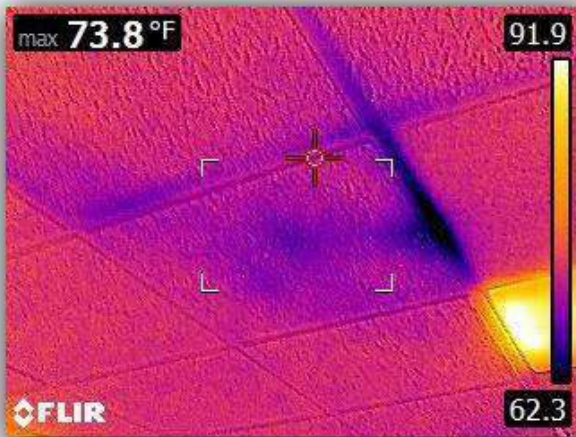
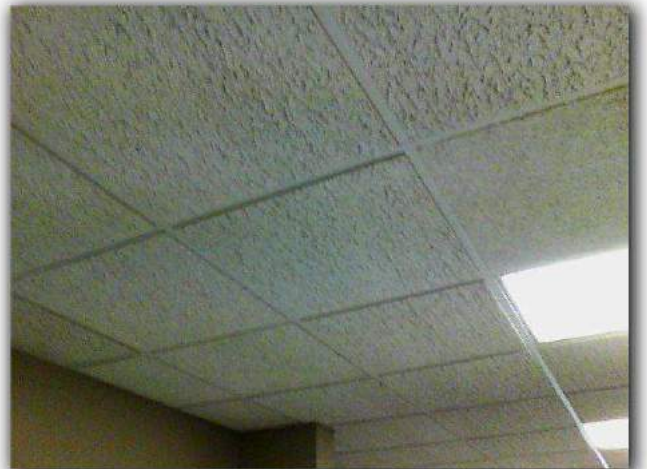
There is a wet tile in the ceiling in Suite 115 as observed by the infrared camera. (2nd Row Pictures Below)
There was an area of water penetration present at the ceiling of suites 101, 104, 106, and 115.
Water dripping from ceiling in 115.
There were water stains at the ceilings in all of the equipment service rooms.(Top Pictures Below)
There was an area of water penetration present at the ceiling of the 4th floor west stairwell. Water penetration was confirmed with a moisture meter and infrared camera. (2nd pictures and 3rd Row Pictures Below)
There were water stains at the ceilings in all of the equipment service rooms.(4th Row Pictures Below)
There was an area of water penetration present at the ceiling of the 4th floor west stairwell. Water penetration was confirmed with a moisture meter and infrared camera. (5th Row Pictures Below)

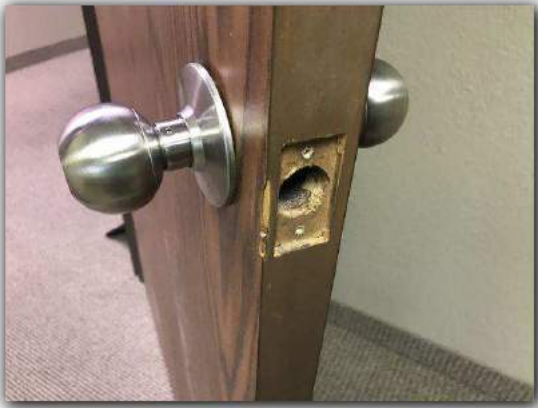
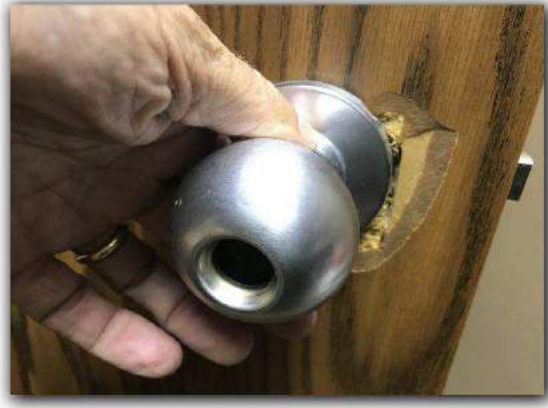
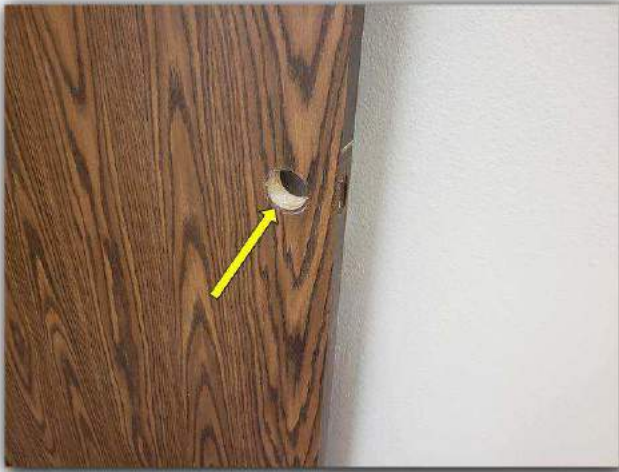
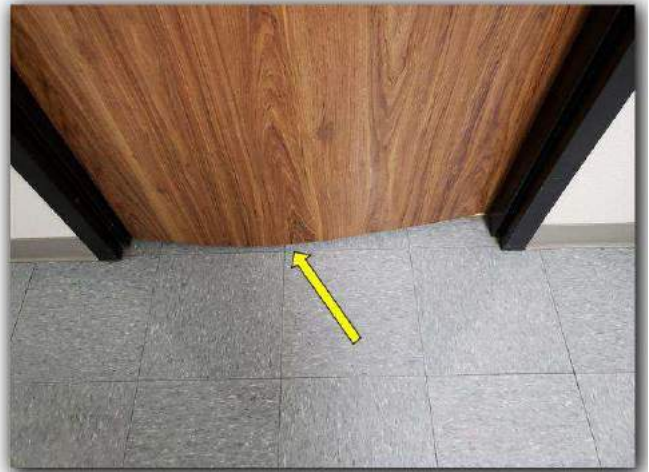
The interior office door in suite 101 opens by itself when left in a fixed position.
The middle right office door in suite 104 opens by itself when left in a fixed position.
Missing door knob on first floor suite 106 utility room.

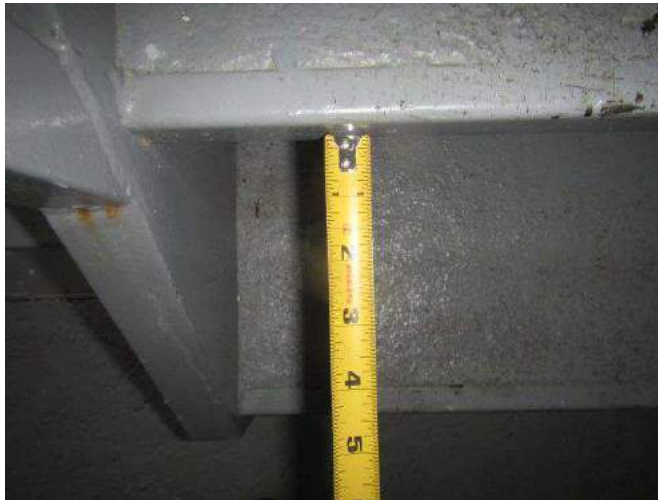
The upper roof level access stairway tread length does not conform to current standards. (see picture below)

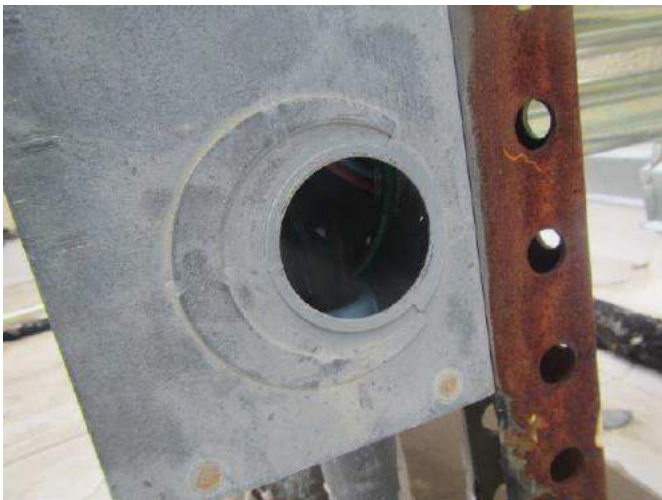
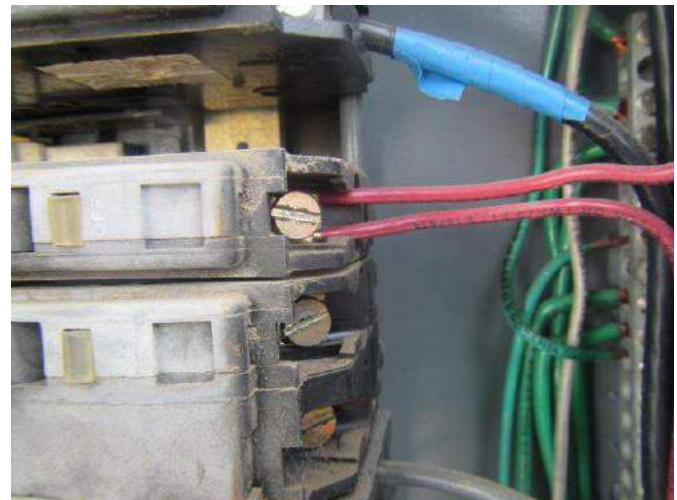
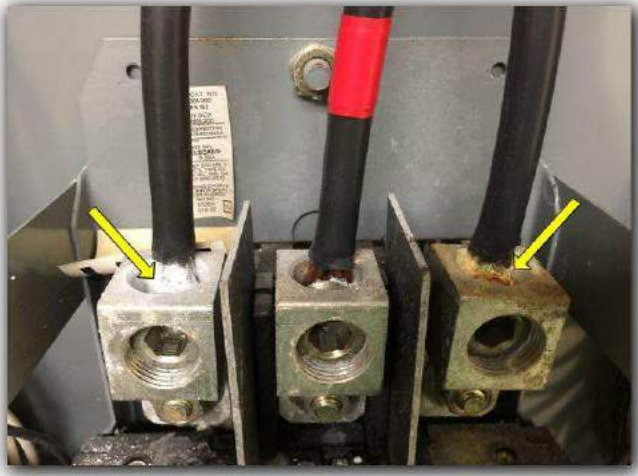
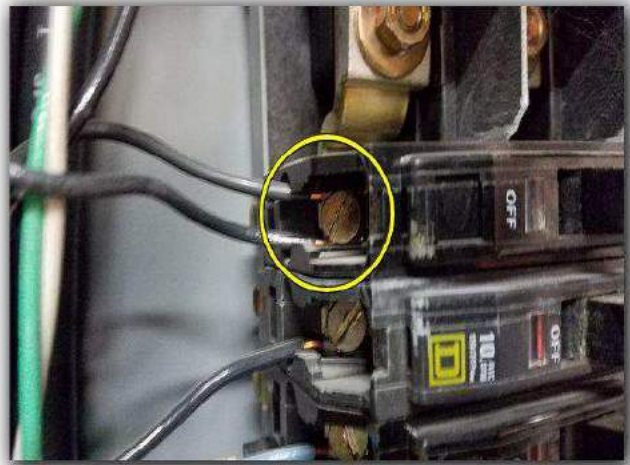
One of the upper roof panel covers was disconnected and the other was damaged. (top left picture below)
There are knockouts missing on the dead front cover at one of the upper roof level electrical panels. (top right picture below)
The roof level electrical panels were not completely labeled.
There are knockouts that were damaged or missing on the dead front cover at the lower left roof level electrical panel. (2nd left picture below)
There was not visible anti-oxidants on aluminum conductor terminations within the lower roof level panels.
There is double lugging evident at one of the circuit breakers in the lower left roof level electrical panel. (2nd right picture below)
The lower rear roof level panel dead front cover is missing screws.
There are knockouts missing on the dead front cover in the 4th floor electrical panel labeled Panel A .
The panel dead front covers are missing screws on the 4th floor in panels 3 and 4. Three screws that hold the electrical panel cover on are missing in the Suite between Suite 101 and 102.

The electrical panel is not labeled in the Suite between Suite 101 and 102.
There was not a main disconnect present at the service panel. in Suite 100.
Corrosion at main service conductor connections in suite 106. (3rd Left Picture Below)
There is double lugging evident at a circuit breaker in the electrical room left panel. The electrical room left panel dead front covers are missing screws.
There was double lugging present at the neutral bar in the electrical room left panel.
There is double lugging evident at a circuit breaker in the electrical room right panel. (3rd right picture below)
The panel dead front cover is missing screws in the electrical room right panel. There was double lugging present at the neutral bar in the electrical room right panel.
There is double lugging evident at a circuit breaker in the 2nd floor building services right electrical panel.
The 2nd floor building serves left panel dead front cover is missing screws.

There is double lugging evident at the circuit breakers in the 2nd floor building services right electrical panel.
The 3rd floor building services right panel dead front cover is missing screws.
There is double lugging evident at the circuit breakers in the 3rd floor building services right electrical panel.

The main neutral wire was not taped white in the roof level panels.

It is highly recommended that the panel be fully evaluated by a licensed Electrician.

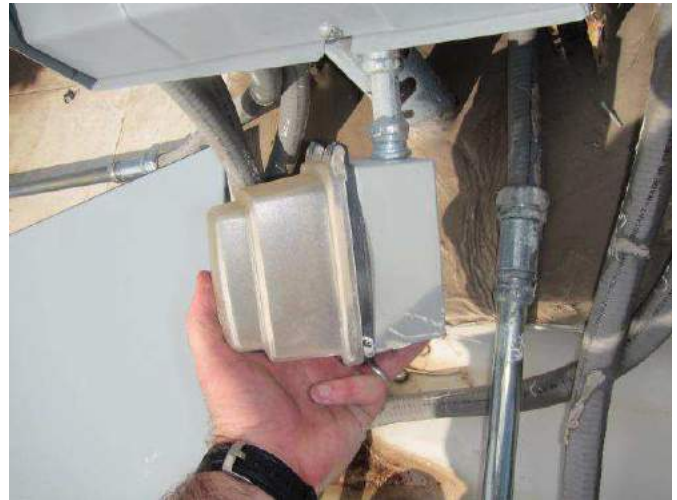
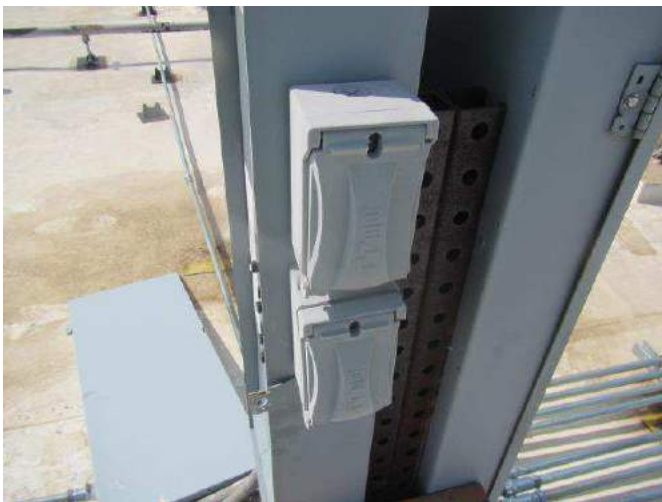
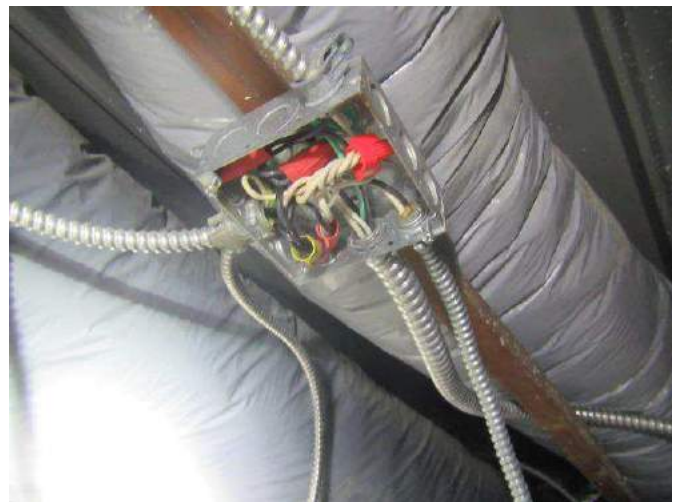
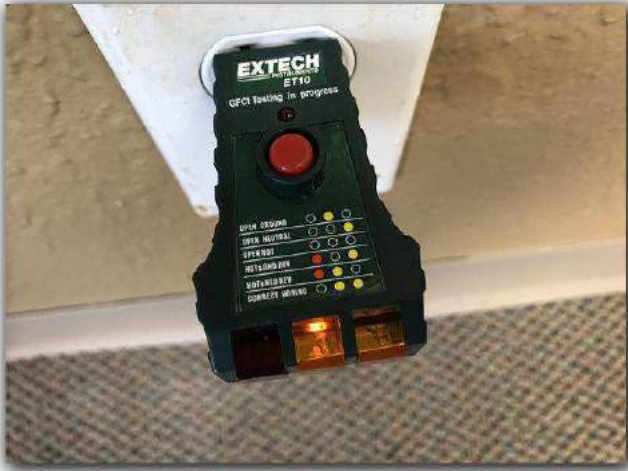
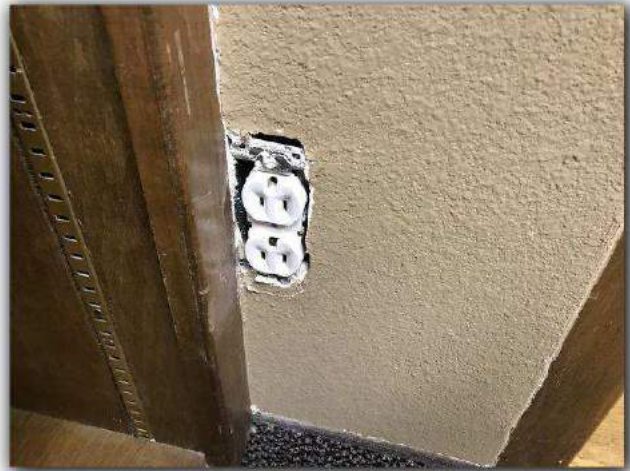
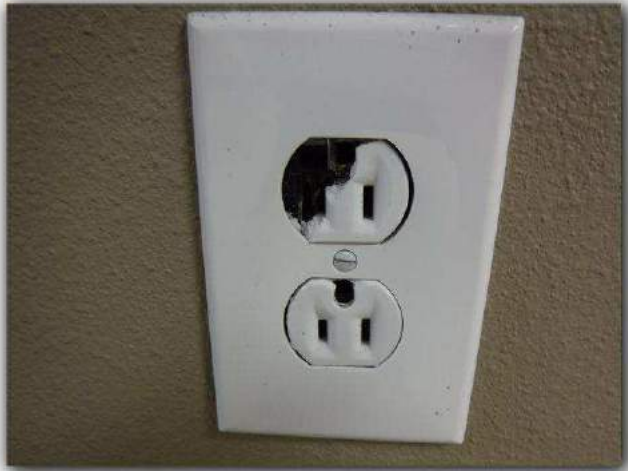
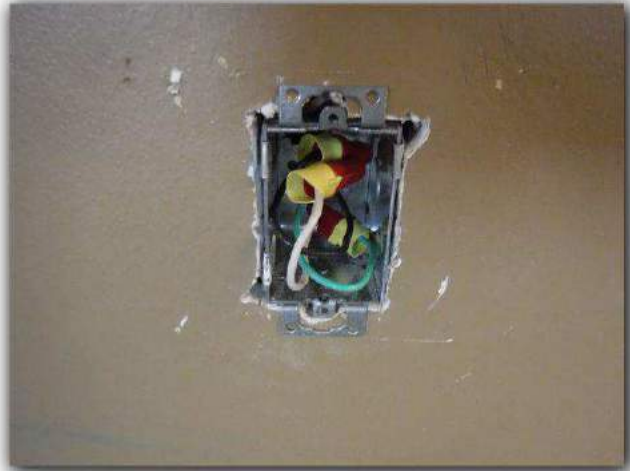
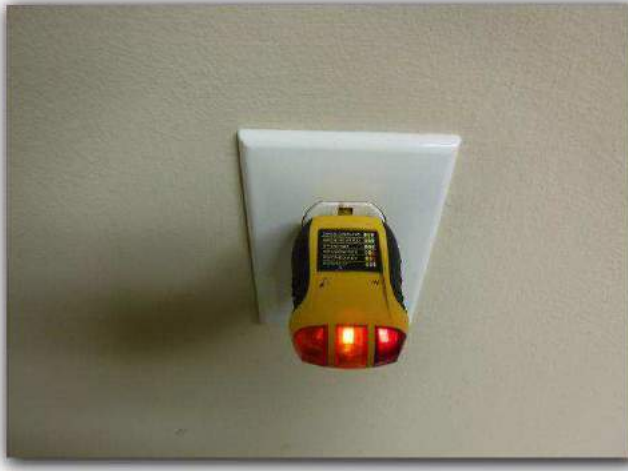
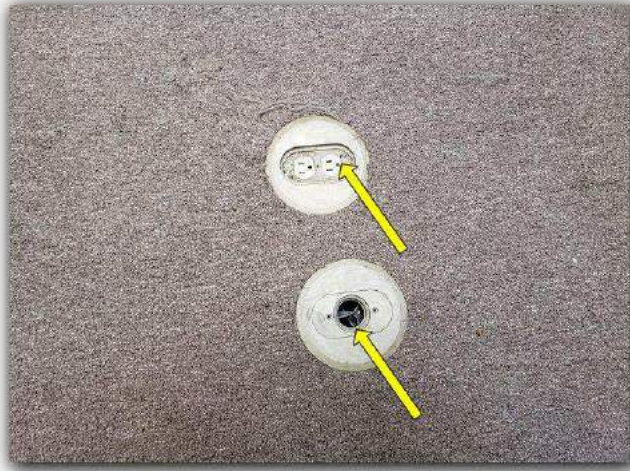
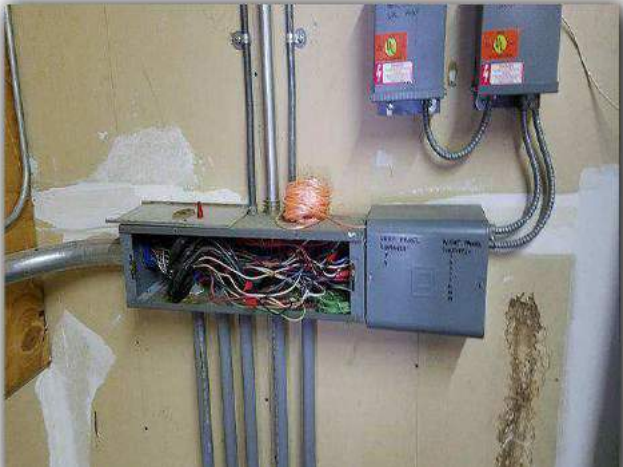
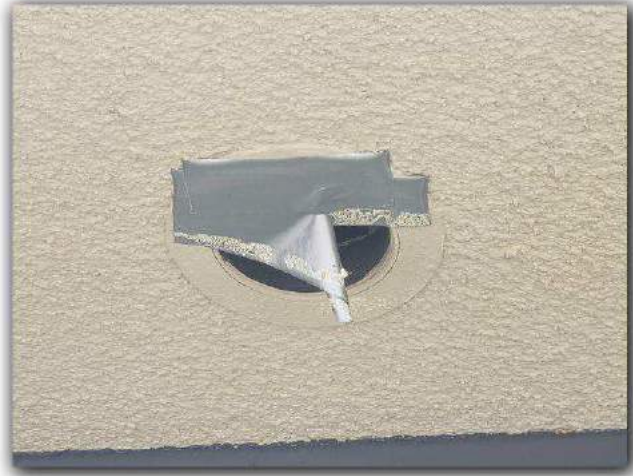
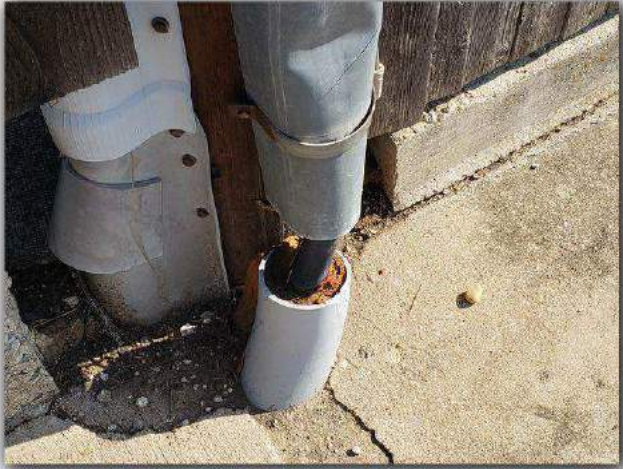
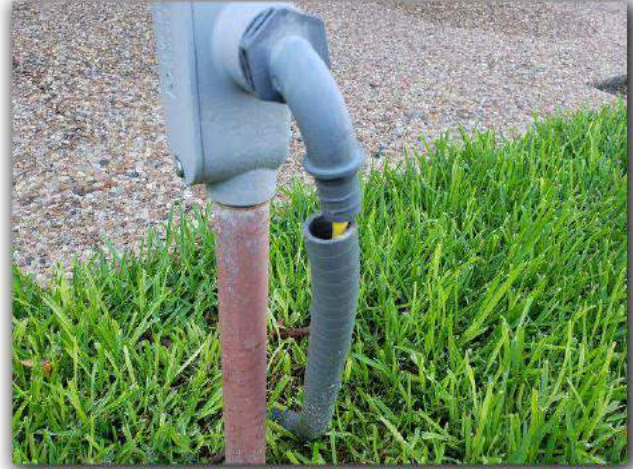
Some lights did not respond to testing.
The dead front cover was not present at the upper roof level exterior condensing unit disconnect for Unit 7, 10 or 13. (top left picture below)
In-use weather proof covers were not present at all exterior outlets. (2nd left picture below)
The upper roof level GFCI outlet was loose and not mounted in place. (top right picture below)
There is an electrical junction box in the Unit 115 drop ceiling that does not have a cover. (2nd right picture below)
Hand held tester had open ground readings in Suite 200 office 3 and 4.

Various loose outlets in the suite 201 lobby.
Missing outlet cover present in the suite 205 lobby.
Not all TREC required areas were GFCI protected. The outlets in the bathrooms on floors 3 and 4 as well as the break rooms in suites 310, 320, 330 and 400 were not protected .
There were several damaged and missing outlet covers in various areas of the 3rd and 4th floor suites. (4th left picture below)
There were damaged outlets in suite 320.
Various loose outlets in the 3rd and 4th floor.
Some lights did not respond to testing in suite 400.
There are visible electrical junction boxes in suite 400 that do not have covers. (4th right picture below)
Hand held tester had reversed polarization reading at the mid wall outlet in the breakroom of suite 310. (5th left picture below)
Various loose outlets in Suite 108.
The outlet at the sink in the kitchen is not GFCI protected in Suite 108.
The outlet at the sink in the kitchen is not GFCI protected in the Suite between Suite 101 and 102.

I could not find a light switch for the hall light in the Suite between Suite 101 and 102.
Various loose outlets in Suite 110.
There is a broken outlet in one of the offices in Suite 110.
Two outlets in the conference room had no power in Suite 110
The outlet at the sink in the kitchen is not GFCI protected in Suite 110..
There is one loose outlet in the wall in Suite 107.
There are loose outlets in the wall in the suite next to the admissions office.
I could not find the light switch for the hall in Suite 109.
The ceiling fluorescent light cover is missing in the storage room in Suite 109.
The outlet at the sink in the kitchen is not GFCI protected in Suite 109.
One outlet in one office is implied ground (open ground) in Suite 107.
One floor outlet needs a cover in Suite 112.(5th Right Picture Below)
The outlet at the sink in the kitchen is not GFCI protected in Suite 107.
One outlet in one office needs a cover in Suite 107.

The outlet in the women's restroom on the first floor, was not GFCI protected.
Not all TREC required areas were GFCI protected.
No GFCI's in the first floor breakrooms except suite 115 and 107.
Light fixture flickering in first floor suite 106 utility room.
Missing outlet cover in first floor main hallway right side by stairwell.
Damaged outlet in 1st floor hallway by coke machine.
There was an open junction box in the drop ceiling at the 1st floor mechanical room.
There are visible electrical junction boxes in the main electrical room, 4th floor building services room, 3rd floor building services rooms, and the fire suppression room that do not have covers or the covers are not properly installed. (6th left picture below)
Conduit has slipped and wiring is exposed at the front of the building. (7th right picture below)
Conduit has slipped and is damaged near the power pole near the back fence line.

Wiring is exposed. (7th left picture below)
The exterior soffit and parking lot lights are not in working order. Duct tape has been used to cover the soffit light fixtures. (6th right picture below)
There were damaged outlets at the 1st floor common area.
Missing outlet covers present in the 1st floor common area.

There was rust at various upper roof level exterior condensing unit disconnects.

It is recommended that the branch circuits be fully evaluated by a Licensed Electrician.

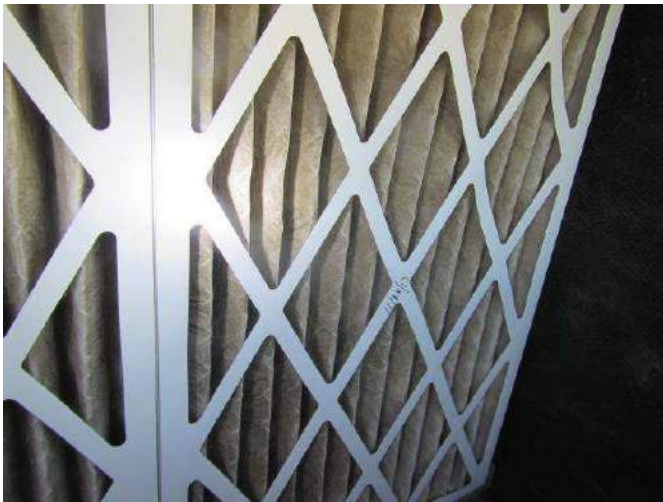
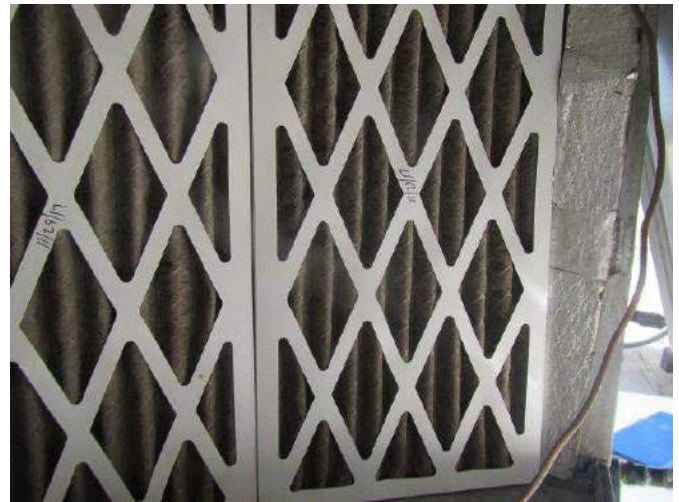
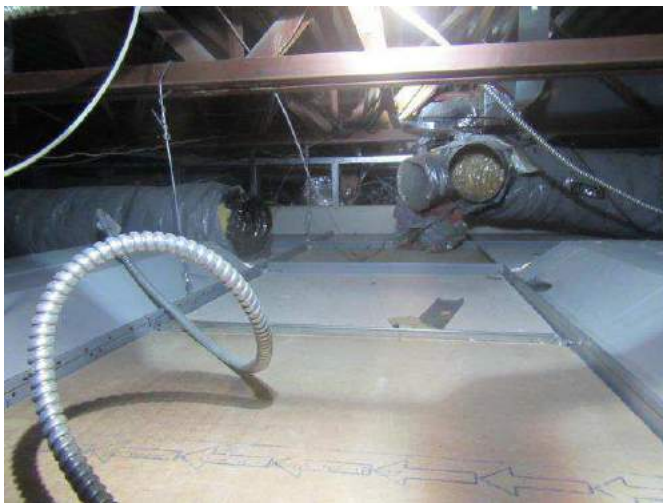
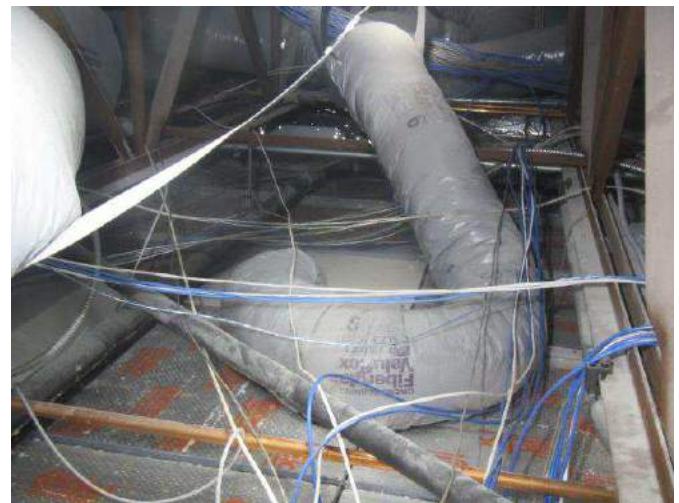
Various filter compartments at roof level HVAC units were mastic sealed or taped in place. These filters were not observed. (3rd row pictures below)

It is recommended that a licensed HVAC technician further evaluate the ducting and vents, and make all necessary repairs/replacements.

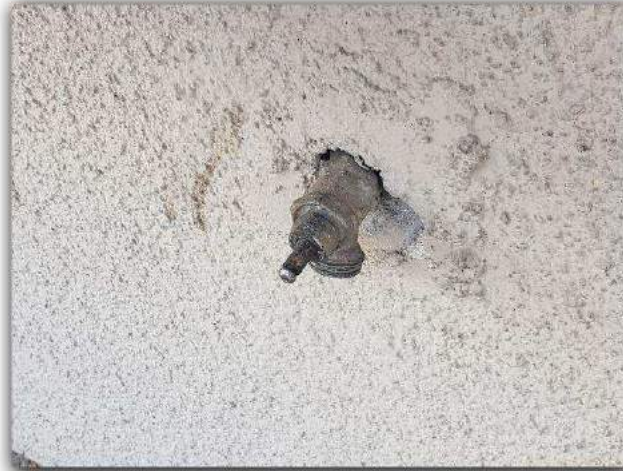
Missing handle at the rear exterior fixture. (Picture Below)

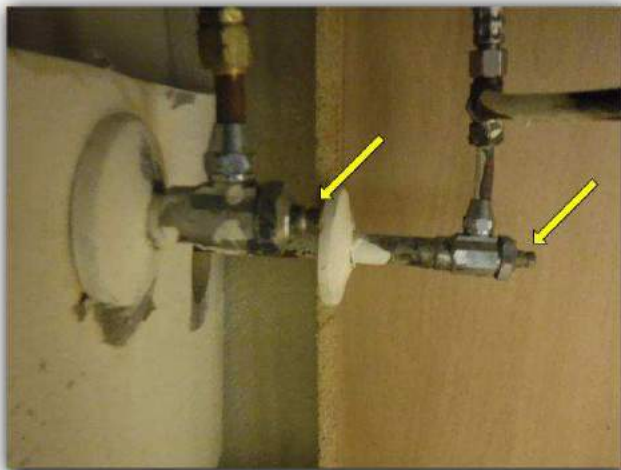
The shut off valve handles are damaged and missing at the break room sink in suite 310. (left picture below)

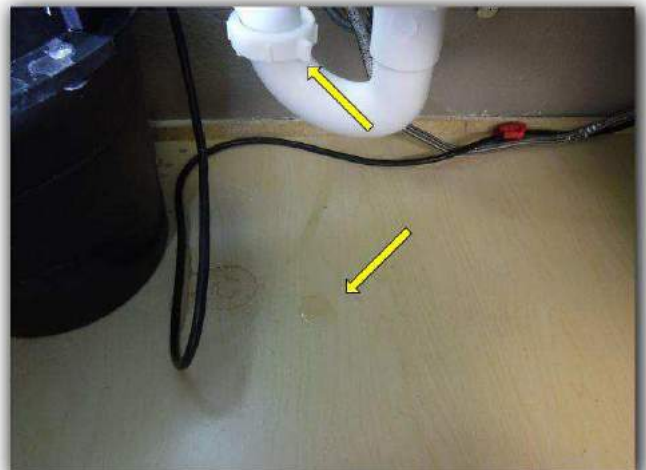
There is a leak from the drain piping at the sink in suite 320. (right picture below)

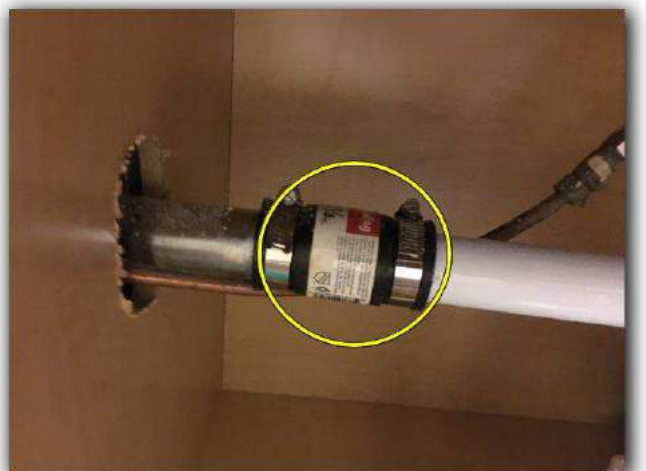
There were temporary repairs observed. There were rubber transition coupler/boots at drain lines within suites 102 and 107. This should be considered a temporary fix. (2nd Right Picture Below)

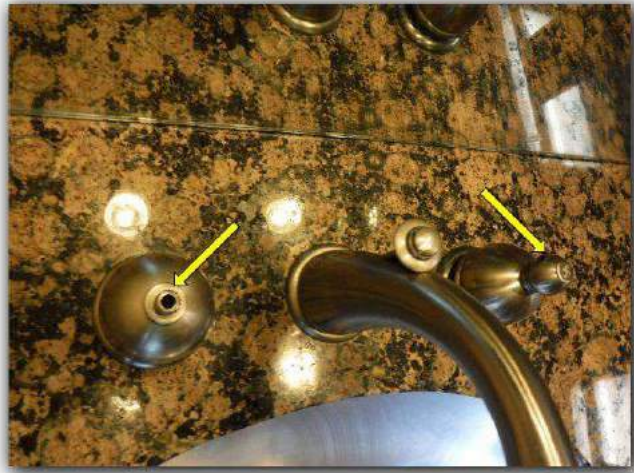
Sink faucet handles were missing at the left sink in the 4th floor men's bathroom.

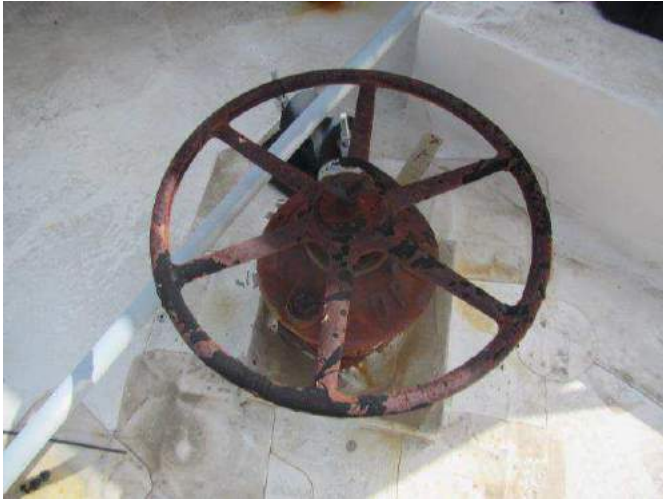
There was rust at the upper roof level valve handle. (top left picture below)
There was excessive rust at some roof level gas lines. (top right picture below)
The water pressure to the home was 100 PSI at time of inspection. Normal pressure is below 80 PSI. A pressure reducing valve should be installed by a licensed plumber to avoid damage.

It is recommended that a licensed plumber further evaluate the water supply system, fixtures, and drainage system, and make all necessary repairs/replacements.

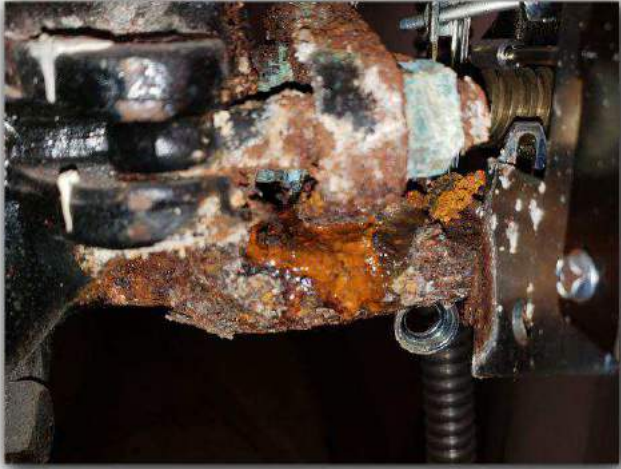
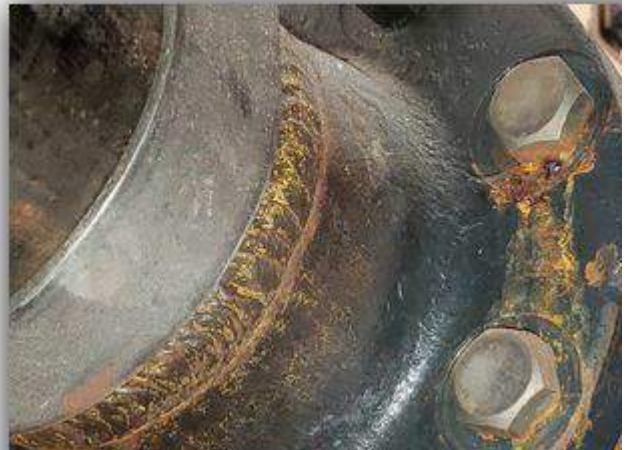
There were areas of extensive rusting, and corrosion present at the cast iron piping at the fire suppression system. It is highly recommended that a licensed plumber further evaluate these areas and make all necessary repairs/replacements.

Active leak was observed at the cast iron piping at the fire suppression system. (2nd and 3rd Pictures Below)

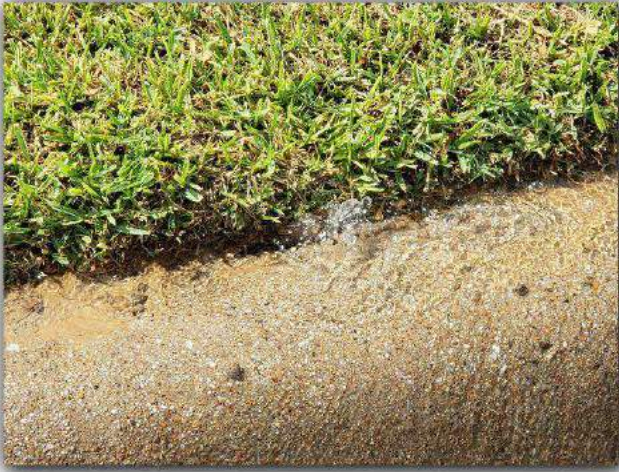
There was a damaged sprinkler head in zone 1.(Top Left Picture Below)

It is recommended that a qualified sprinkler technician further evaluate the lawn sprinklers and make all necessary repairs/replacements.

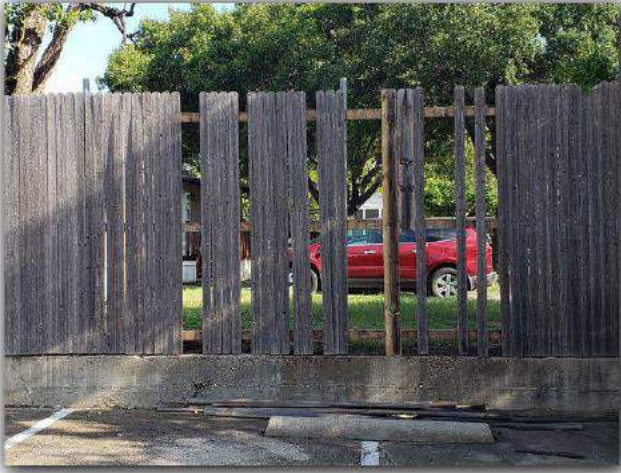
The fence is in need of repair. (top left picture below)
