GREENWORKS SERVICE COMPANY

GW STANDARD HOME INSPECTION

PROPERTY INSPECTION REPORT FORM

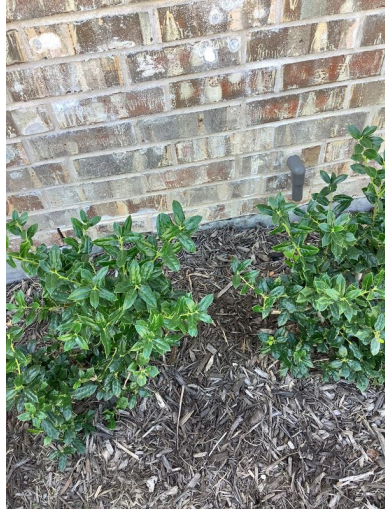
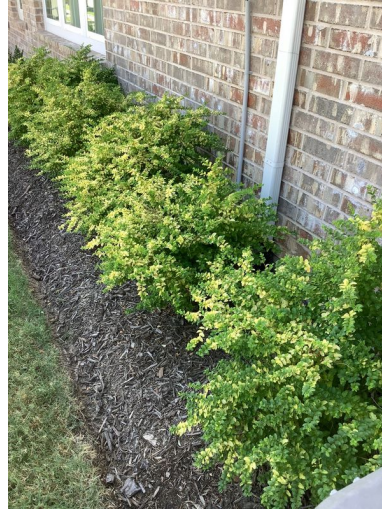
There were areas of excessive/Insufficient exposure of the foundation wall. Preferably 6 to 8 inches of foundation exposure should be present around the perimeter of the home. The higher the soil level the more inviting it is for wood destroying insect activity and moisture intrusion.

Recommendation: Contact a qualified grading contractor.

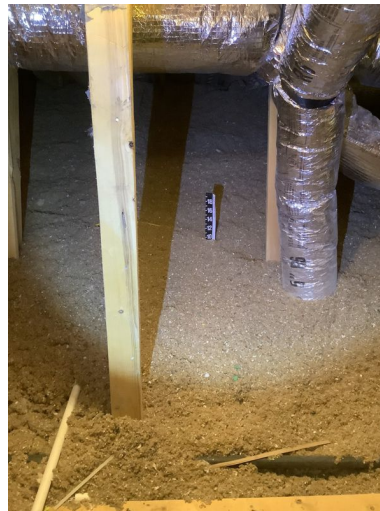
There were areas of low insulation. The Department of Energy currently recommends an insulation value of R-30 to R-49 for the attic area.

Recommendation: Contact a qualified insulation contractor.

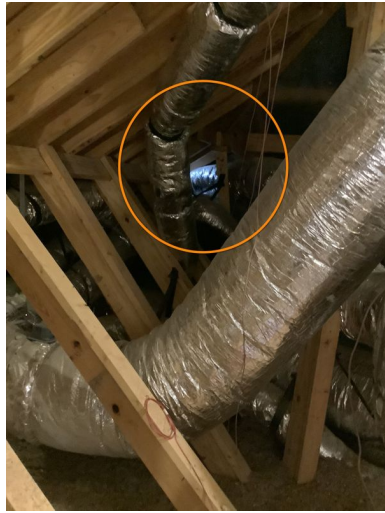
3: Light From Exterior Visible From Attic

Recommendation: Contact a qualified professional.

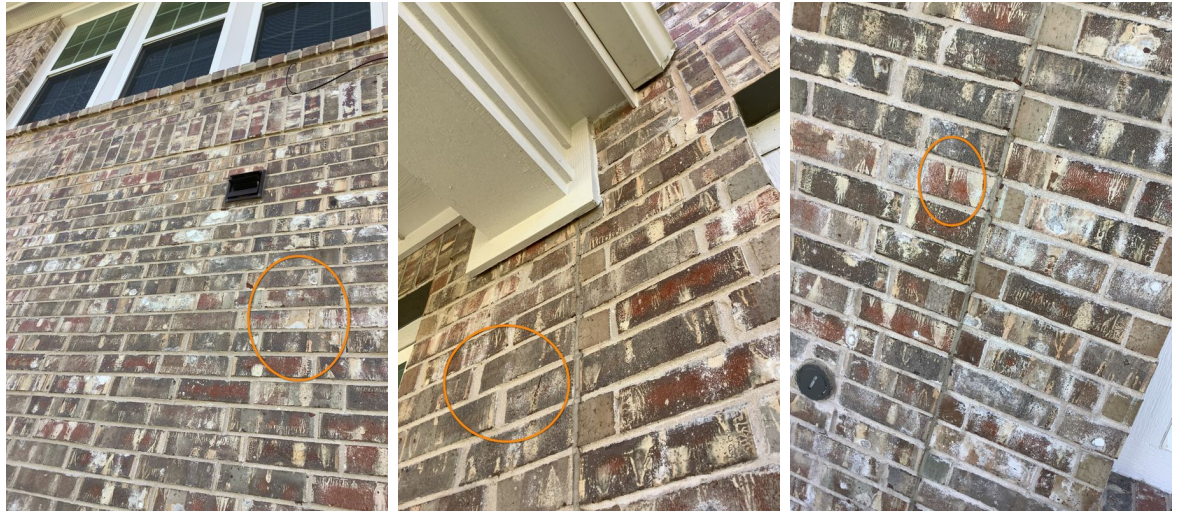
2: Mortar Separation

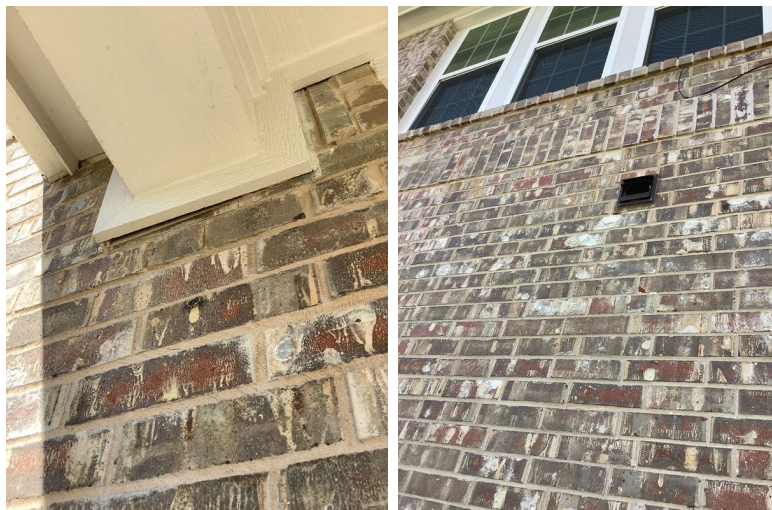
3: Lack of Sealed Penetrations

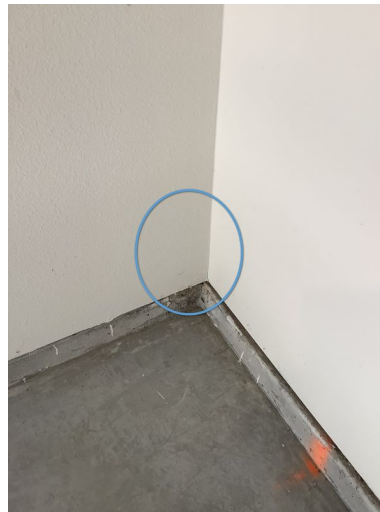
Trim separation was observed at areas of the interior trim materials.

Recommendation: Contact a qualified professional.

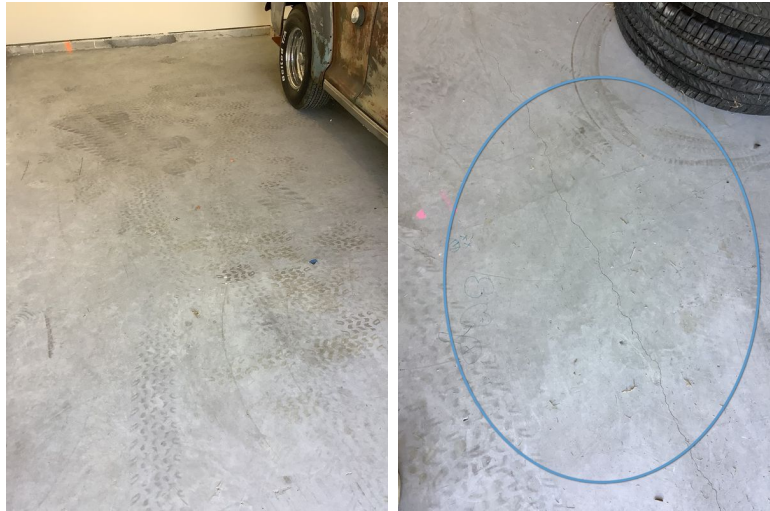
There were cracks in the garage floor. This is typical of concrete and is not considered significant. It should be monitored for large separations or differential movement.

Recommendation: Contact a qualified professional.

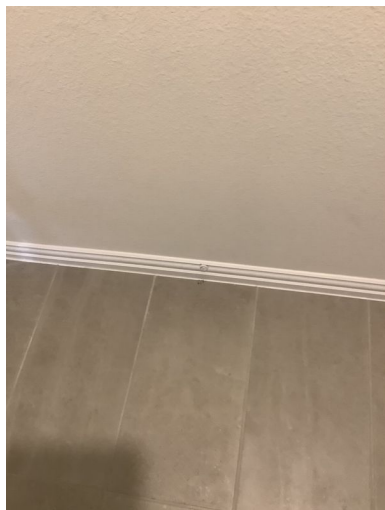
There were loose, damaged and/or missing door stops in the home. Repair or replacement is recommended to limit damage to walls.

Recommendation: Contact a handyman or DIY project

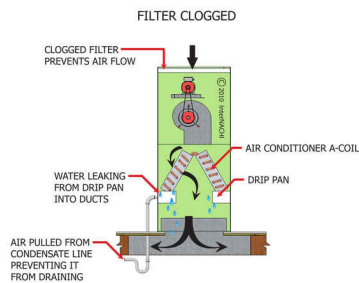
At the time of inspection the filters were dirty. Air filters are recommended to be changed monthly for 1" filters and every 3-6 months for 4" filters.

Recommendation: Recommended DIY Project

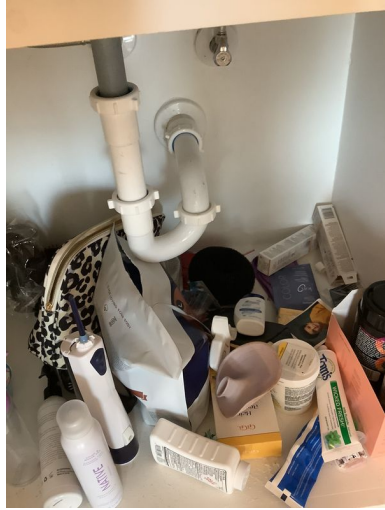
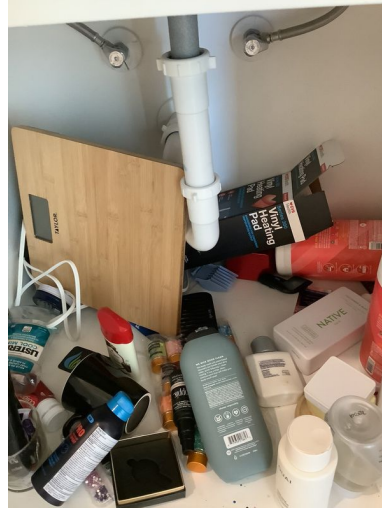
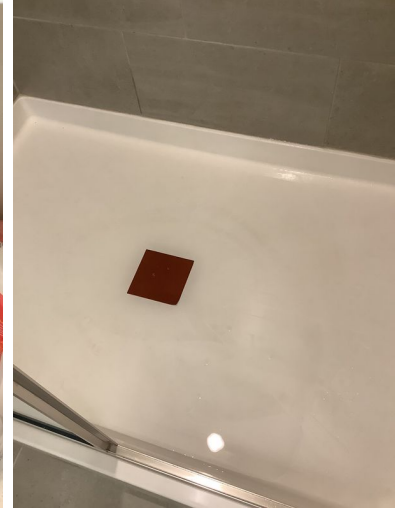
1: Gurgling Observed

Gurgling sound was observed. Possible venting issue or clog in the area of concern. Recommend a qualified professional evaluate and repair.

Recommendation: Contact a qualified plumbing contractor.

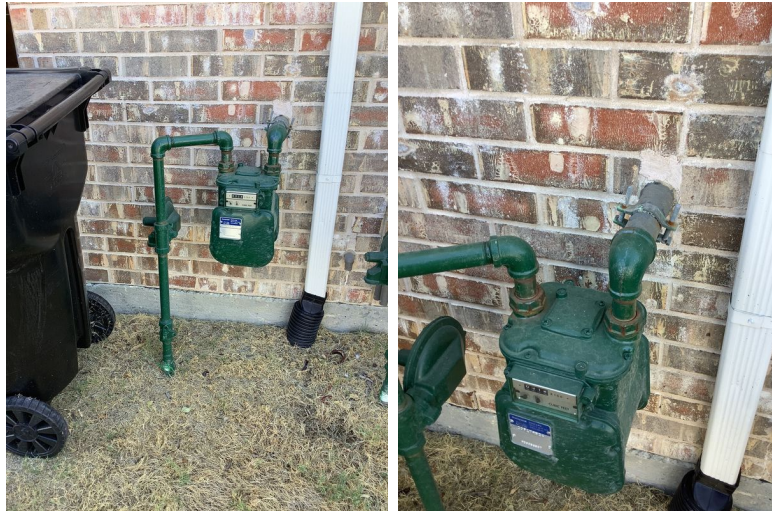
Areas of Rusting/Damage - Gas: Yes

1: Rusted Gas Lines

There was rusting at the gas lines at the home. Rusted lines can lead to gas leaks.

Recommendation: Contact a qualified plumbing contractor.

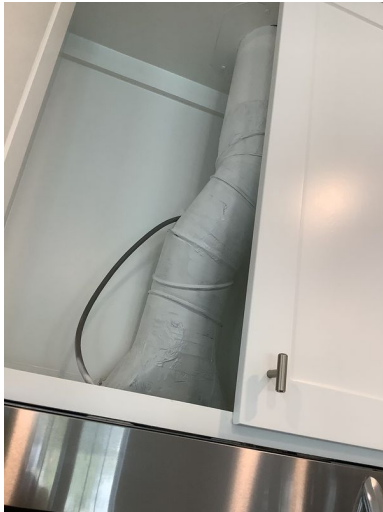
1: Missing Filter

The range exhaust vent filter is missing.
