GREENWORKS SERVICE COMPANY

GW STANDARD HOME INSPECTION

PROPERTY INSPECTION REPORT FORM

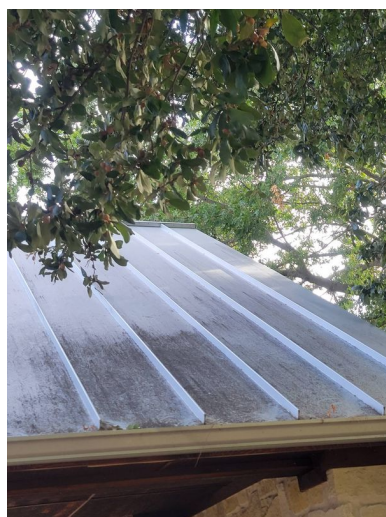
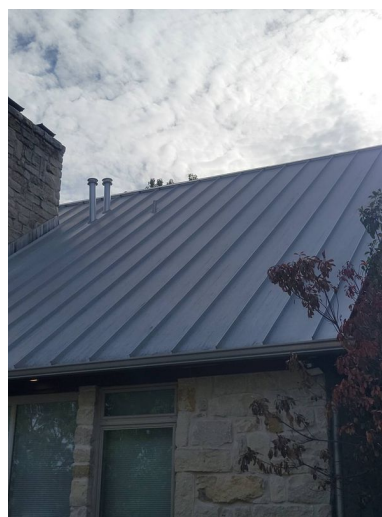
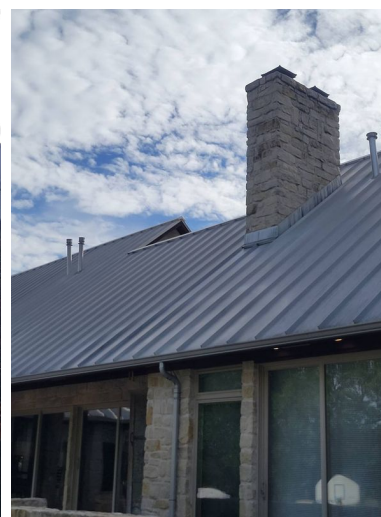
[Here is a helpful article](#) on common roof stains.

Recommendation: Contact a qualified roofing professional.

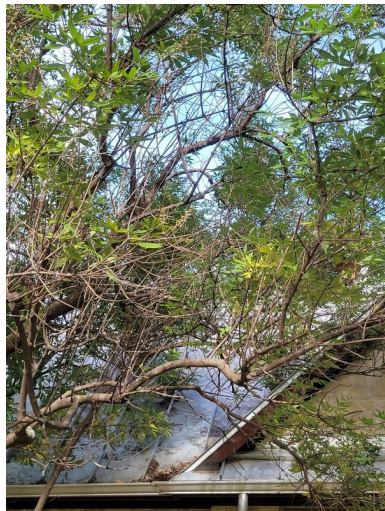
3: Roof Debris

There was debris on the roof at the time of inspection. Removal is recommended for proper drainage.

Recommendation: Contact a handyman or DIY project

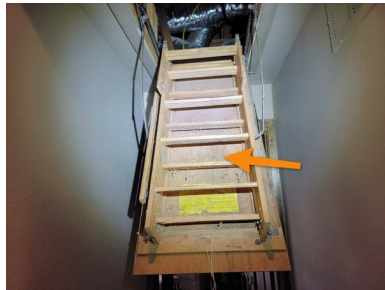
Master/Primary Attic

3: Attic Door Insulation Insufficient

The attic pull down stairway at the interior of the home was missing insulation, foam board, or insulation tent. An R-value of greater than or equal to 10 is recommended.

Recommendation: Contact a qualified professional.

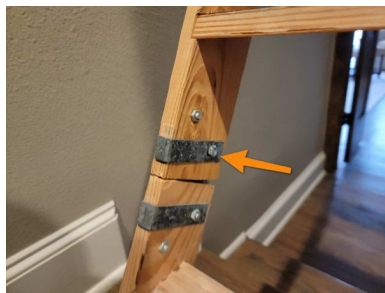
4: Loose/Missing Hardware

Loose and/or missing hardware was noted at the pull down attic stairway. Repair is recommended.

Recommendation: Contact a qualified professional.

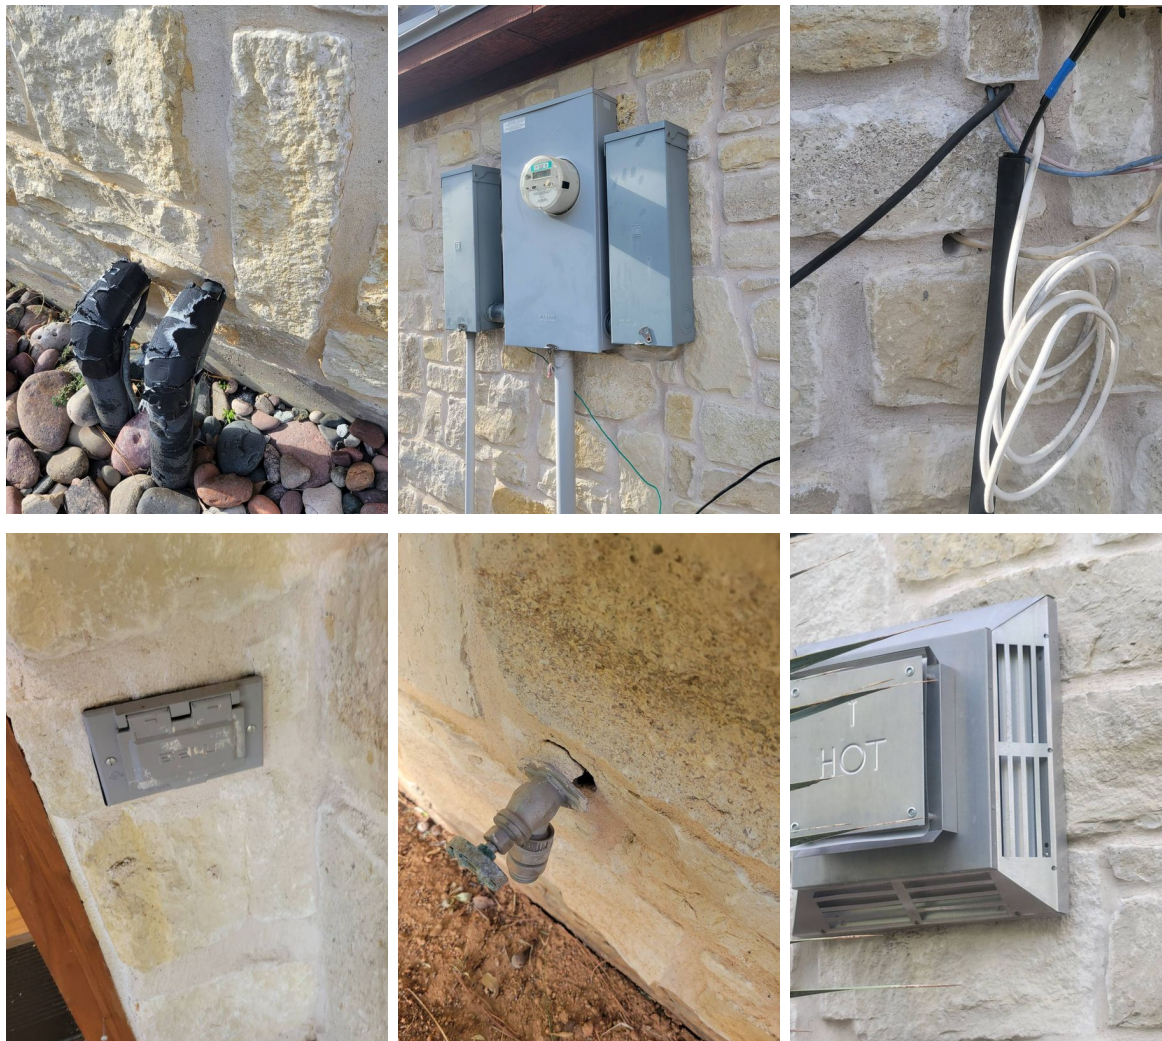
2: Lack of Sealed Penetrations

It is recommended that all protrusions through the siding and fixtures mounted on the exterior be sealed in order to prevent moisture incursion. Using a quality exterior caulk type sealant around pipes, wires, light fixtures etc. can prevent moisture related failure of electrical components and siding materials.

Recommendation: Contact a qualified professional.

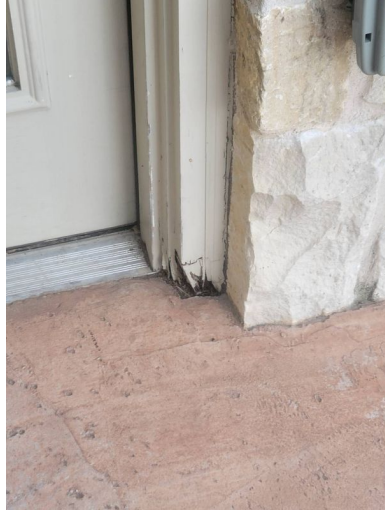
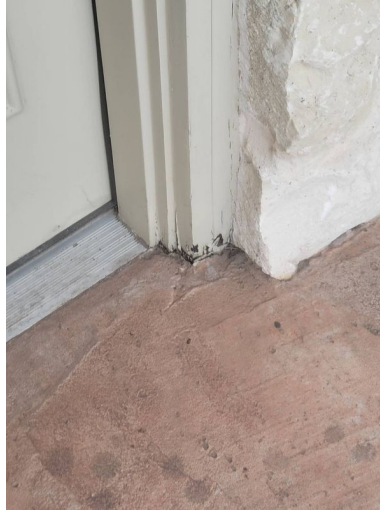
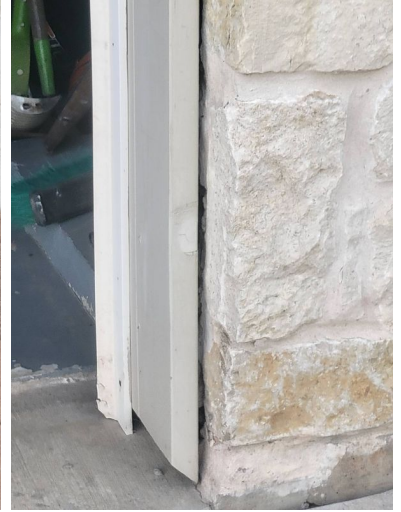
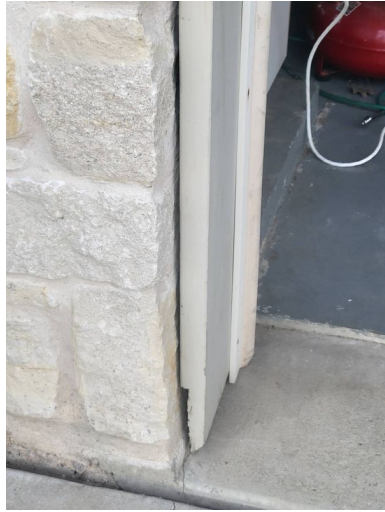
4: Rot/Exposed Wood - Discoloration

There were various areas of damage and/or rot to the siding and trim. Chipped and/or missing paint were noted at time of inspection. Areas of discoloration. Repair/Replacement is recommended.

Recommendation: Contact a qualified professional.

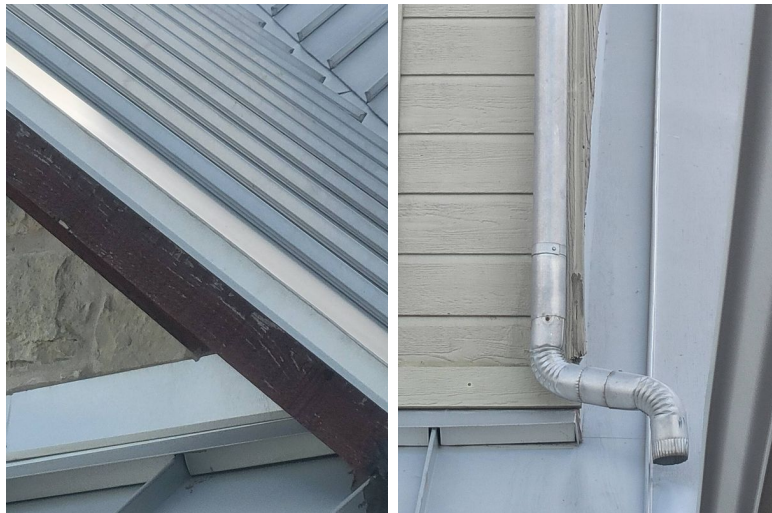
5: Weep holes - Missing

Weep holes were not observed above all windows and doors at the exterior wall where brick/stone is resting on lintels. Repair is recommended.

Recommendation: Contact a qualified masonry professional.

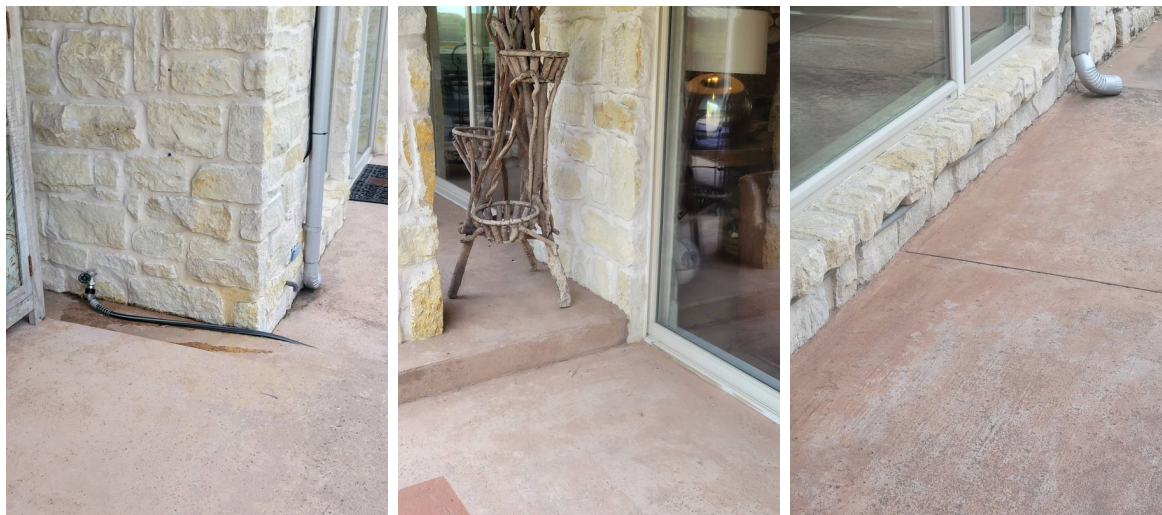
Weep holes/ screeds contained debris. Weep holes/ screeds should be free and clear of debris to allow proper ventilation.

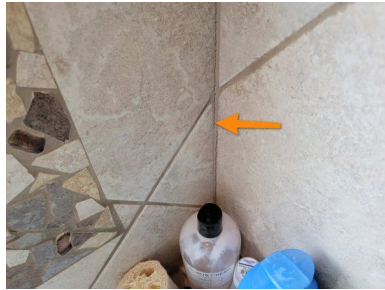
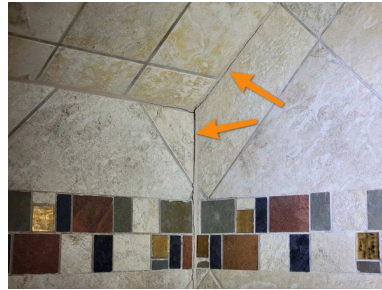
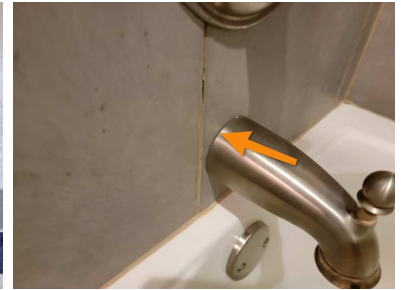
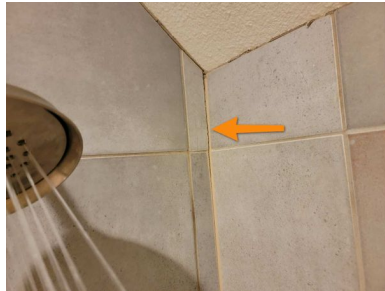
There were various areas of missing and damaged caulking and/or grout at the shower and/or tub walls. This can include between the tiles, in corners, around the tub and at the penetrations into or through the walls. All shower and tubs should be completely water tight and sealed. Repair is recommended.

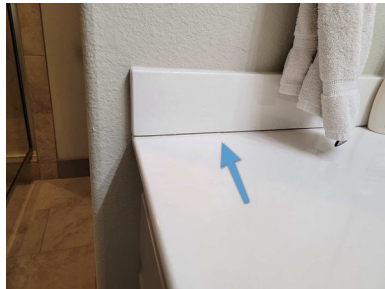
Upstairs Back Right Bathroom

Caulking is needed at the wall / counter connection point.

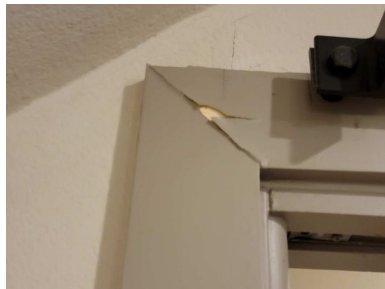
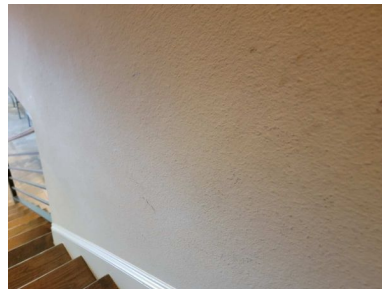
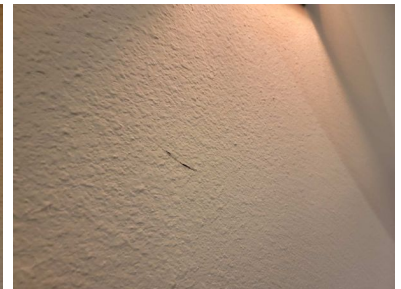
There are nicks and missing paint in various areas.

Recommendation: Contact a qualified painting contractor.

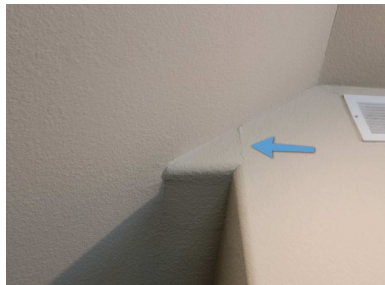
Back Middle Bedroom

There are joint separations in various areas.

Recommendation: Contact a qualified drywall contractor.

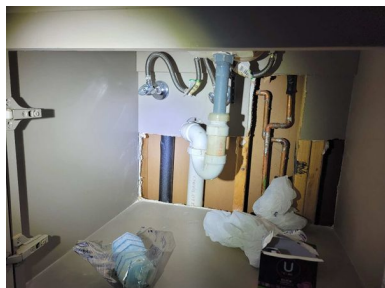
Upstairs Middle Bathroom

There were unfinished or unpainted areas at the interior of the home.

Recommendation: Contact a qualified professional.

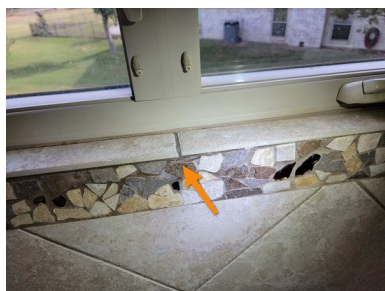
Upstairs Right Bathroom

Grout was observed to be cracked and/or damaged at the wall tiles outside of the tub/shower enclosure. Repairs are recommended.

Recommendation: Contact a qualified tile contractor

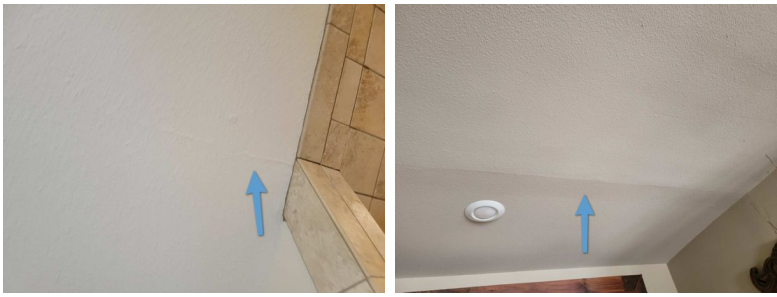
Upstairs Back Right Bathroom

There is joint separation in various areas.

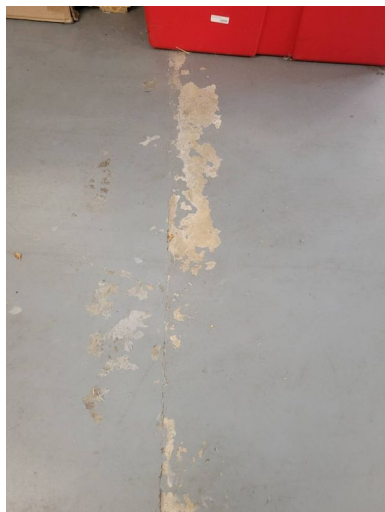
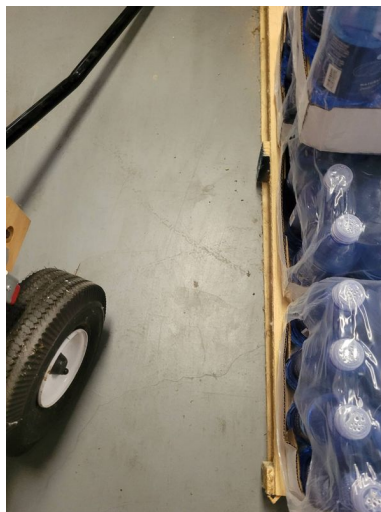
There were cracks in the garage floor. This is typical of concrete and is not considered significant. It should be monitored for large separations or differential movement.

Recommendation: Contact a qualified professional.

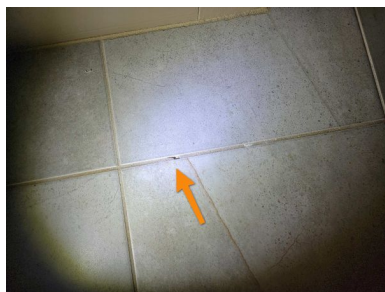
Upstairs Middle Bathroom

Grout is cracked, damaged or missing between the floor tiles. Repair is recommended.

Recommendation: Contact a qualified flooring contractor

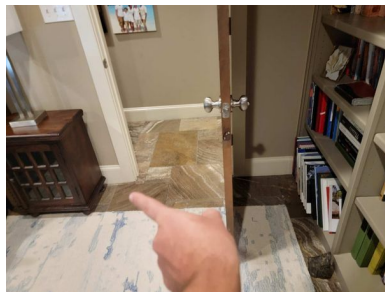
Front Right Bedroom Downstairs

There were doors within the home that open/close when left in a fixed position.

Recommendation: Contact a qualified door repair/installation contractor.

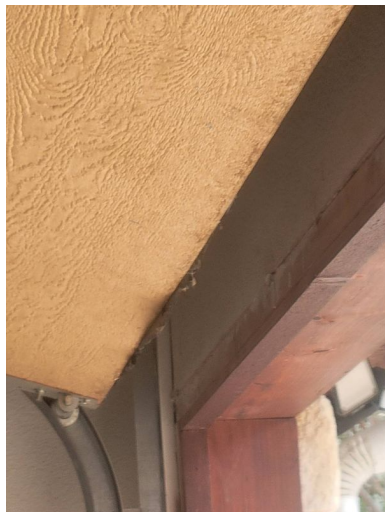
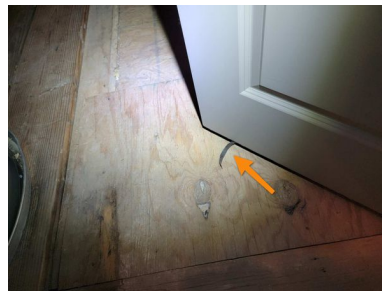
Front Right Attic

The door has a damaged weather strip. This can result in significant energy loss and moisture intrusion. Recommend installation of standard weatherstripping.

Recommendation: Contact a qualified door repair/installation contractor.

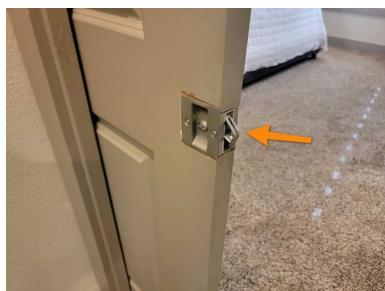
Upstairs Front Right Bedroom

Observed door hardware that was loose, missing, rusted, or damaged. ("Hardware" could include, but is not limited to: hinges, hinge pins, knobs, springs, latches, locks, deadbolts, strike plates, or any other piece of hardware necessary to allow the door to function properly.) Recommend further evaluation and repairs as necessary.

Recommendation: Contact a qualified door repair/installation contractor.

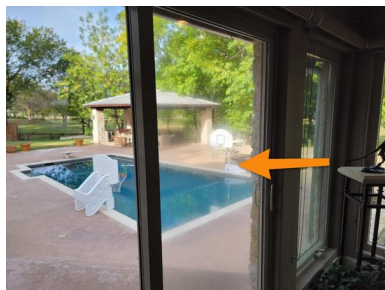
Kitchen Back

The glass door had double-pane glazing in which condensation/fogging was visible. This indicates a loss of thermal integrity. The door should be repaired or replaced as necessary by a qualified contractor. Replacement is more typical.

Recommendation: Contact a qualified door repair/installation contractor.

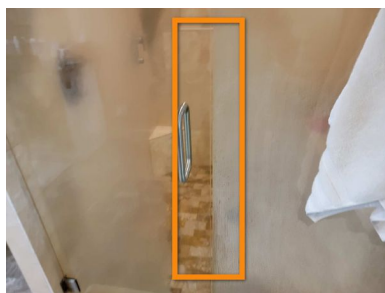
Master/Primary Bathroom

Observed loose, missing, or damaged water seal at the bathroom shower door. Water may splash onto the bathroom floor when shower is in use. Recommend further evaluation and repairs as necessary.

Recommendation: Contact a qualified professional.

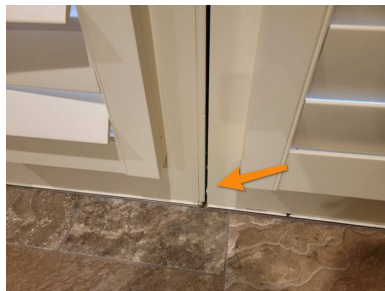
Downstairs Right Side

Light and air gaps were present at the exterior doors. This can result in significant energy loss and moisture intrusion. Recommend installation of additional weatherstripping.

Recommendation: Contact a qualified door repair/installation contractor.

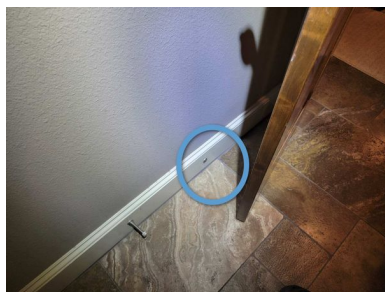
Downstairs Front Right Bathroom

There were loose, damaged and/or missing door stops in the home. Repair or replacement is recommended to limit damage to walls.

Recommendation: Contact a handyman or DIY project

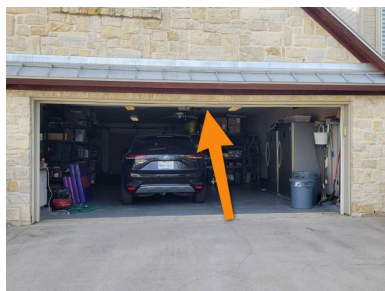
The lintel is sagging at the overhead garage door.

Recommendation: Contact a qualified professional.

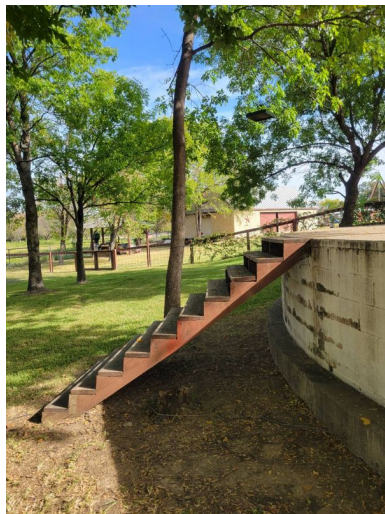
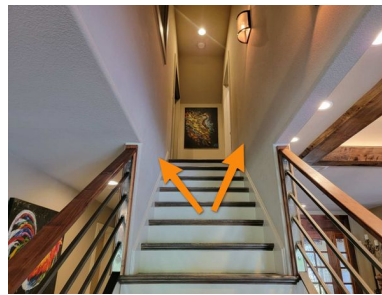
Railing is needed for the stairway.

Recommendation: Contact a qualified professional.

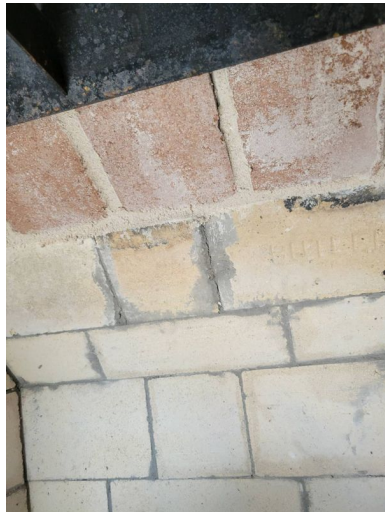
2: Firebrick - Needs mortar repair

The fireplace interior firebrick needs mortar repair.

Recommendation: Contact a qualified fireplace contractor.

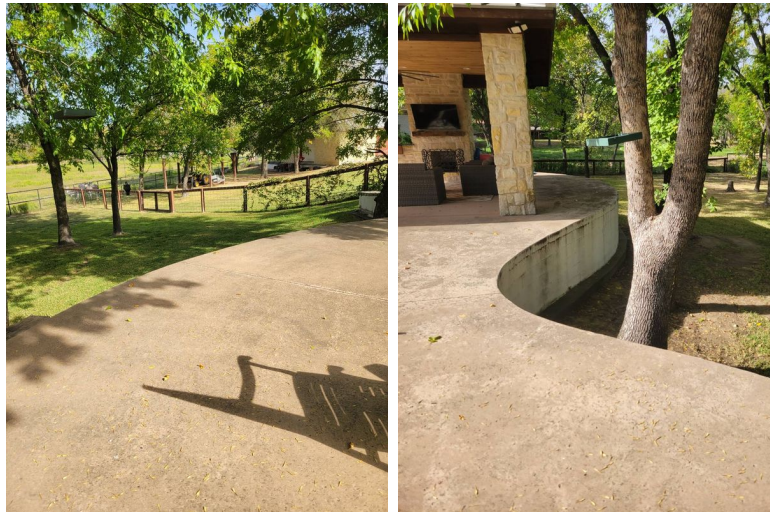
1: Railing Recommended

It is recommended that railing is added to patios that are more than 30" above grade.

Recommendation: Contact a qualified professional.

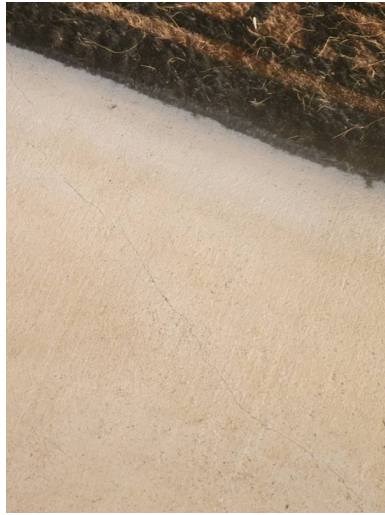
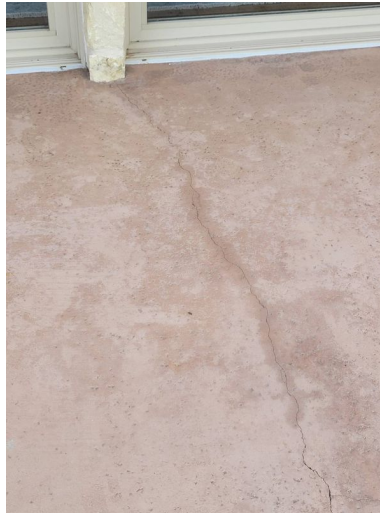
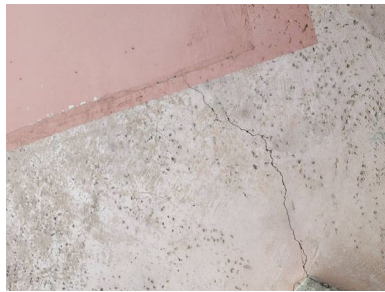
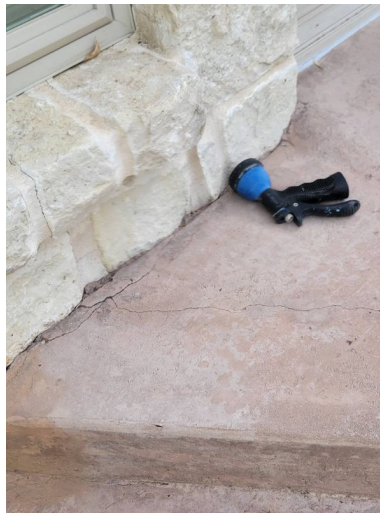
2: Patio/Porch Cracking - Cosmetic

There is cracking noted at the patio/porch surfaces.

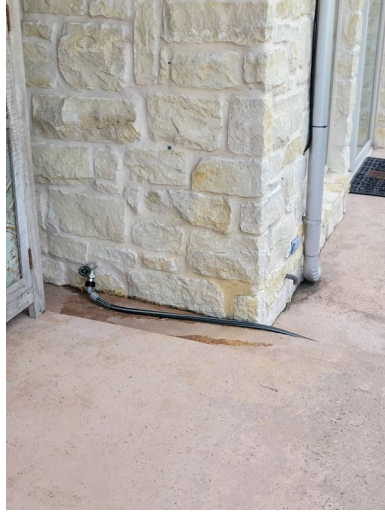
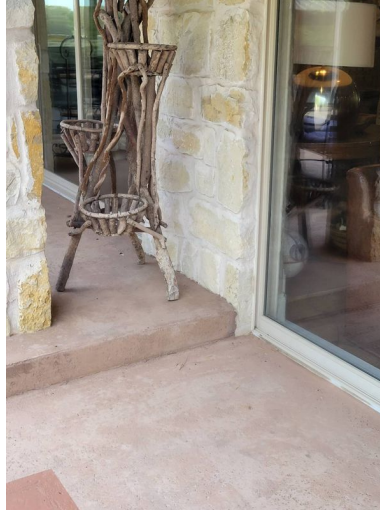
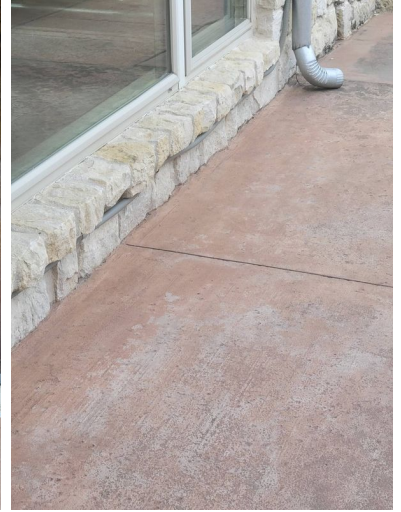
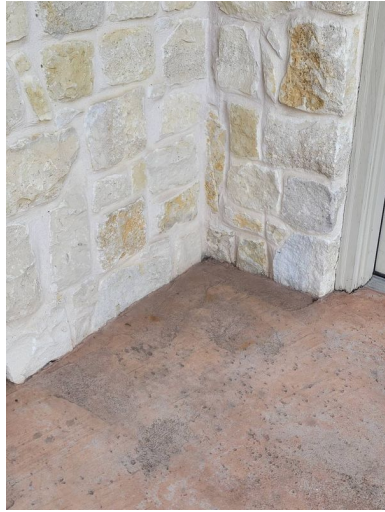
3: Patio Level Higher Than Interior Floor

The level of the exterior patio is higher than the interior floor level. This condition is conducive for water intrusion and wood destroying insect infestation.

Recommendation: Contact a qualified professional.

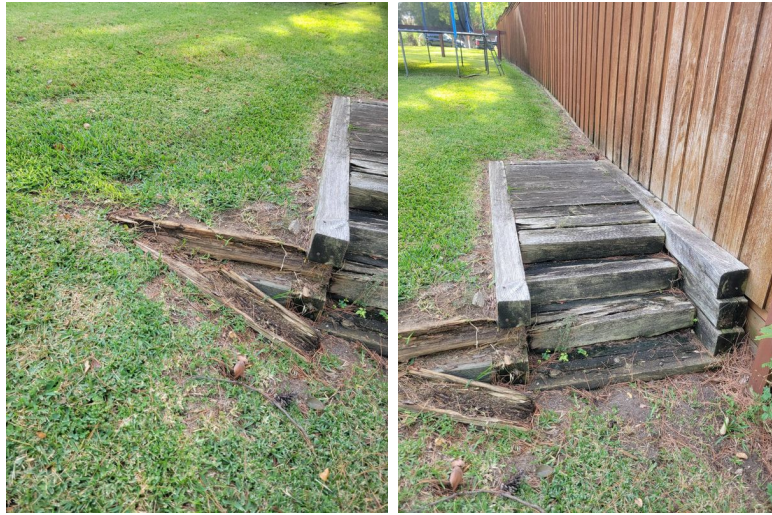
1: Retaining Walls - Wood rot

The retaining wall has various areas of wood rot present.

Recommendation: Contact a qualified professional.

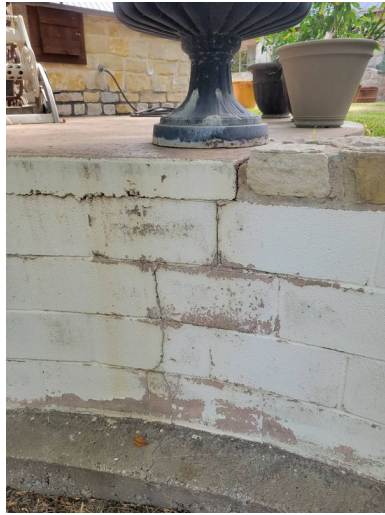
2: Retaining Walls - Cracks

There were cracks and repaired cracks in the retaining walls.

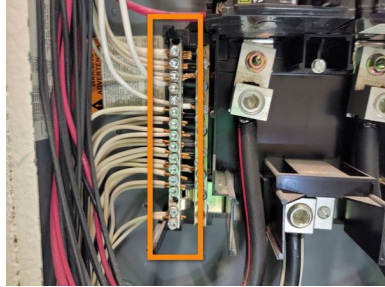
2: Double Lugging - One Breaker

There is double lugging evident at a circuit breaker in the electrical panel. Repair is highly recommended.

Recommendation: Contact a qualified electrical contractor.

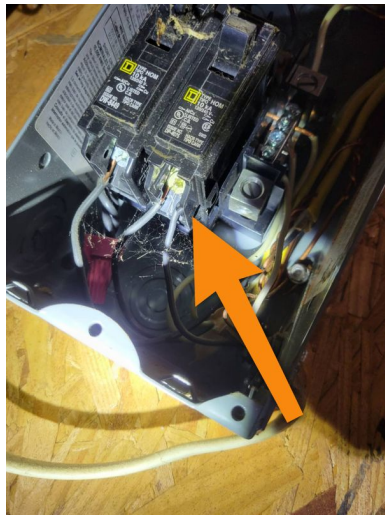
Barn

3: Missing A Screw

The panel dead front cover is missing one or more screws.

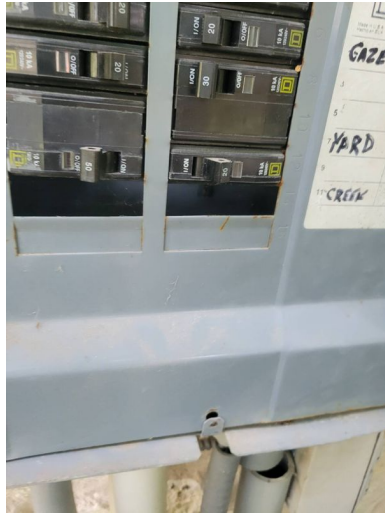
Pool panel

5: Missing Bushings

There were loose or missing bushings at some wiring in the electrical panel. Wire should have proper bushing protection when exiting the panel box.

Recommendation: Contact a qualified electrical contractor.

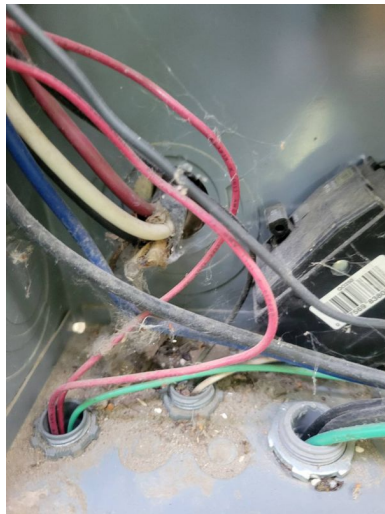
Pool

6: Wiring Not Connected

Recommendation: Contact a qualified electrical contractor.

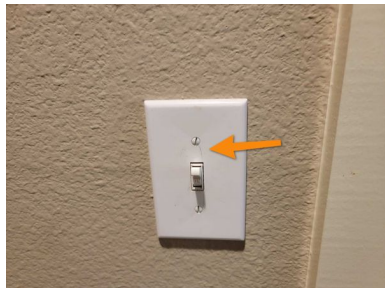
Kitchen

2: Cover Plates Damaged

One or more receptacles or switches have a damaged cover plate. Recommend replacement.

Recommendation: Contact a qualified electrical contractor.

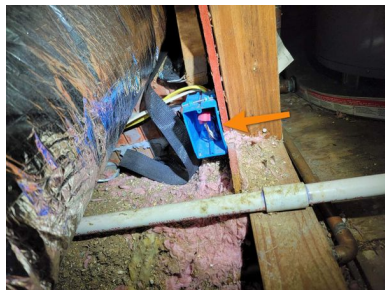
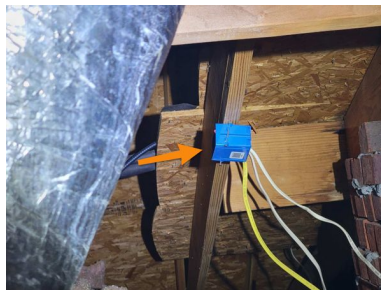
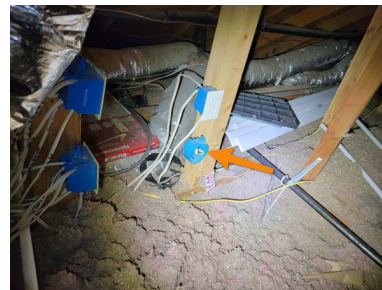
3: Junction Box Covers Missing

Visible electrical junction box observed that does not have a cover.

Recommendation: Contact a qualified electrical contractor.

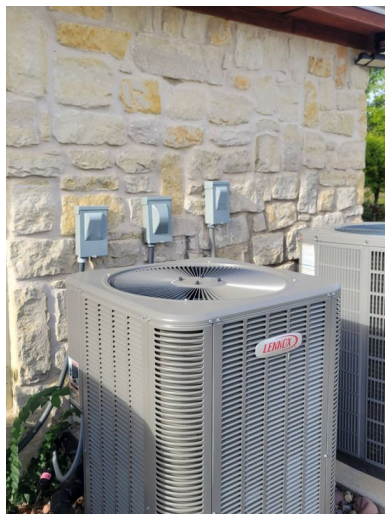
4: Condensing Unit Disconnect - Behind AC

The outdoor AC unit is positioned in front of the manual disconnect. Due to current electrical installation guidelines this is not considered proper.

Recommendation: Contact a qualified electrical contractor.

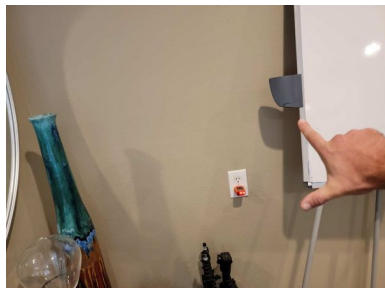
Office

5: Loose Outlets and Switches

Various loose outlets/switches observed in the home. Tightening of these receptacles is recommended to prevent any loose wiring or electrical shock from occurring.

Recommendation: Contact a qualified electrical contractor.

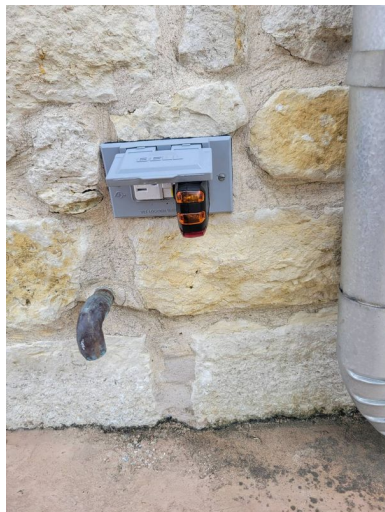
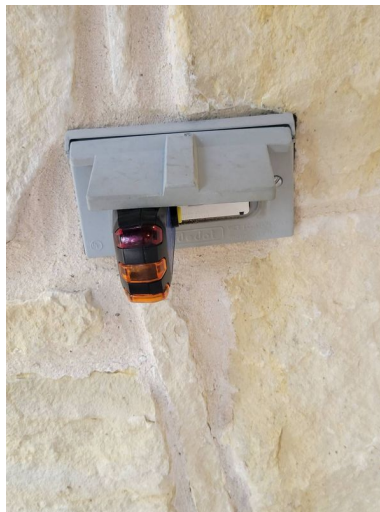
6: Outlet Not Responding

Outlet did not respond to testing. Repair or replacement is recommended.

Recommendation: Contact a qualified electrical contractor.

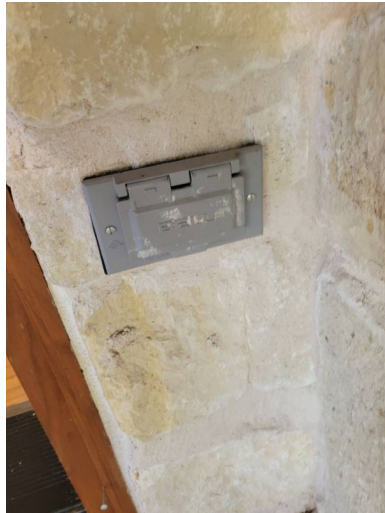
7: No In-Use Weatherproof Covers

Recommendation: Contact a qualified electrical contractor.

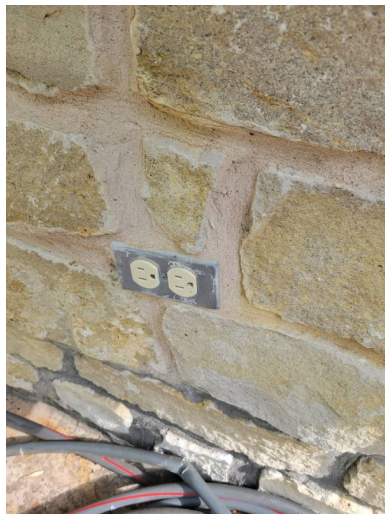
Patio

8: Missing Exterior Outlet Covers

Outlet covers were not present at the exterior outlets. Exterior outlets should be covered with an in-use weatherproof cover.

Recommendation: Contact a qualified electrical contractor.

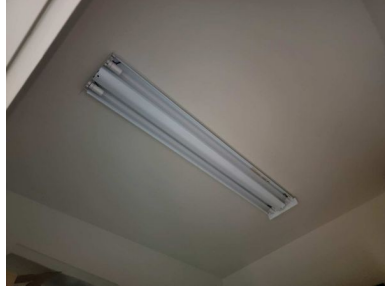
Upstairs Back Right Bedroom Closet

9: Uncovered Light

The cover is missing at the light fixture in one or more areas.

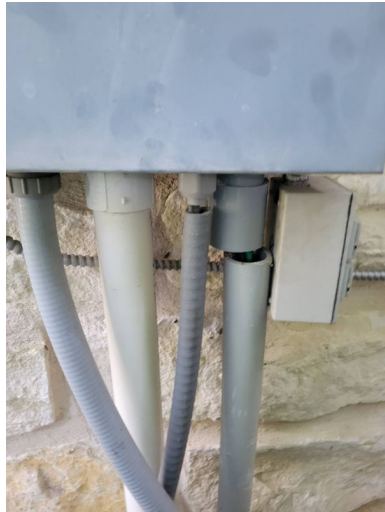
10: Slipped Conduit

Electrical conduit slipped and the wiring is exposed. Recommend a qualified professional evaluate and repair.

Recommendation: Contact a qualified professional.

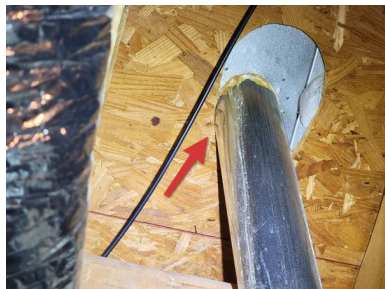
1: Gas Flue - Improper Clearance

The flue pipe serving the gas furnace does not have sufficient clearance from combustibile materials. Normally, a clearance of at least 1" is required. This situation may result in pyrolysis, which can possibly lower the auto-ignition temperature of the surrounding materials. This condition should be improved for safety reasons.

Recommendation: Contact a qualified HVAC professional.

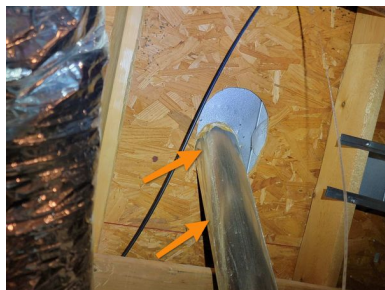
2: Flue Rusted/Corrosion

There was rust/corrosion noted at the furnace flue in areas.

Recommendation: Contact a qualified professional.

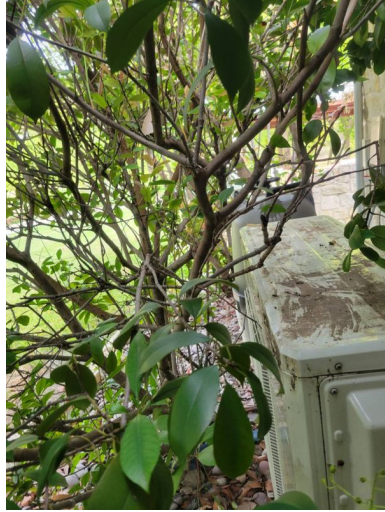
Vegetation obstructs the condensing coils on the air conditioning compressor. Free air flow is needed around this unit.

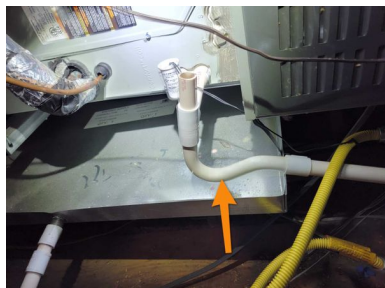
Master/Primary

There was an uninsulated trap at the HVAC unit. This can lead to water damage. It can also lead to mold growth.

Recommendation: Contact a qualified HVAC professional.

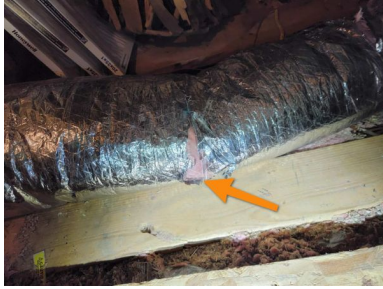
Left Side

1: Damaged Duct Insulation

Insulation was damaged on the ducts in one or more areas. Repair or replacement of the ducting is recommended.

Recommendation: Contact a qualified HVAC professional.

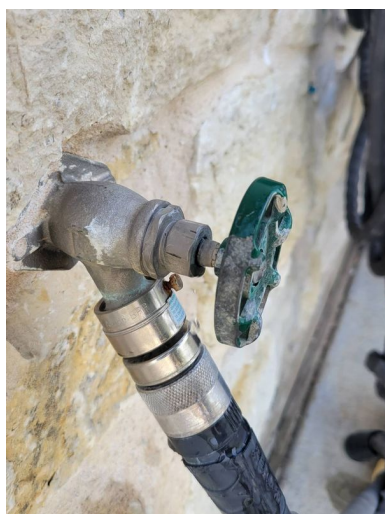
Back Right

1: Leaking Handle - Exterior Faucet

The exterior faucet leaks at the handle when turned on.

Recommendation: Contact a qualified plumbing contractor.

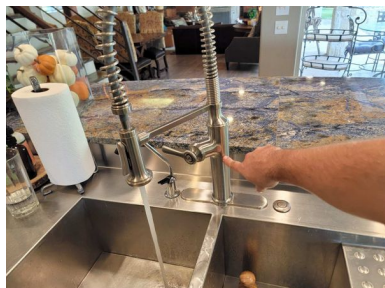
Kitchen

2: Loose Fixtures

The fixture is loose. Tightening is recommended to prevent leaking.

Recommendation: Contact a qualified plumbing contractor.

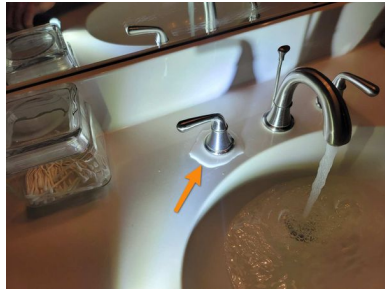
Downstairs Front Right Bathroom

3: Leaking Faucet Handle

There is a leak at the faucet handle. Repair is recommended.

Recommendation: Contact a qualified plumbing contractor.

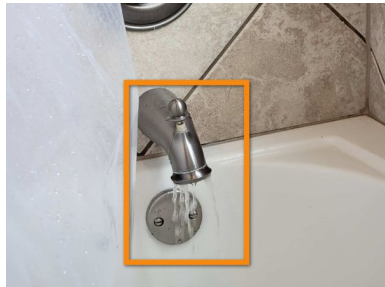
Upstairs Front Right Bathroom

4: Diverter - Doesn't Shut Off

The shower diverter does not fully shut off water to the spout when the shower is on.

Recommendation: Contact a qualified plumbing contractor.

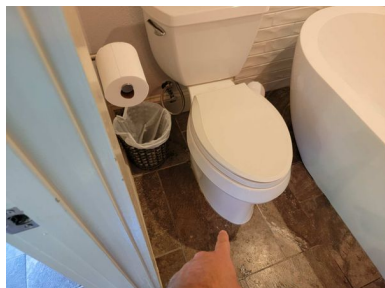
Downstairs Back Right Bathroom

5: Toilet Loose - Floor

The toilet is loose at the floor, which can result in damage to the wax seal under the toilet and possible leakage.

Recommendation: Contact a qualified plumbing contractor.

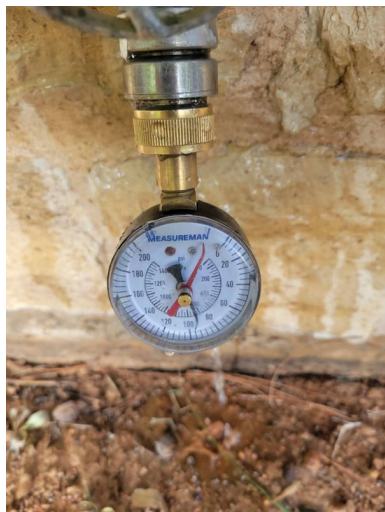
6: High PSI

At the time of the inspection, the water pressure to the home was above normal pressure of 80 PSI. A pressure adjustment valve should be installed or adjusted if present by a licensed plumber. Normal water pressure range is between 40 and 80 PSI.

Recommendation: Contact a qualified plumbing contractor.

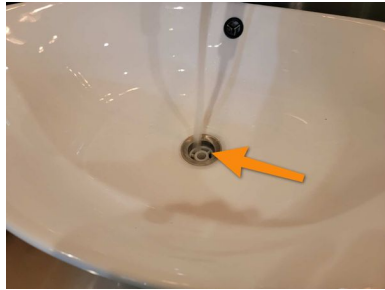
Master/Primary Bathroom

1: Missing Stopper Plunger - Sink

The stopper plunger is missing at the bathroom sink.

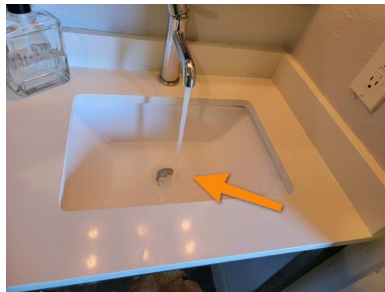
Downstairs Back Right Bathroom

2: Sink Stopper - Does Not Hold Water

The sink stopper did not hold water when engaged.

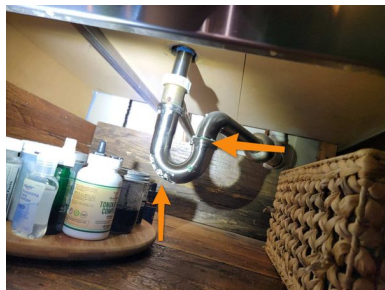
Master/Primary Bathroom

4: Corrosion at Drainage Piping - Sink

There was corrosion present at the sink drainage piping.

Recommendation: Contact a qualified plumbing contractor.

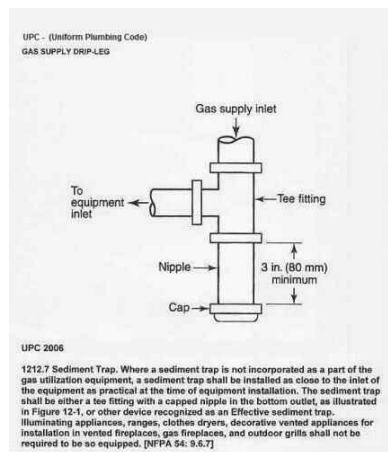
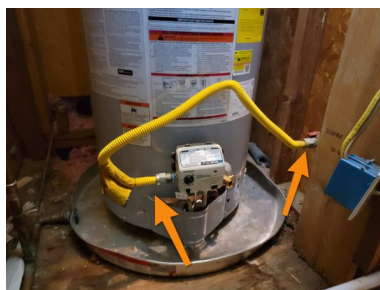
Drip leg or sediment trap was not observed on the gas line at the unit.

Recommendation: Contact a qualified plumbing contractor.

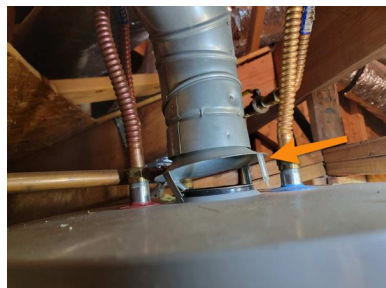
2: Draft Hood - Not Secured

The draft hood to the water heater is not securely centered above the unit.

Recommendation: Contact a qualified plumbing contractor.

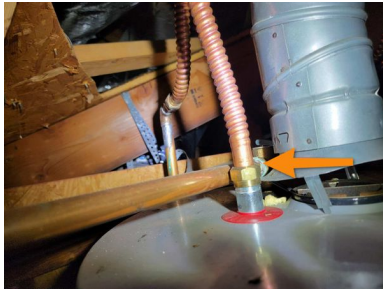
3: TP Corrosion

The temperature and pressure relief drain line valve showed corrosion. According to most manufacturers of water heaters, TPR valves that are over 3 years old should be inspected by a licensed plumber for corrosion deposits.

Recommendation: Contact a qualified plumbing contractor.

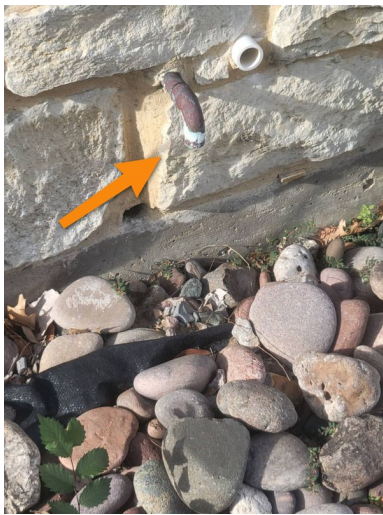
Right

4: Termination Point

The temperature and pressure relief drain line should terminate less than 6" from the ground and point downward.

Recommendation: Contact a qualified plumbing contractor.

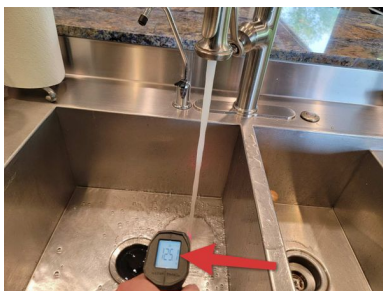
5: Excessive Water Temperature

Excessive water temperatures were observed at the time of inspection. Temperature settings should be adjusted to prevent risk of scalding and burning.

Recommendation: Contact a qualified professional.

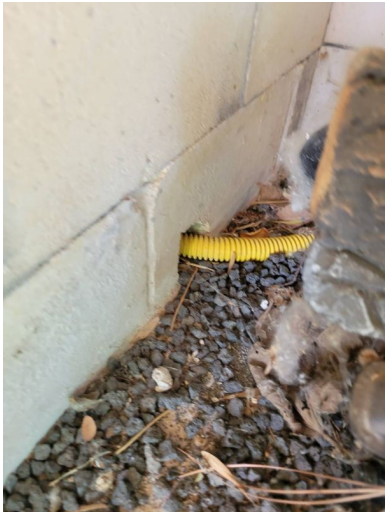
Patio Fireplace

The flex line penetrates the wall. Black iron pipe should penetrate the wall.

Recommendation: Contact a qualified plumbing contractor.

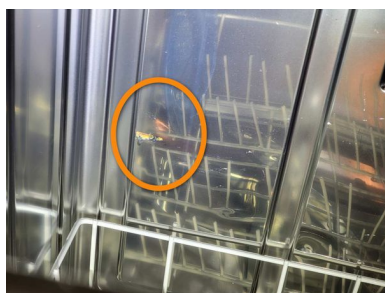
1: Corrosion on Racks/Cabinet

Corrosion was noted on the dishwasher racks / cabinet.

Recommendation: Contact a qualified appliance repair professional.

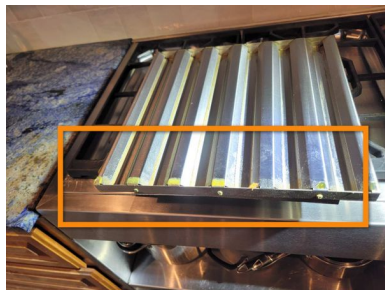
1: Dirty Filter

Dirty filter at time of inspection. Cleaning or replacement of the filter is recommended.

Recommendation: Contact a handyman or DIY project

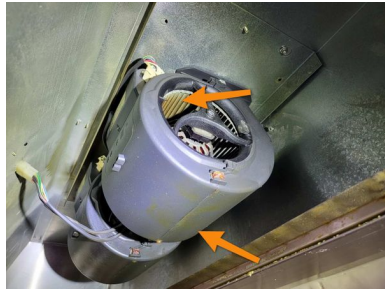
2: Grease Buildup

Grease buildup was present on the unit. Cleaning is highly recommended.

Recommendation: Contact a qualified professional.

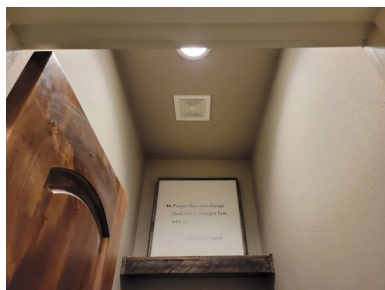
The exhaust fan is noisy when in use.

Recommendation: Contact a qualified professional.

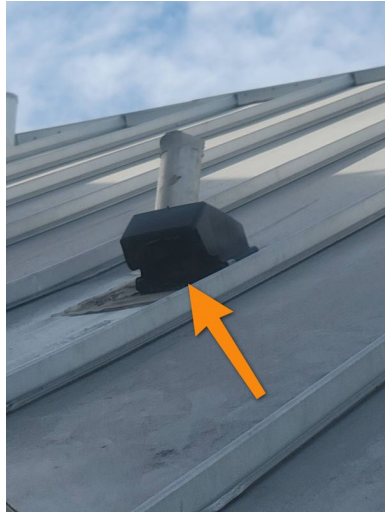
The dryer vent flap is stuck in the open position.

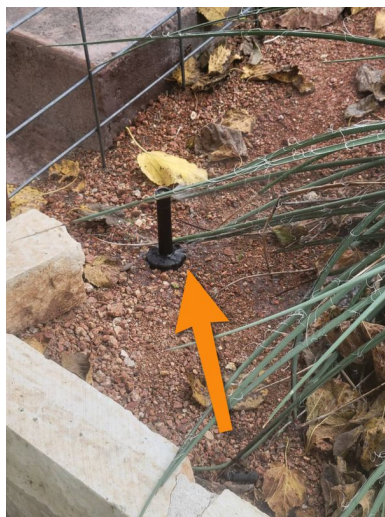
Back

There are sprinkler heads that leak water when tested. Repair is recommended.

Recommendation: Contact a qualified professional.

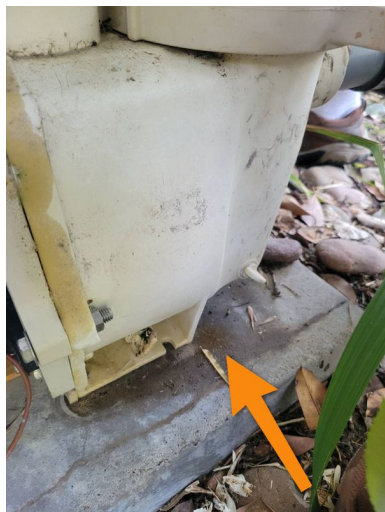
3: Water Leak - Pump

There was a water leak observed at the pump. Repair is recommended.

Recommendation: Contact a qualified Swimming Pool Contractor

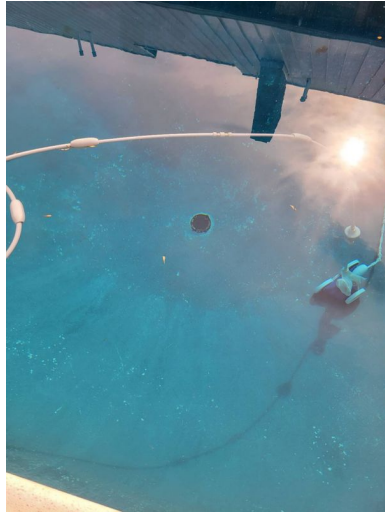
4: One Pool Drain

The swimming pool has one drain. There should be two drains to reduce risk of entrapment. The swimming pool should have at least two circulation drains that are hydraulically balanced or a proper anti-suction drain cover.

Recommendation: Contact a qualified Swimming Pool Contractor

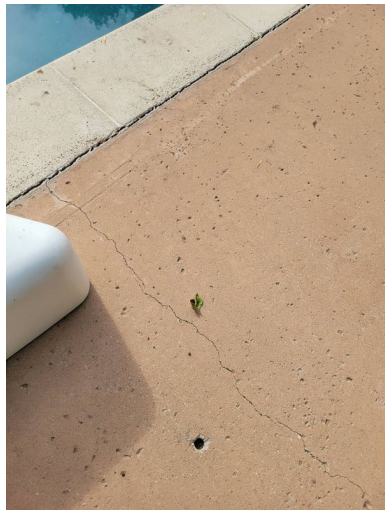
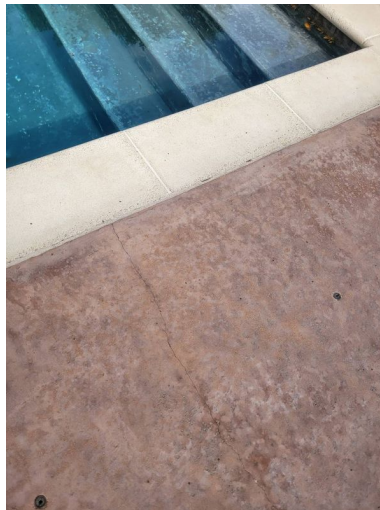
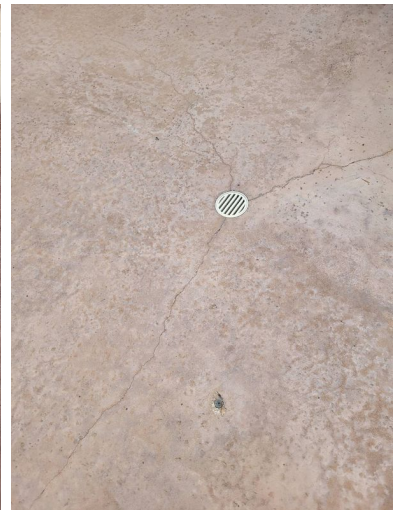
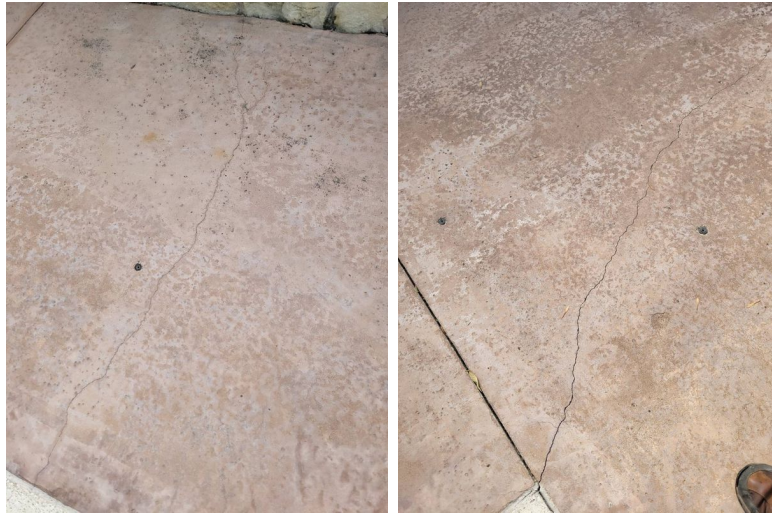
5: Cracked/Damaged Decking

The decking area was cracked, damaged, and/or uplifted in areas.

Recommendation: Contact a qualified Swimming Pool Contractor

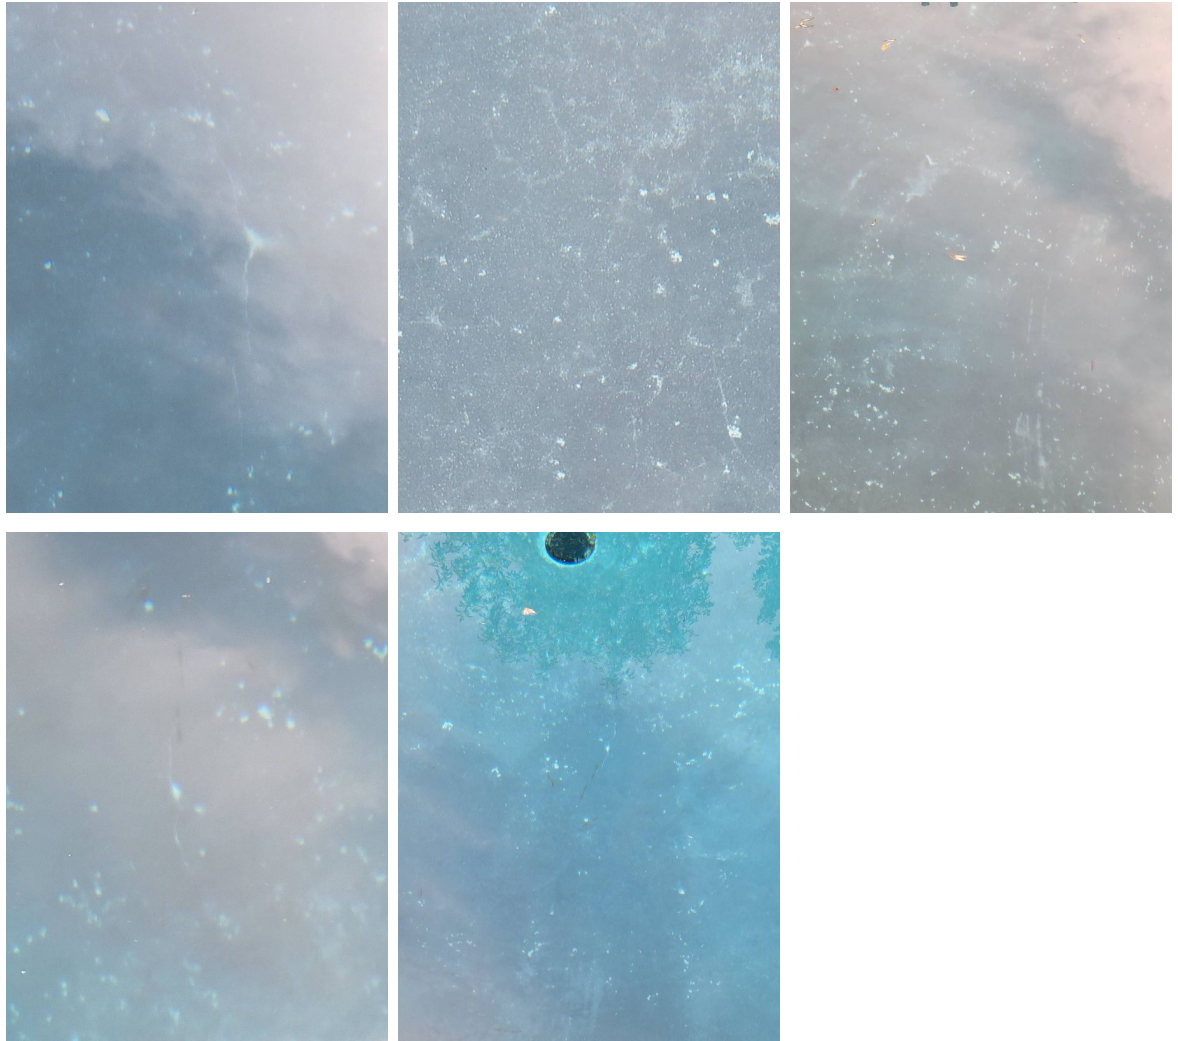
6: Pool Surface/Gunite Cracks

There were areas of cracking and damage at the pool surface. Recommend a qualified professional evaluate and repair.

Recommendation: Contact a qualified Swimming Pool Contractor
