GREENWORKS SERVICE COMPANY

GW STANDARD HOME INSPECTION

PROPERTY INSPECTION REPORT FORM

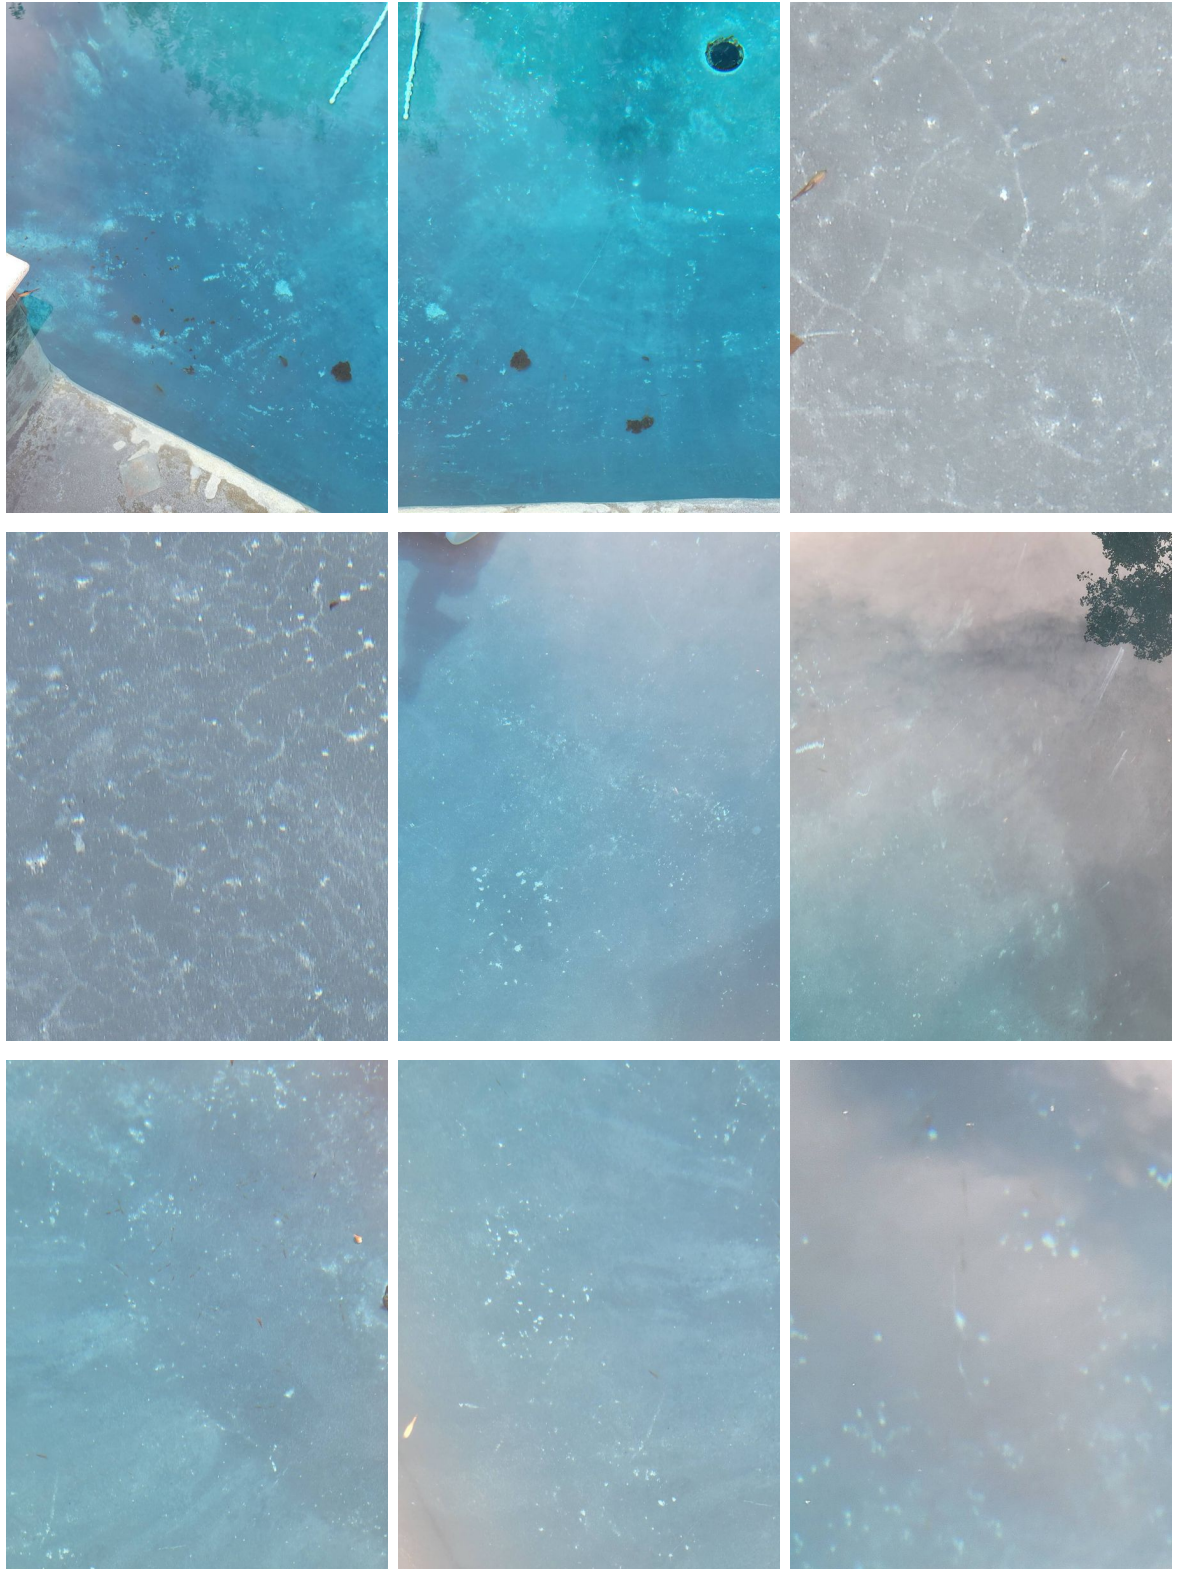
7: Pool Guniting Damage

There were areas of damaged and missing guniting at the pool surface.

Recommendation: Contact a qualified Swimming Pool Contractor

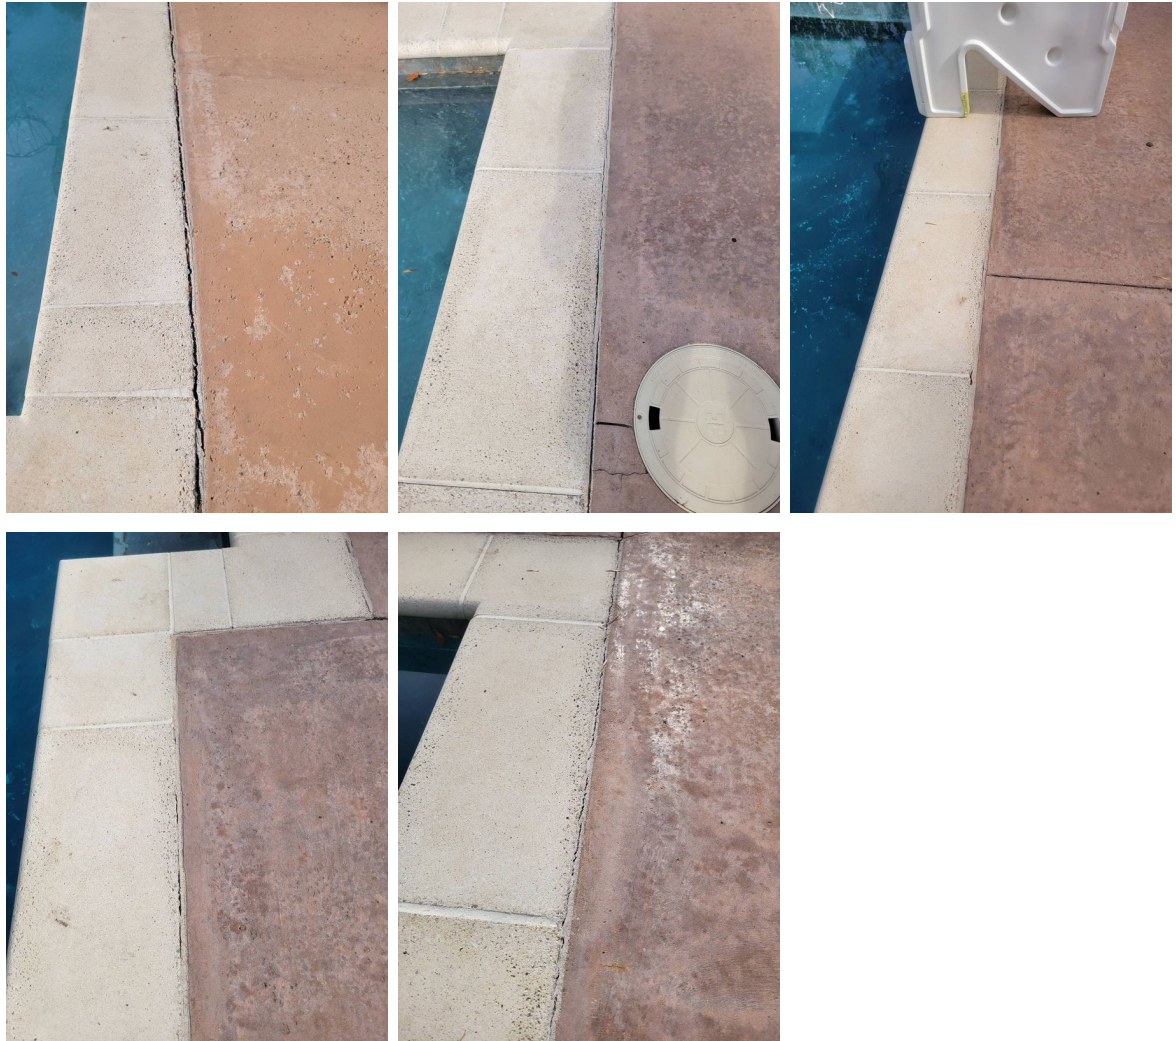
9: Deck-O-Seal Damage

There was Deck-O-Seal damage and separation around the pool.

Recommendation: Contact a stucco repair contractor

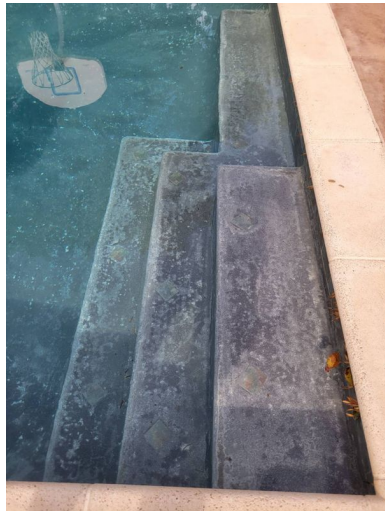
11: Not Clearly Marked - Steps

The steps are not clearly marked.

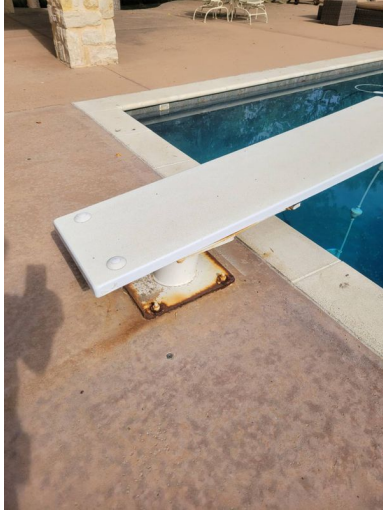
12: Diving Board - Rusted

The base of the diving board is rusting and should be further evaluated for safety.

Recommendation: Contact a qualified Swimming Pool Contractor

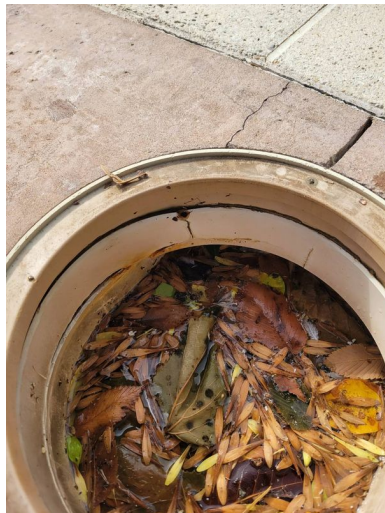
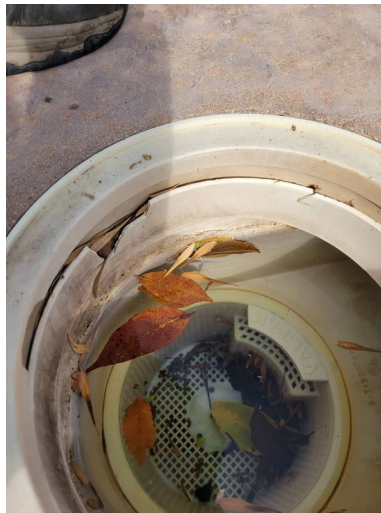
The skimmer housing is damaged.

Recommendation: Contact a qualified Swimming Pool Contractor

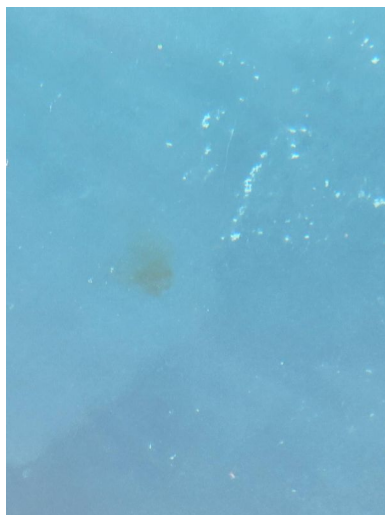
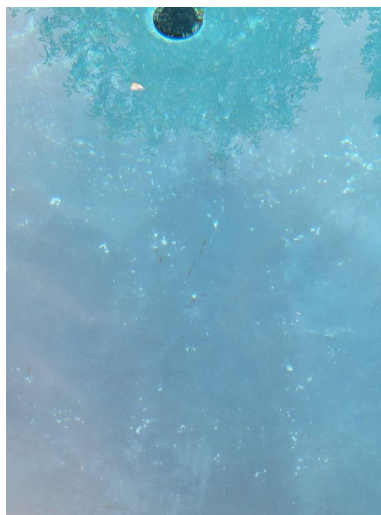
16: Surface Staining

Staining and/or discoloration at the pool surface was observed at the time of inspection.

Recommendation: Contact a qualified professional.

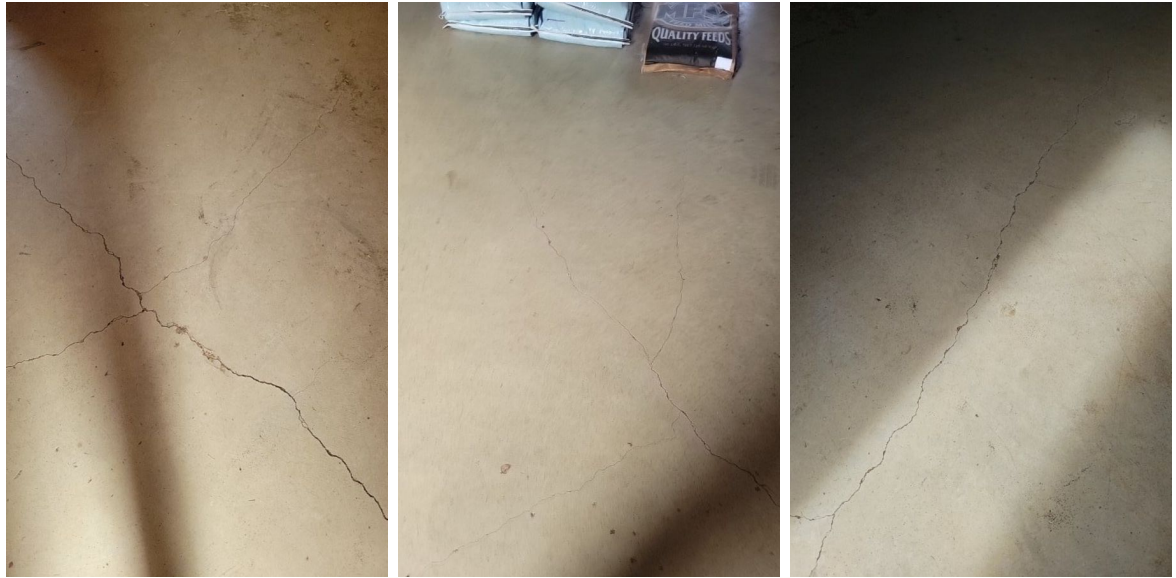
2: Floor Cracks

There were cracks in the floor.

Recommendation: Contact a qualified professional.

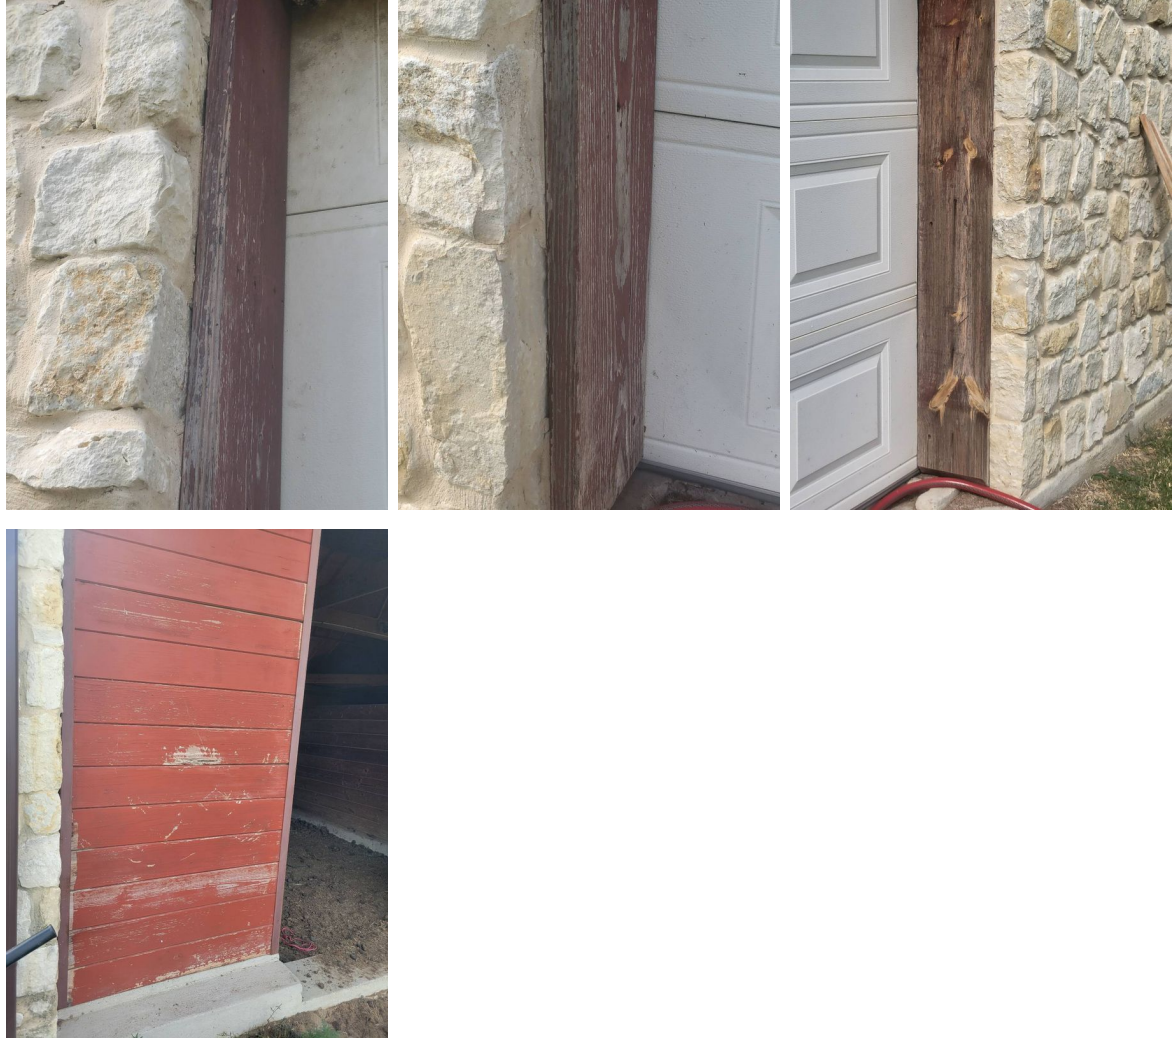
3: Rot/Exposed Wood - Discoloration

There were various areas of damage to the siding and trim. Rot, chipped, and missing paint were noted at time of inspection. Areas of discoloration. Repair/Replacement is recommended.

Recommendation: Contact a qualified professional.

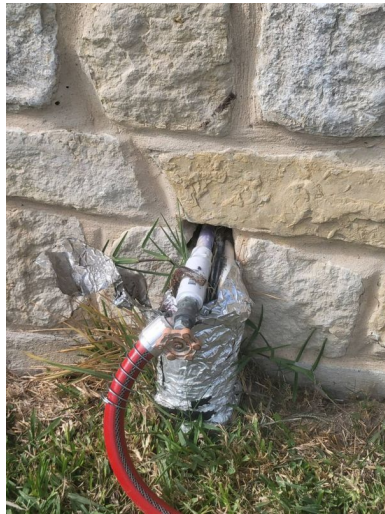
5: Lack of Sealed Penetrations

Lack of sealed penetrations were noted at the exterior wall. All penetrations should be sealed to prevent water from entering the structure.

Recommendation: Contact a qualified professional.

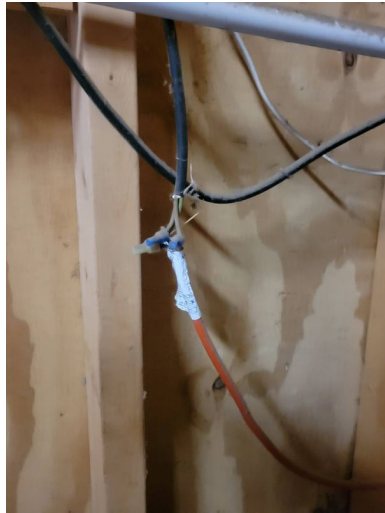
6: Splice

Open wire splices observed. Repair is recommended.

Recommendation: Contact a qualified professional.

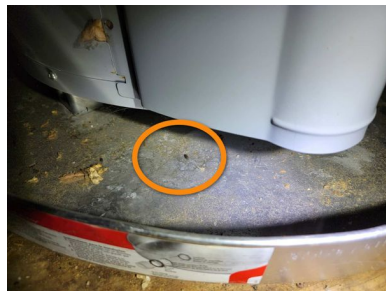
There was evidence of rodent activity present at the home. Pest control service is recommended.

Recommendation: Contact a qualified pest control specialist.

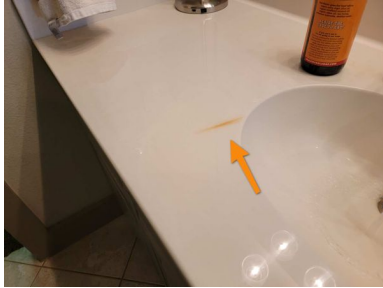
Some counter tops were damaged.

Recommendation: Contact a qualified professional.

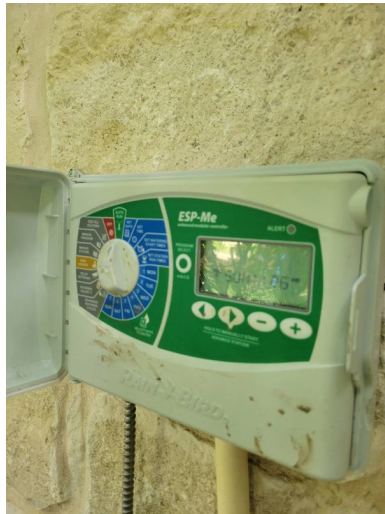
Sprinkler System Departure Setting: Auto
