GREENWORKS SERVICE COMPANY

GW STANDARD HOME INSPECTION

PROPERTY INSPECTION REPORT FORM

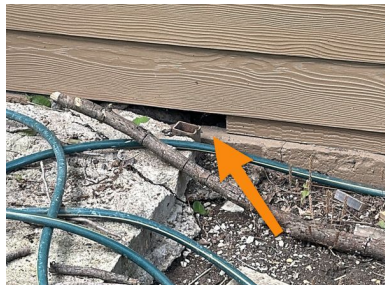
Back

There is a deep hole into the foundation wall. Repair is recommended.

Recommendation: Contact a qualified concrete contractor.

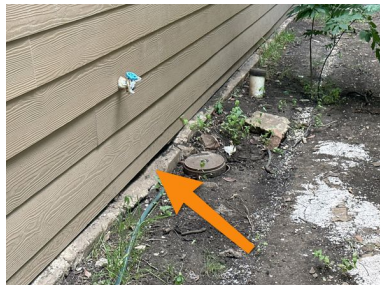
Left

2: Efflorescence

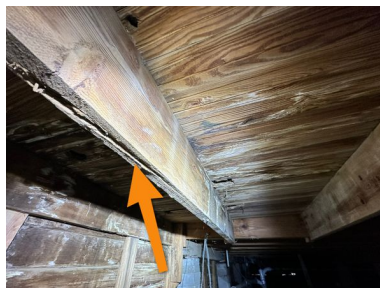
4: Subfloor - Previous water loss

🔧Handyman/Maintenance Item

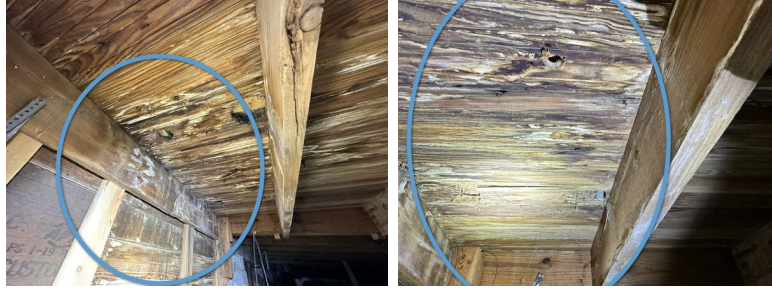
5: Subfloor - Rot Damage

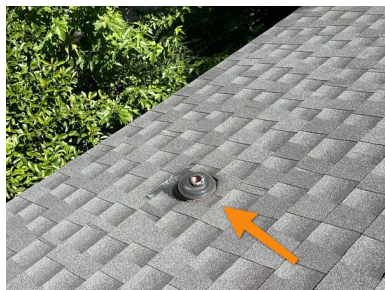
6: Metal Vent/Chimney Paint Peeling

The metal vent or chimney has missing or damaged paint. These should be painted for weather protection.

Recommendation: Contact a qualified roofing professional.

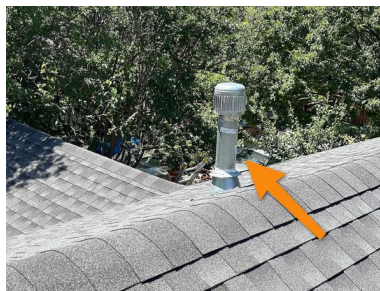
7: Plumbing Vent Paint

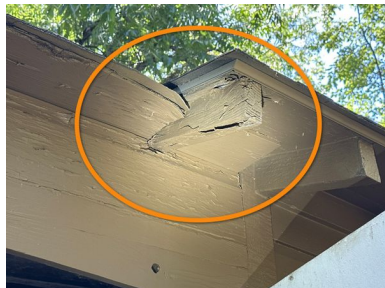
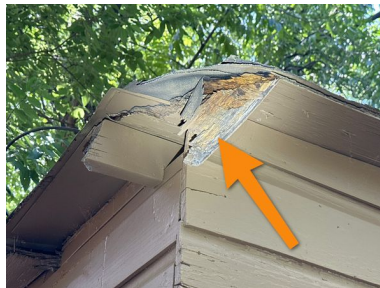
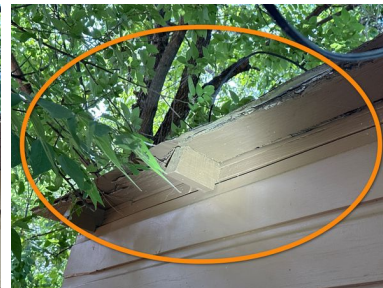
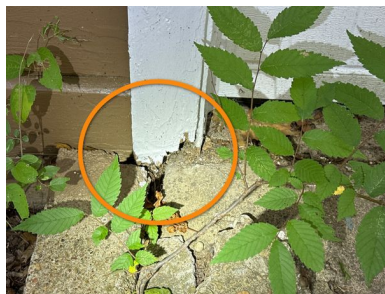
3: Damaged Siding/Trim

There were areas of cracked and damaged siding and trim materials. Repair or replacement is recommended.

Recommendation: Contact a qualified siding specialist.

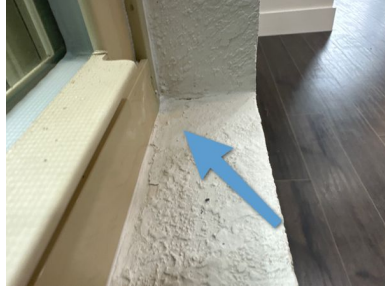
Living Room

4: Trim Separation/Gapping

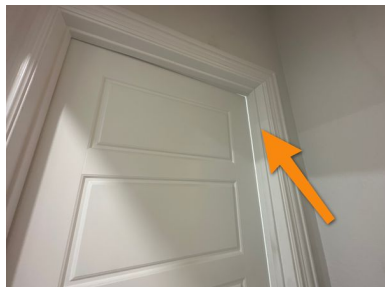
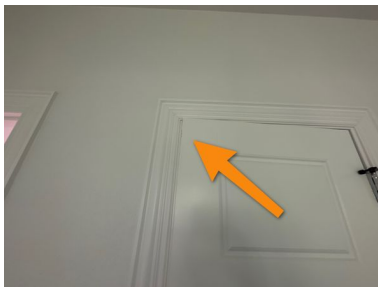
The door binds at the jamb. Adjustments may be needed for proper operation.

Recommendation: Contact a qualified door repair/installation contractor.

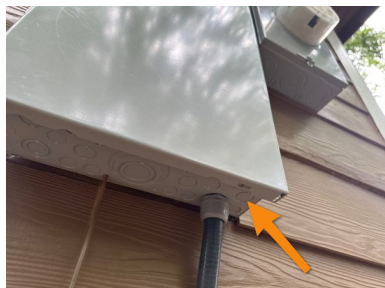
2: Test Breaker Not Tripping

The test breaker did not trip when tested. Repair or replacement is recommended.

Recommendation: Contact a qualified professional.

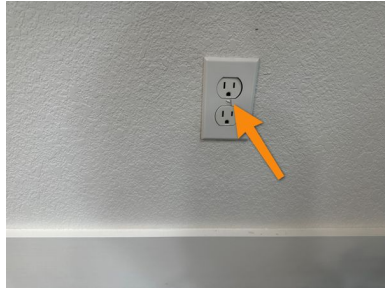
Living Room

2: Cover Plates Damaged

One or more receptacles or switches have a damaged cover plate. Recommend replacement.

Recommendation: Contact a qualified electrical contractor.

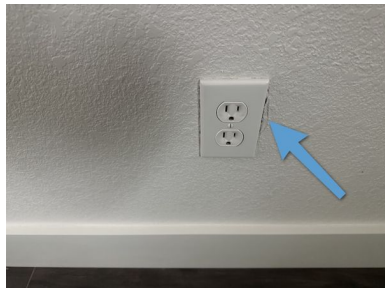
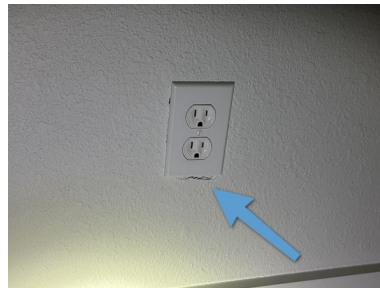
Back Right Bedroom

There were gaps around various outlet covers and switch plates.

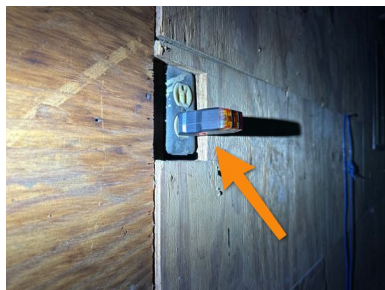
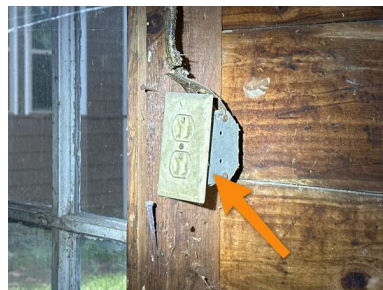
Garage

5: Outlet Not Responding

Outlet did not respond to testing. Repair or replacement is recommended.

Recommendation: Contact a qualified electrical contractor.

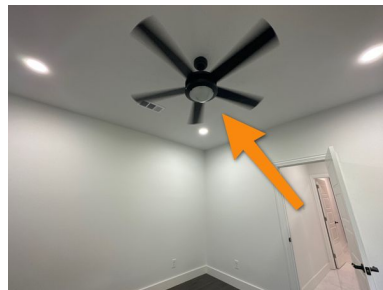
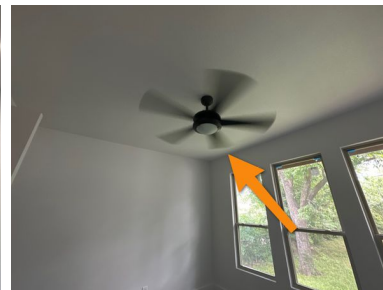
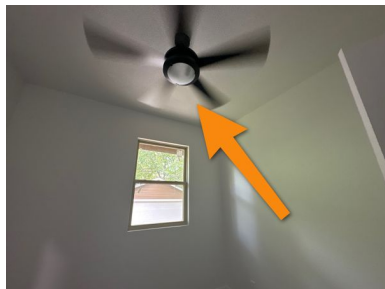
6: Lights Not Responding

Recommendation: Contact a qualified electrical contractor.

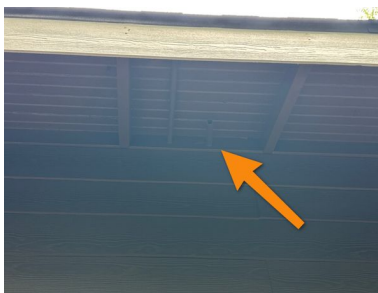
Right

3: Secondary Drain Improper

The secondary drain line was not properly terminating at the soffit. The secondary drain line should be installed in a conspicuous location so if a backup is present, it can be rectified before damage occurs. Repair is recommended.

Recommendation: Contact a qualified heating and cooling contractor

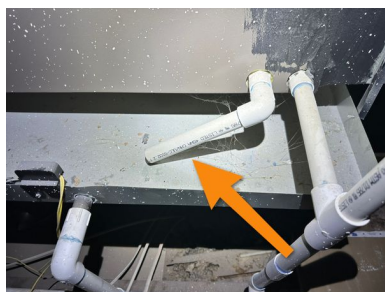
4: Secondary Drain Line Not to Exterior

The secondary drain line did not fully terminate to the exterior of the home. If water is present in the secondary drain pan, this water would drain into the home instead of to the exterior. Repair is recommended.

Recommendation: Contact a qualified HVAC professional.

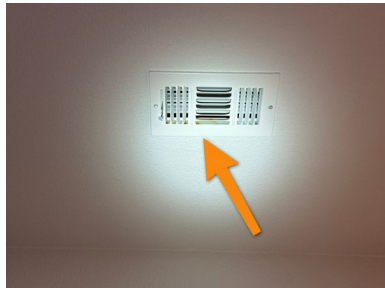
Shared Bathroom

1: Register Grill - Rusted

There is rust at one or more register grills within the home.

Recommendation: Contact a qualified HVAC professional.

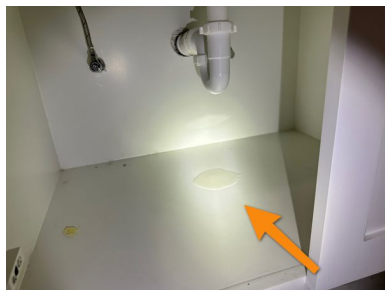
Master/Primary

2: Leaking Fixture

Recommendation: Contact a qualified plumbing contractor.

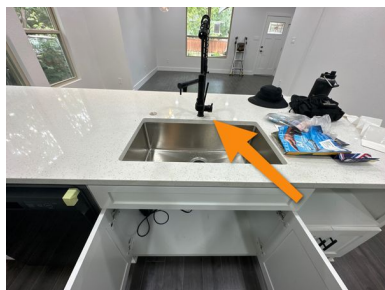
Kitchen

3: Fixture Did Not Respond

The fixture did not respond to testing. Recommend a qualified plumbing professional evaluate and repair.

Recommendation: Contact a qualified plumbing contractor.

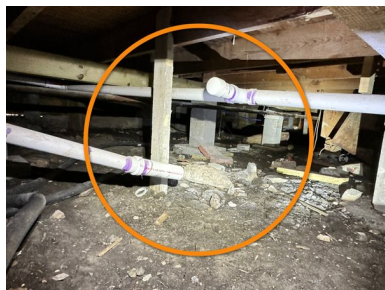
The drainage piping was disconnected and capped off. Further evaluation recommended.

Recommendation: Contact a qualified plumbing contractor.

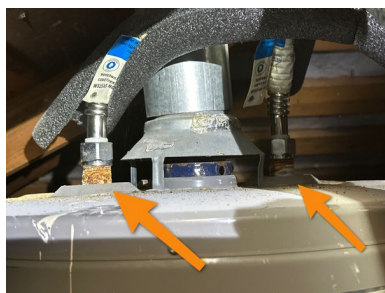
There is corrosion on the valves and fittings at the water heater. Corrosion is prone to water leaking and corroded areas should be replaced as needed.

Recommendation: Contact a qualified plumbing contractor.

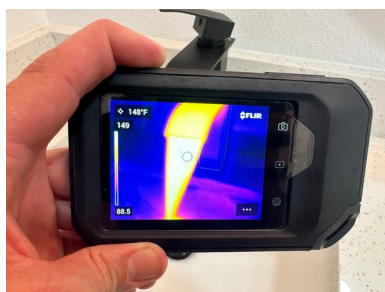
3: Excessive Water Temperature

Excessive water temperatures were observed at the time of inspection. Temperature settings should be adjusted to prevent risk of scalding and burning.

Recommendation: Contact a qualified professional.

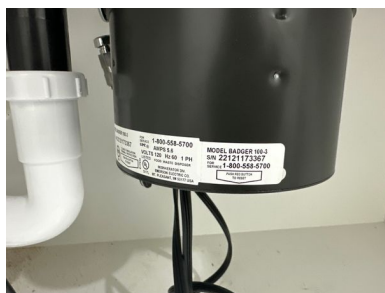
Unit Not Fully Installed:

Unit was not fully installed at the time of inspection. Unable to test.

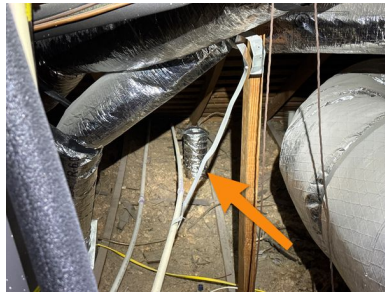
The visible bath/laundry exhaust vent flues terminate to the attic ventilation. Exhaust to the attic ventilation can cause moisture from the vents to be pulled back into the attic. Exhaust vent flues should terminate directly to the exterior.

Recommendation: Contact a qualified professional.

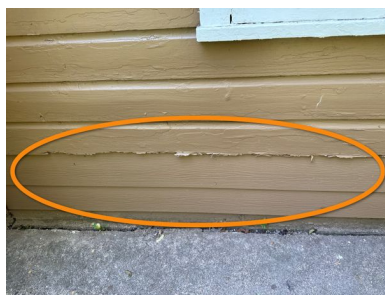
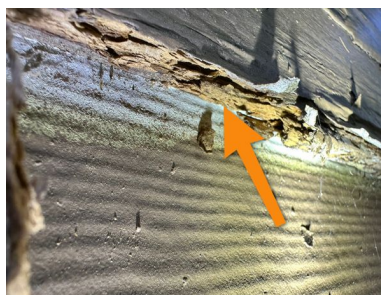
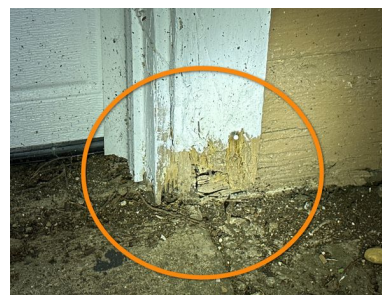
Garage

There were areas of wood destroying insect activity at the home. It is recommended that a treatment be performed.

Recommendation: Contact a qualified pest control specialist.

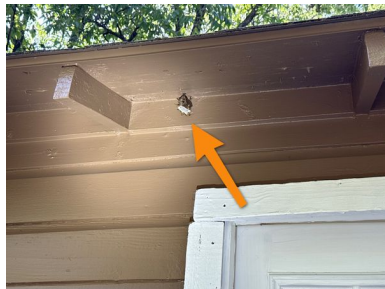
Garage

There were wasps and wasp nests observed at the property. General pest control is recommended.

Recommendation: Contact a qualified pest control specialist.

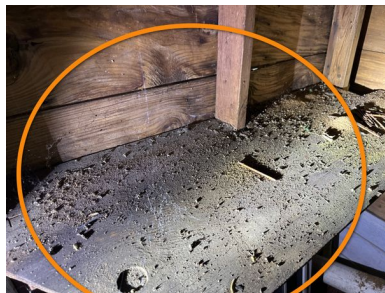
Shed

3: Rodent Activity At The Home

There was evidence of rodent activity present at the home. Pest control service is recommended.

Recommendation: Contact a qualified pest control specialist.

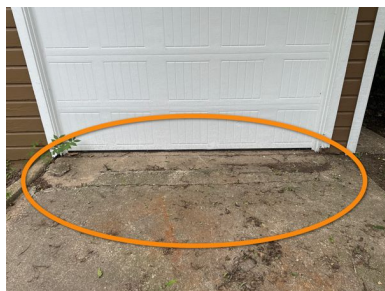
4: Driveway Uplift

Severe cracking, damage, or uplift was noted at the driveway. Recommend a qualified professional evaluate and repair.

Recommendation: Contact a qualified concrete contractor.

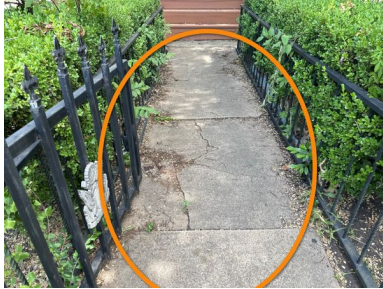
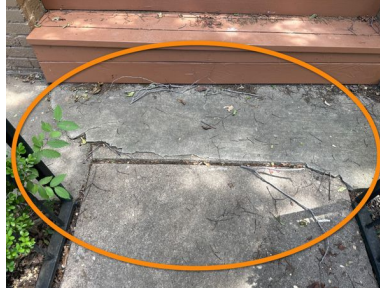
5: Sidewalk Cracks

Cracking, damage, or uplift was noted at the sidewalk. Recommend a qualified professional evaluate and repair.

Recommendation: Contact a qualified professional.
