GREENWORKS SERVICE COMPANY

GW STANDARD HOME INSPECTION

PROPERTY INSPECTION REPORT FORM

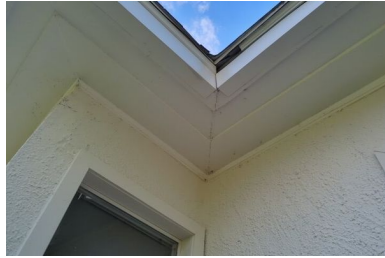
4: Trim/Siding Gaps

There were gaps at the exterior surfaces. These areas can allow water penetration into the structure. It is recommended these areas be sealed.

Recommendation: Contact a qualified professional.

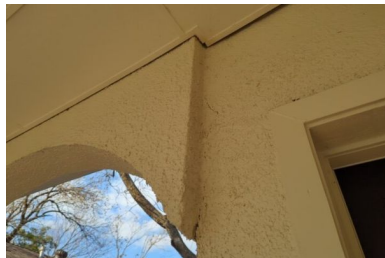
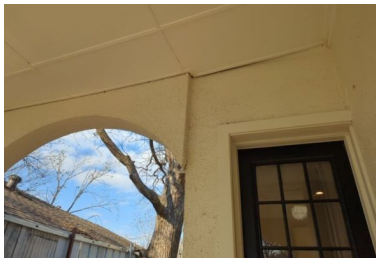
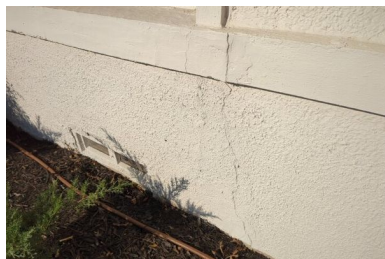
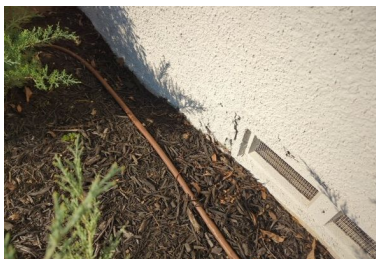
5: Veneer damage

Various areas of cracking and damage noted to the exterior veneer materials. Repair is recommended.

Recommendation: Contact a qualified professional.

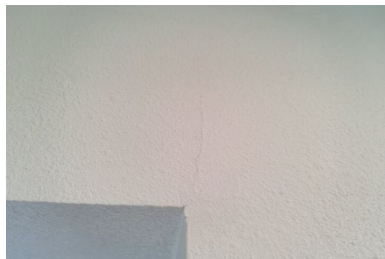
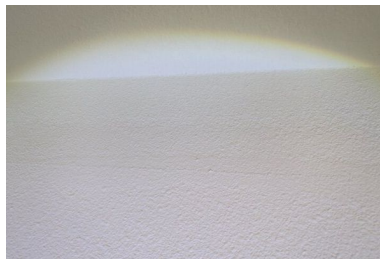
Kitchen

There are joint separations in various areas.

Recommendation: Contact a qualified drywall contractor.

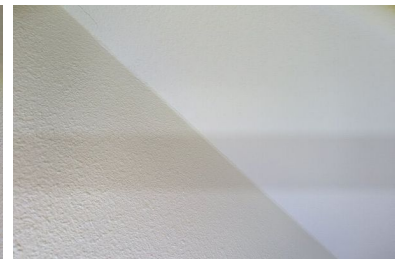
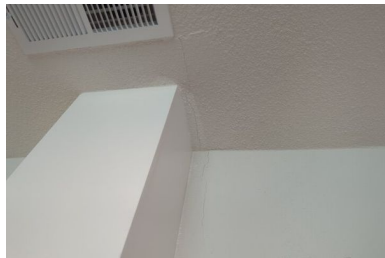
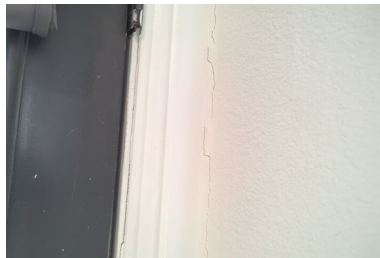
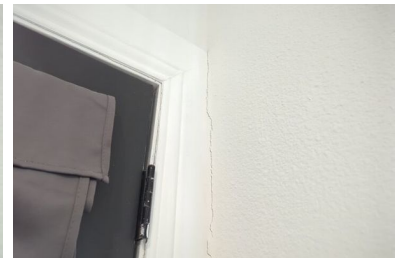
4: Tape Pulls - Ceiling/Wall

There were tape pulls and cracks at ceiling/wall connection points.

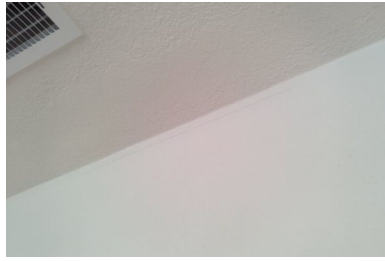
Living Room

5: Wall Damage

There was damage to the walls within the home. Repair is recommended.

Recommendation: Contact a qualified general contractor.

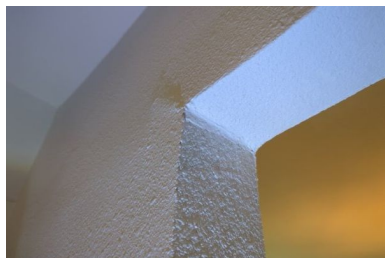
8: Trim Separation/Gapping

Trim separation was observed at areas of the interior trim materials.

Recommendation: Contact a qualified professional.

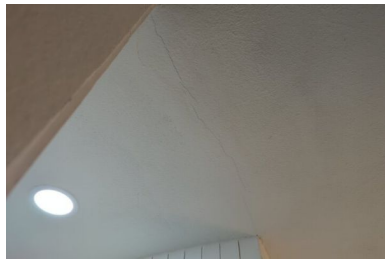
Guest bath

1: Ceiling Cracks

Cracks in the ceilings were observed at the time of inspection.

Recommendation: Contact a qualified professional.

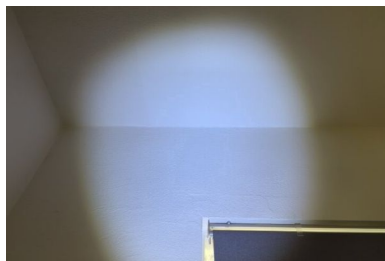
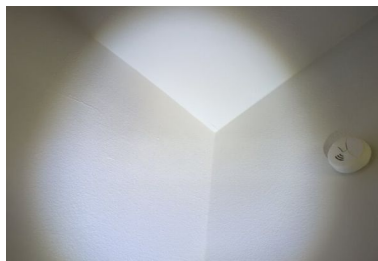
Bedroom 1

2: Joint Separation

There is joint separation in various areas.

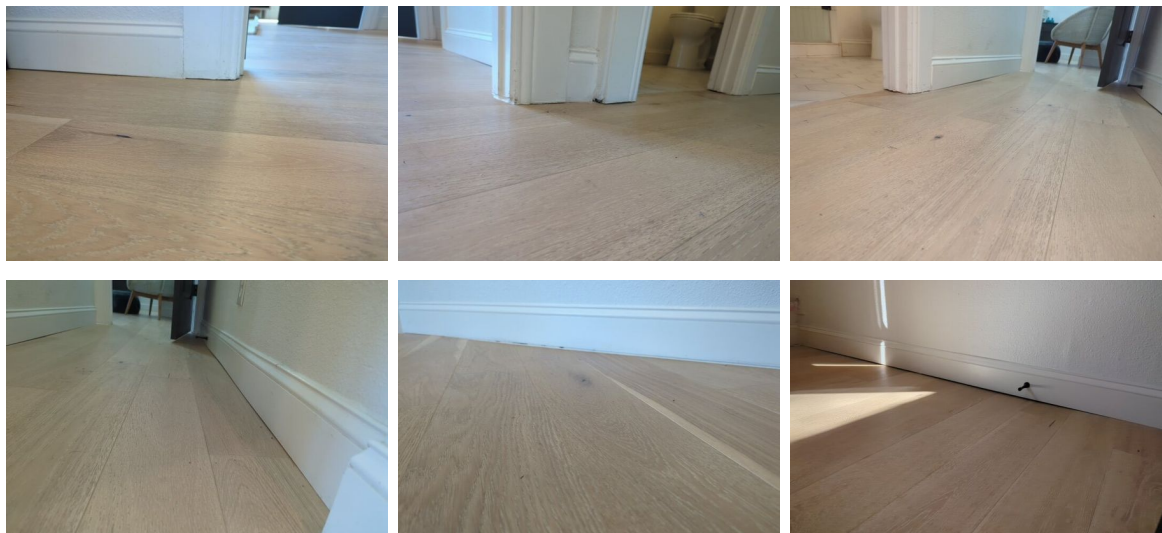
2: Creaking Floors

Creaky floors were noted in various areas.

Recommendation: Contact a qualified flooring contractor

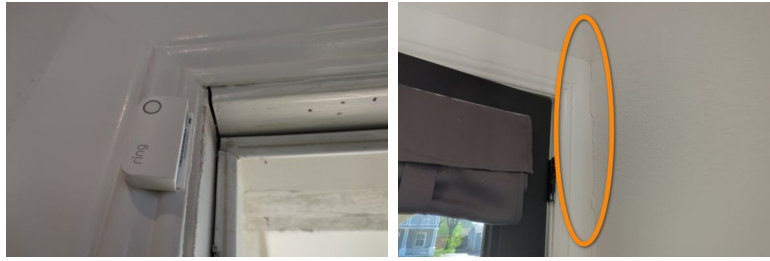
Bedroom 2

Observed door frame separation at the home.

Recommendation: Contact a qualified professional.

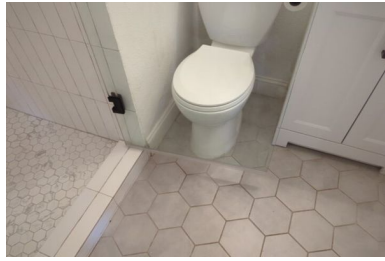
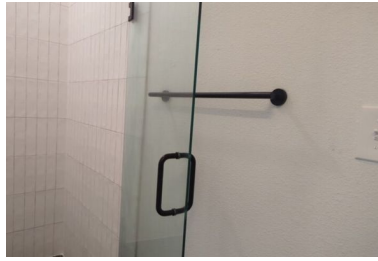
Master

The shower door collides with another surface in the bathroom. Risk for damage is high and adjustment or stopper installation is recommended.

Recommendation: Contact a handyman or DIY project

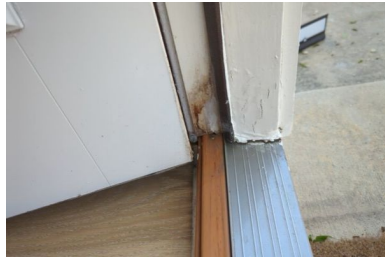
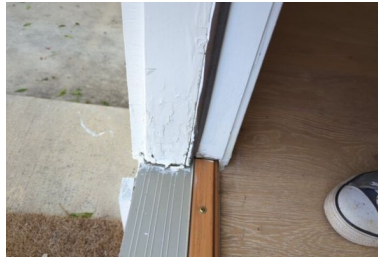
Patio

5: Door Frame Damage

The door frame is damaged. Repair is recommended.

Recommendation: Contact a qualified door repair/installation contractor.

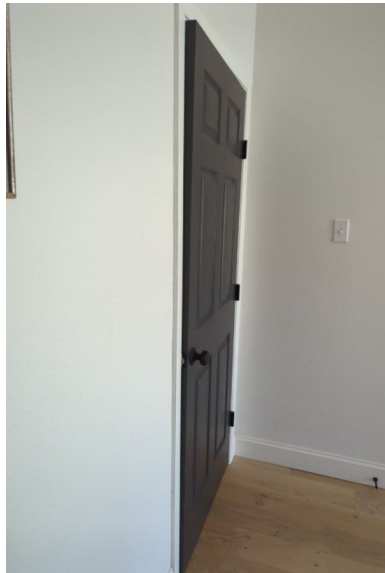
Master

6: Door out of plumb

Recommendation: Contact a qualified professional.

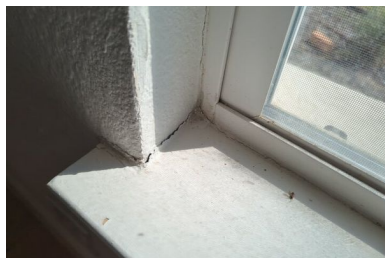
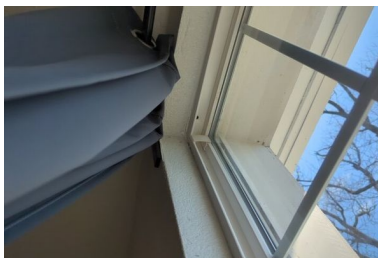
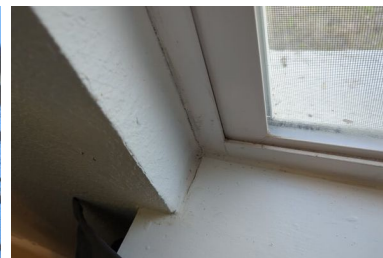
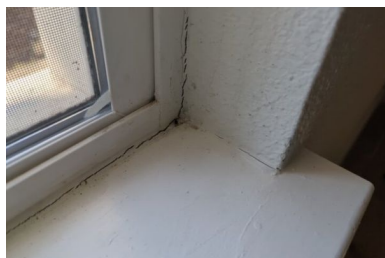
The interior caulk is missing, cracked, or separated around the windows in the home.

Recommendation: Contact a handyman or DIY project

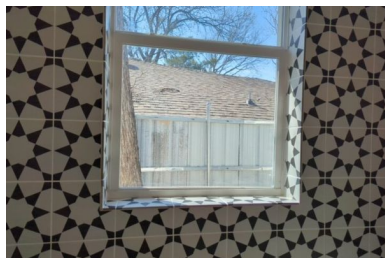
Bathroom

2: Missing Screens

Window screens were not installed at some windows at the time of inspection. It is recommended that screens be installed to prevent insects from coming in if windows are left open.

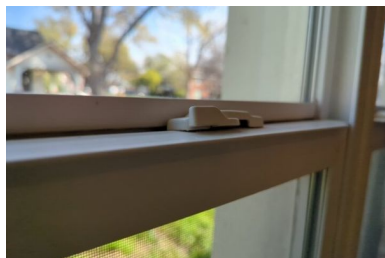
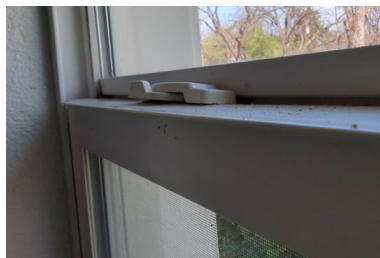
Dining Room

5: Hardware Loose

Hardware was loose at some windows in the home. This makes it difficult to operate the window in case of emergency.

Recommendation: Contact a qualified professional.

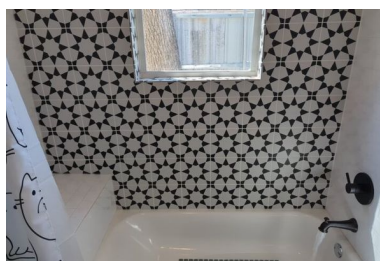
6: Safety Glass - Tub

Safety glass should be present within 5 feet of the tub edge. Markings were not found.

Recommendation: Contact a qualified professional.

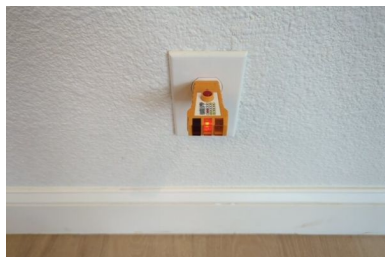
Dining Room

Hand held tester showed open ground readings at one or more outlets. This can be a risk of shock to people or damage to equipment, notably electronics and appliances, that are plugged into the outlet. Repair is recommended.

Recommendation: Contact a qualified electrical contractor.

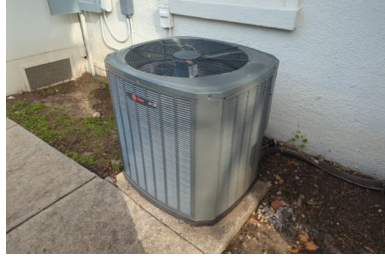
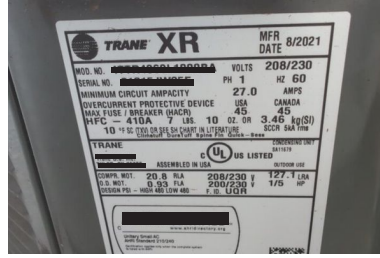
Insulation is damaged and separating on the large Freon suction line from the air conditioning compressor.

Recommendation: Contact a qualified heating and cooling contractor

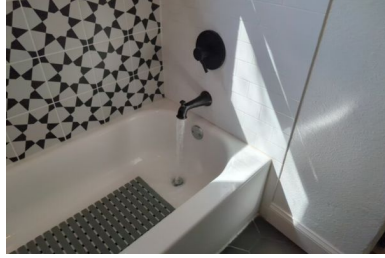
4: Loose Fixtures

The fixture is loose. Tightening is recommended to prevent leaking.

Recommendation: Contact a qualified plumbing contractor.

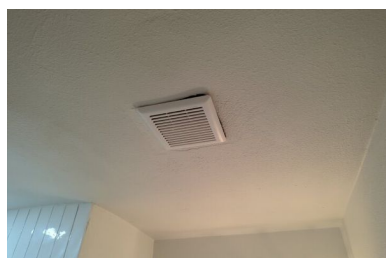
Exhaust fan cover was loose at the time of inspection.

Recommendation: Contact a qualified professional.

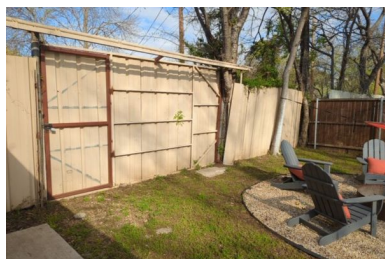
The fence around the home was observed to be leaning. Recommend a qualified fence contractor evaluate and repair.

Recommendation: Contact a qualified fencing contractor
