STRUCTURAL 360 INSPECTION

FEBRUARY 17, 2024

Project Information: Purpose - Structural 360

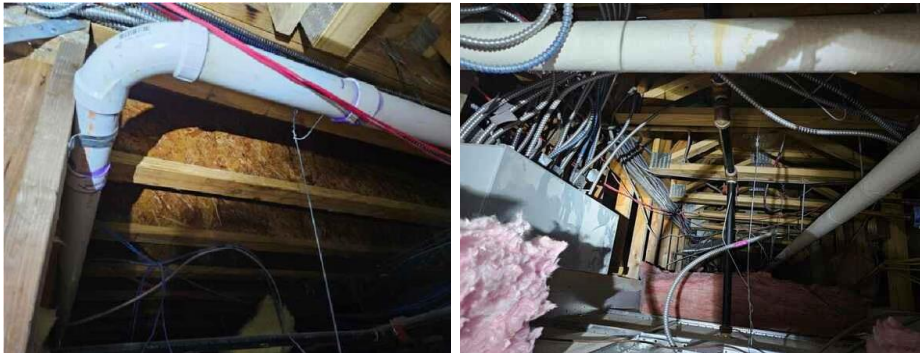
General Information: Typical 2nd Level Floor Joists
TJI Joists @ original construction, 16" oor trusses at additions

General Information: Typical Addition Floor Joist Span
18 feet

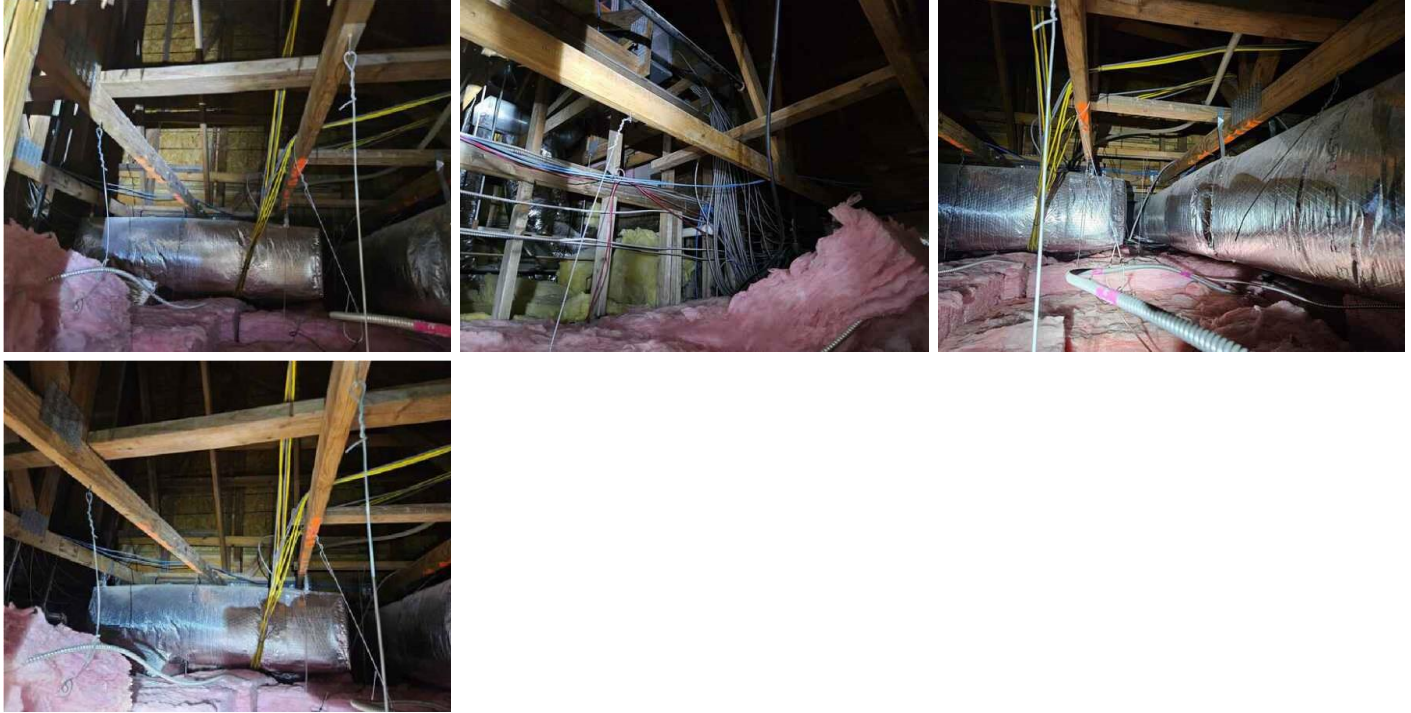
Wood Truss Type #1: Original Roof Truss Photos

Wood Truss Type #1: Truss
Spacing

24 inches
