GREENWORKS SERVICE COMPANY

GW STANDARD HOME INSPECTION

PROPERTY INSPECTION REPORT FORM

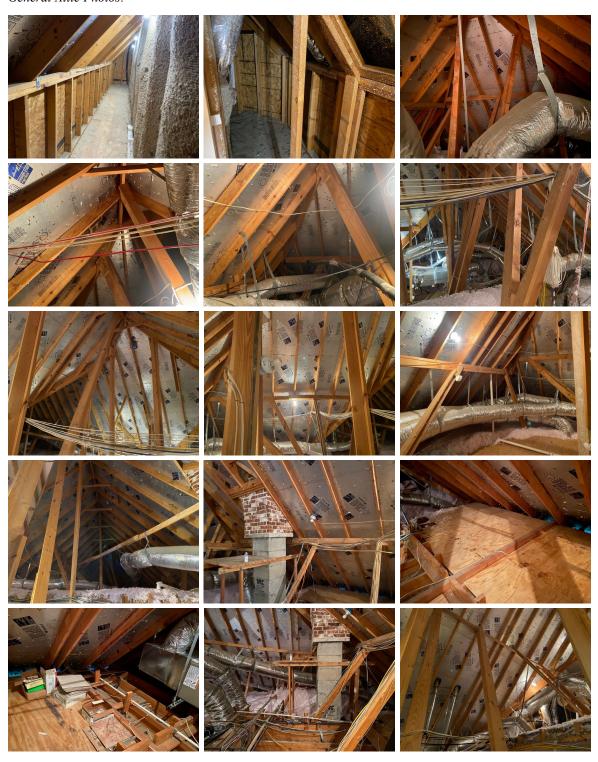
> Comments: General Attic Photos:

Roof Decking Type: Plywood, Radiant Barrier Board

Framing Type: Conventional Ventilation Type: Soffit Attic Entry Point: Interior

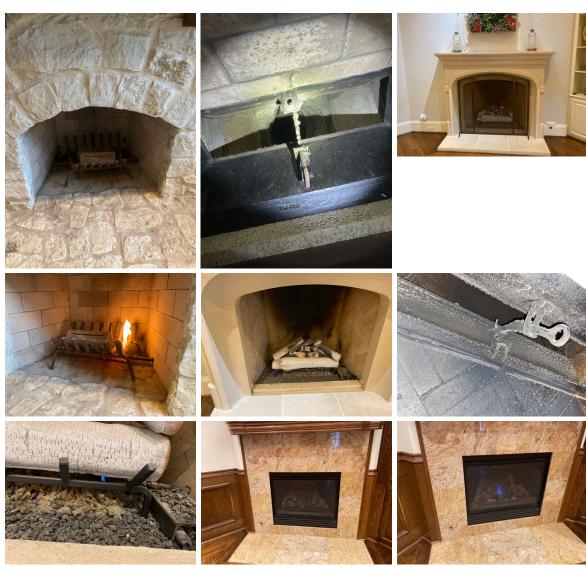
> Comments: General Photos:

Fireplace Fuel Source: Gas Logs, Electric

Cclamp?: No

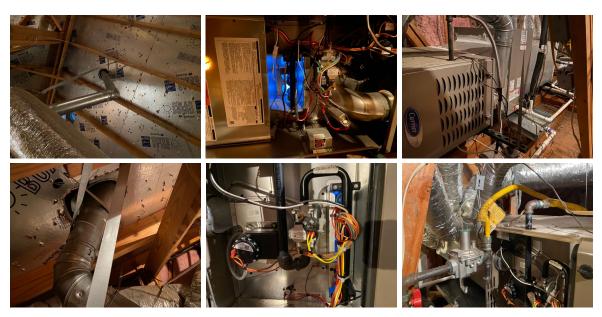
Furnace Location: Attic Furnace Energy Source: Gas

Furnace Type: Forced Air - Gas Fired

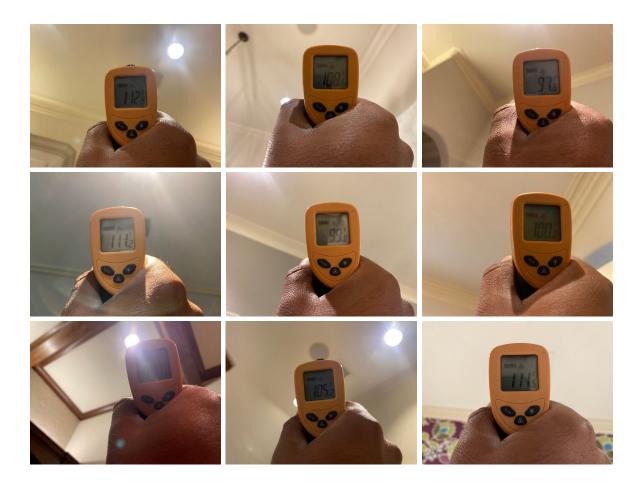
Kitchen	112°
Living Room	97°
Dining Room/ Nook	100°/109°
Master Bedroom	111°
Bedroom 2 DW/FR	100°
Bedroom 3 UP/FR	105°
Bedroom 4 UP/BR	111°

Report Identification		fication	, ,				
I=Inspected				NI=Not Inspected	NP=Not Present	D=Deficient	
I	NI	NP	D				
				Office	111°		
				Family Room	116°		
				Game Room	120°

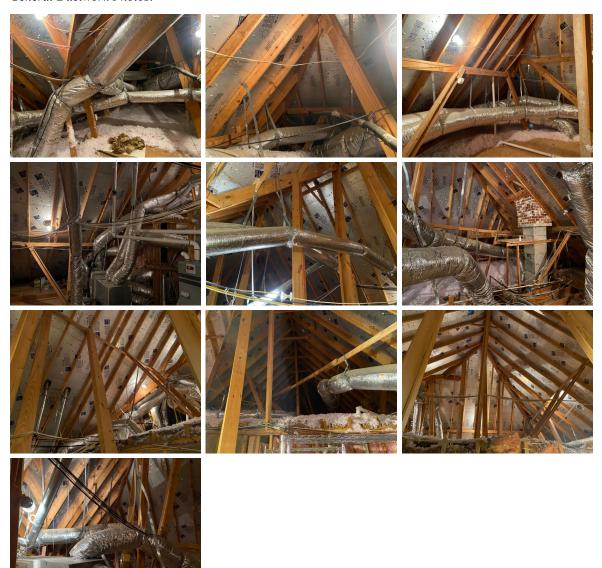
General Ductwork Photos:

Filter Type: Disposable

Filter Location: At Unit(s) in Attic Filter Size: 16X25X4, 20X25X4

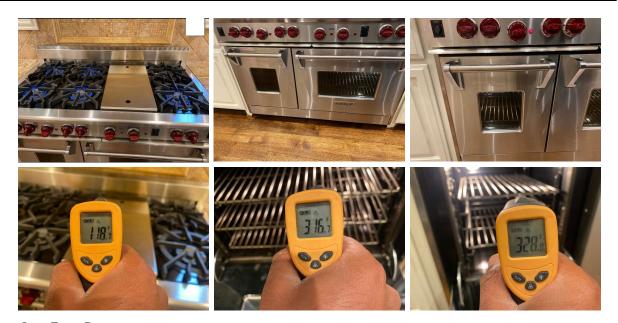
Appliance Information:

Oven Type: Gas Range Type: Gas Gas Line Access: No

Oven Heating Within 25 Degrees of 350: Yes

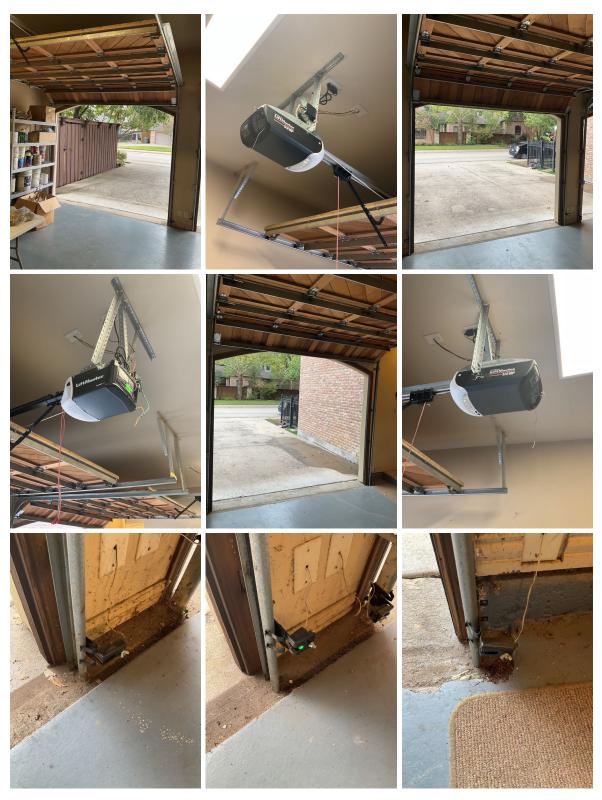
Door Operated: Yes - Automatic door controls Sensors 6 Inches Or Less From Garage Floor: Yes

Unit Operational: Yes

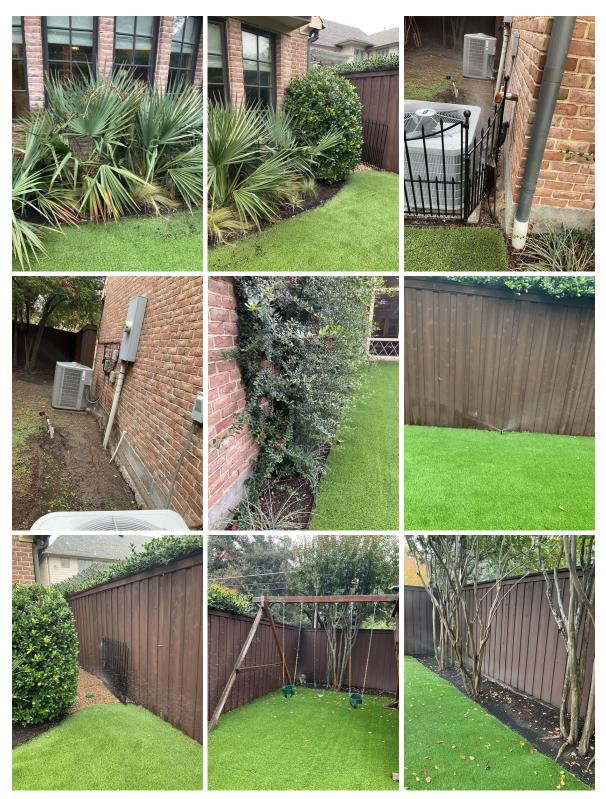
Sprinkler Panel Location: Garage Full Yard Coverage: Yes

Sprinkler Heads Responding: Yes

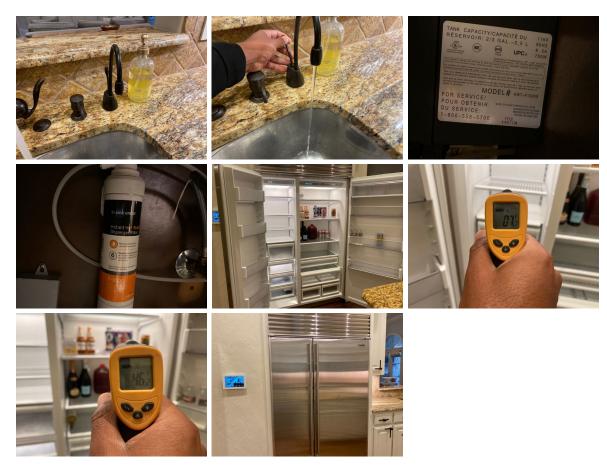
Refrigerator: Refrigerators are tested for function only. Not the ability to cool for extended periods of time.
