Foundation Engineering Letter  
[REDACTED]

GreenWorks Engineering has completed an abbreviated review of the foundation at the address referenced above to determine its condition.

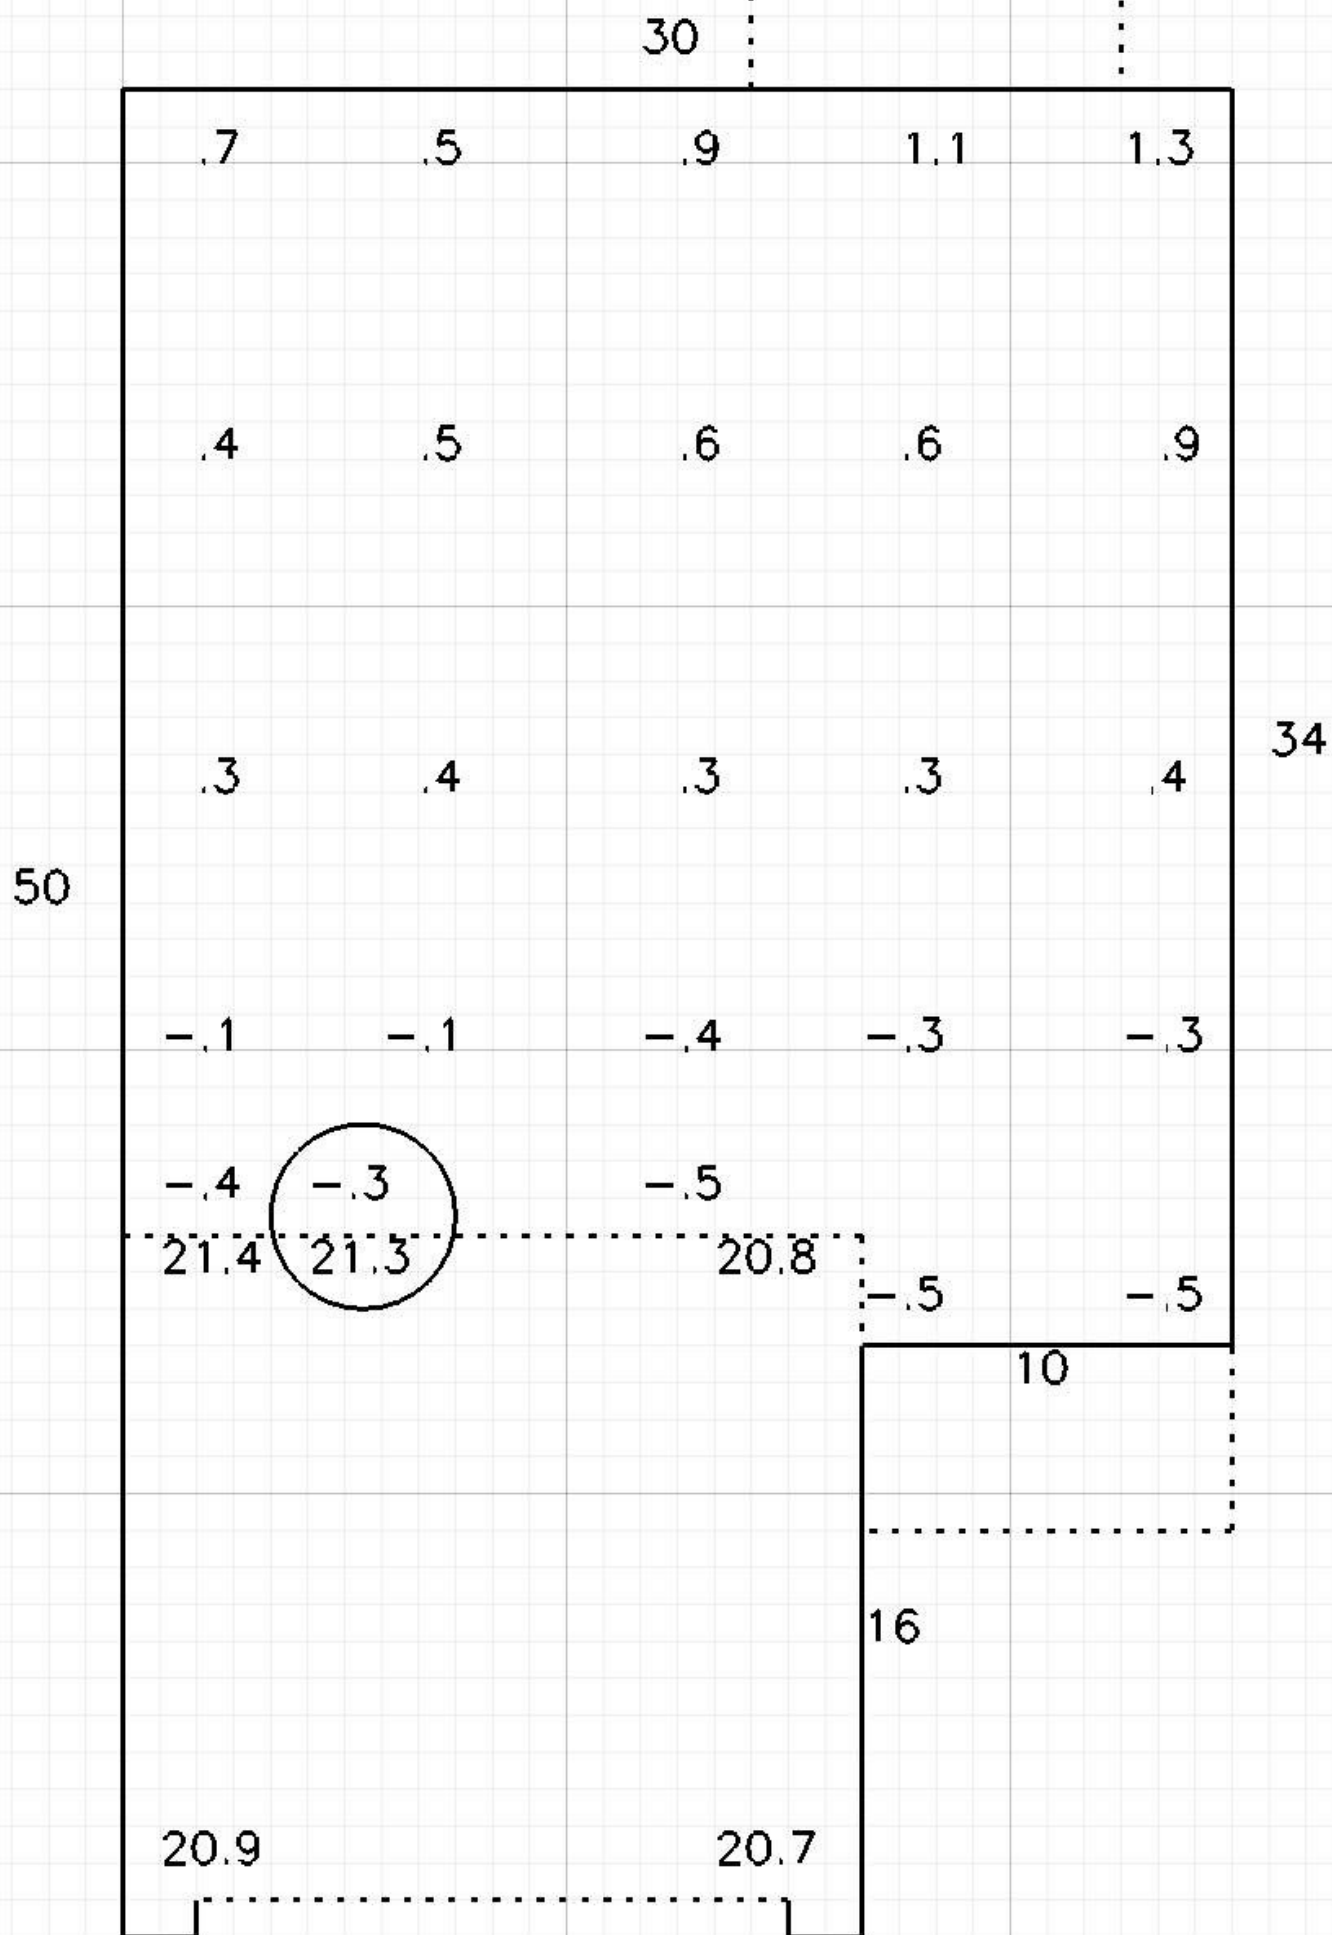
An abbreviated interior floor elevation survey was performed on the living area of the structure, with the elevations recorded to the nearest 10<sup>th</sup> of an inch (0.1"). Adjustments were made to account for the thickness of the floor coverings. The elevations within the garage were recorded

Based on our observations of the interior and exterior cosmetic distress, the floor elevations, and calculations, the foundation appears to be in relatively good condition. The maximum differential deflection is 0.3 inches and occurred over an approximate distance of 22.5 feet. This amount of deflection is within the standard allowable deflection of 0.8 inches for this distance.

The foundation has also experienced a moderate amount of tilt. The maximum tilt is 0.4%. Tilt is the percentage of elevation change divided by the length between those elevations. The maximum elevation change measured across the foundation is 1.8 inches over an approximate distance of 34.0 feet. This amount of tilt is within the standard allowable tilt of 4.1 inches for this distance.
