## Radon Inspection Report

Document Number  
RP22304130018\_19May23\_1019

123 GreenWorks Way  
San Antonio, Texas 78247

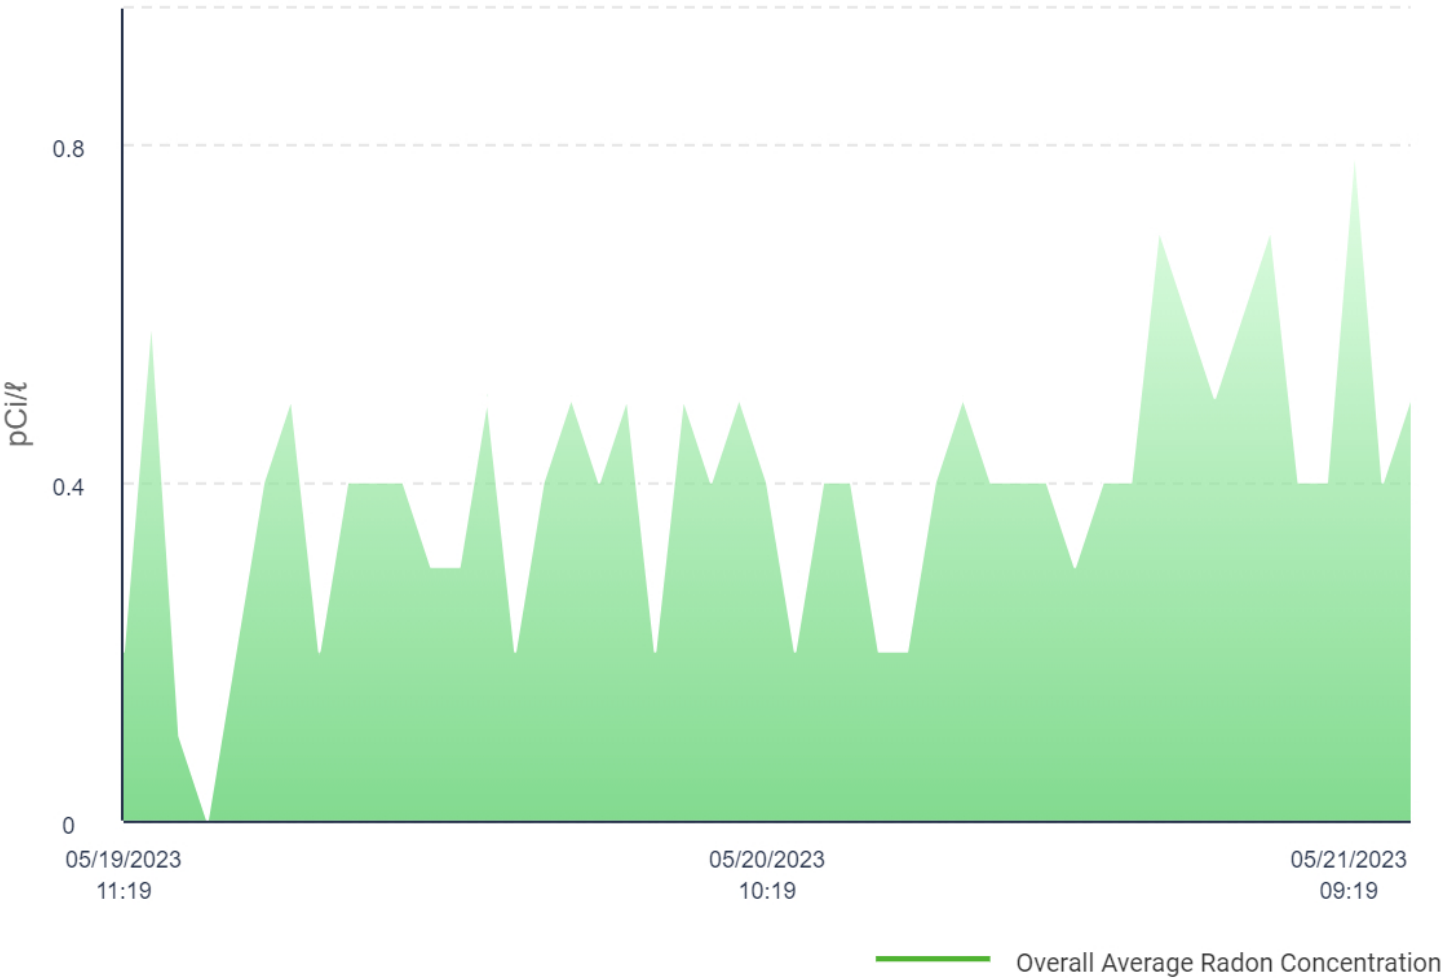
## Historical Radon Trend

Measurement Radon Concentration Max

0.8 pCi/L

Measurement Radon Concentration Min

0.0 pCi/L

Overall Average Radon Concentration

0.4 pCi/L
