GREENWORKS SERVICE COMPANY

GW STANDARD HOME INSPECTION

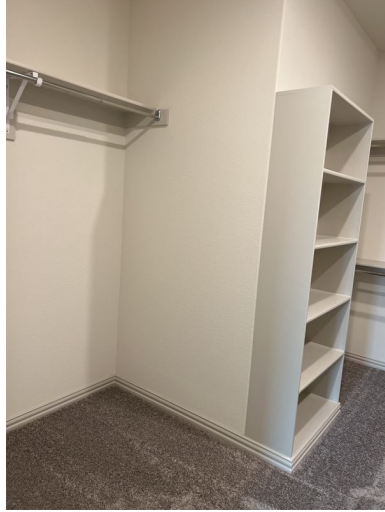
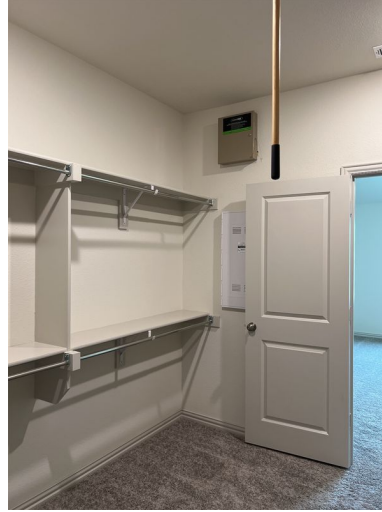
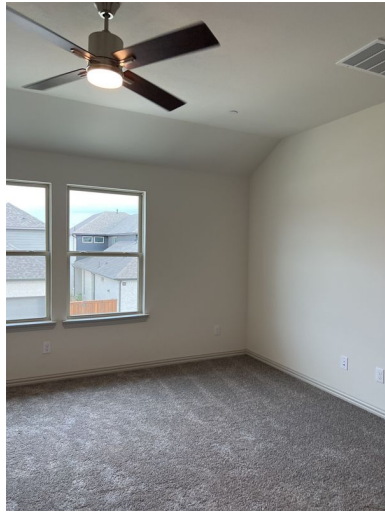
1: Wall Damage

Interior Wall Finishes: Sheet Rock

There was damage to the walls within the home. Repair is recommended.

Recommendation: Contact a qualified general contractor.

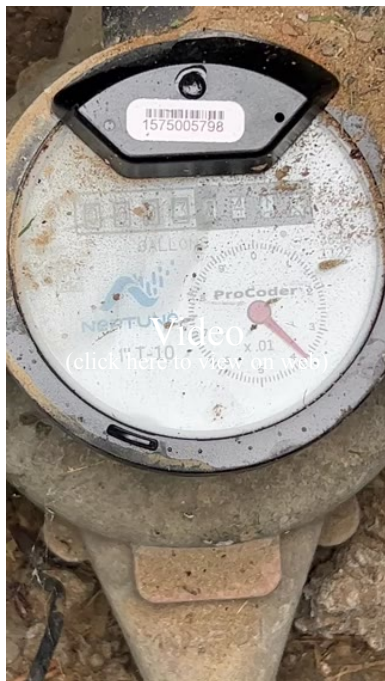
There was NO movement in the water meter dials after a meter test. This indicates no supply line leaks at the time of inspection.

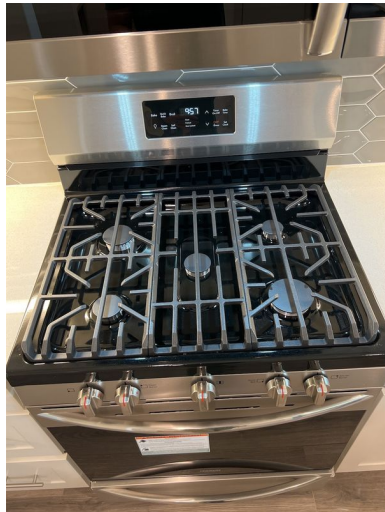
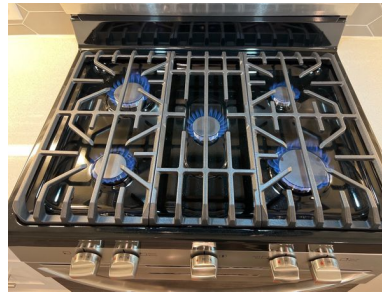
Range Type: Gas

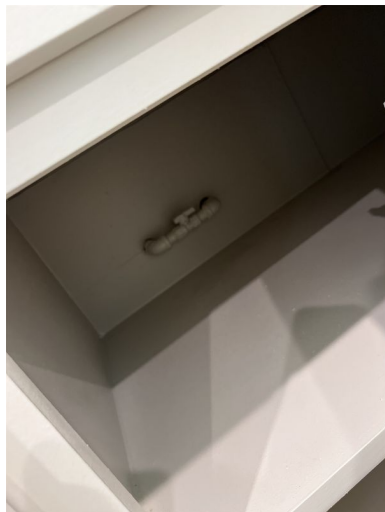
Gas Line Access: Yes
