STRUCTURAL ENGINEERING INSPECTION

APRIL 8, 2024

Project Information: GreenWorks Project Information: Inspection		Project Information: Report Issue
Project Number	Date	Date
106936	04/08/2024	04/16/2024

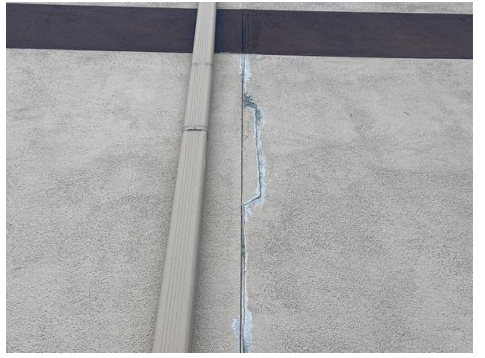
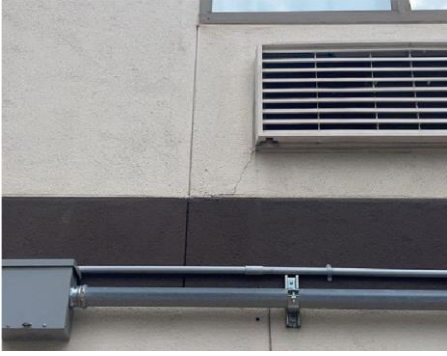
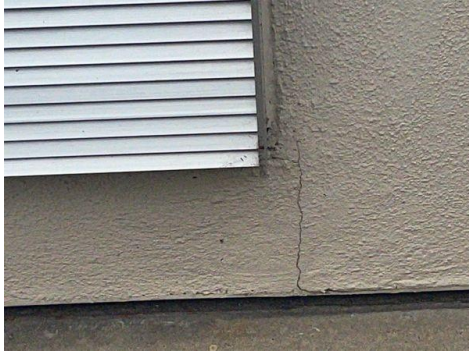
Exterior Distress: Stucco Veneer Cracks

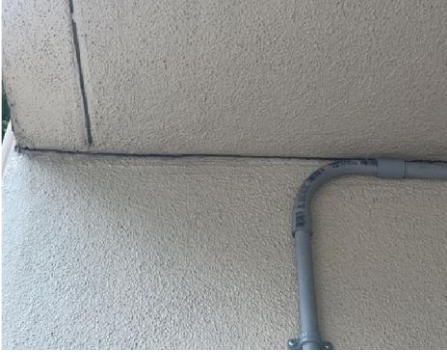
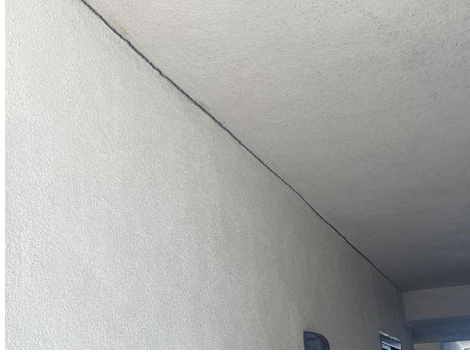
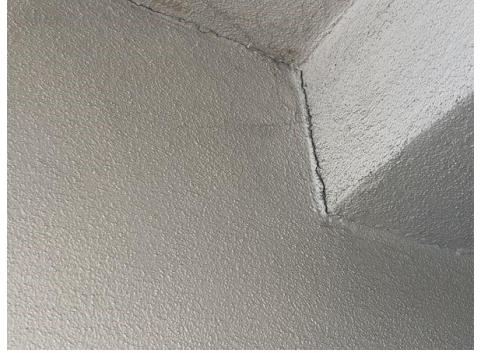
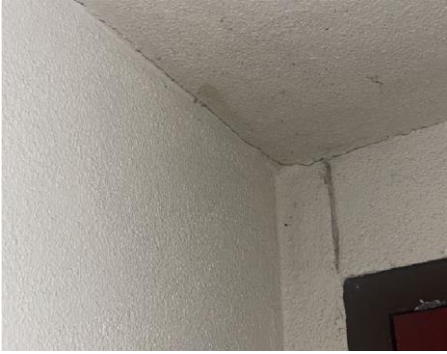
Wall/Ceiling Separation

Exterior Distress:

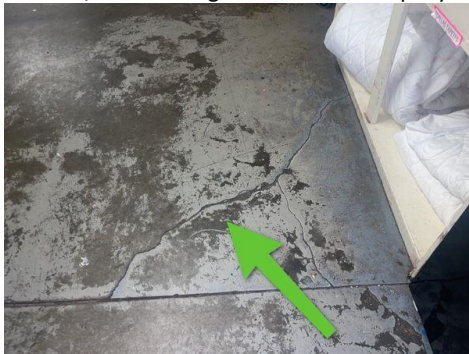
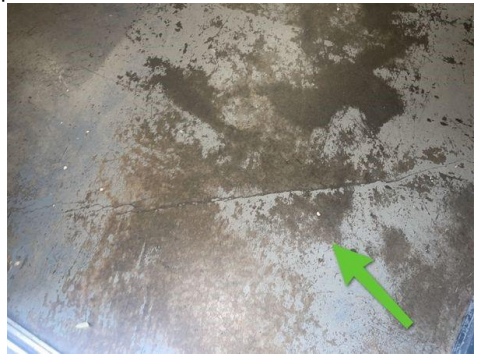
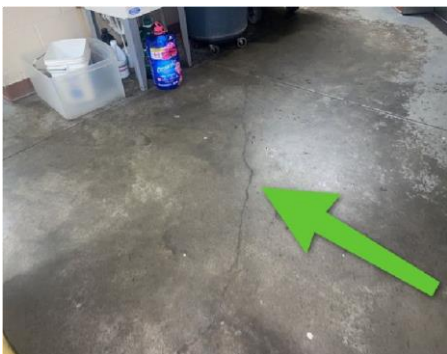
Laundry Room

Floor Distress: Cracking at Top Surface of Slab

We recommend injecting slab cracks of about 1/16" and larger in width with epoxy repair cement to restore strength across the crack.
