GREENWORKS SERVICE COMPANY

FOUNDATION INVESTIGATION

MARCH 22, 2025

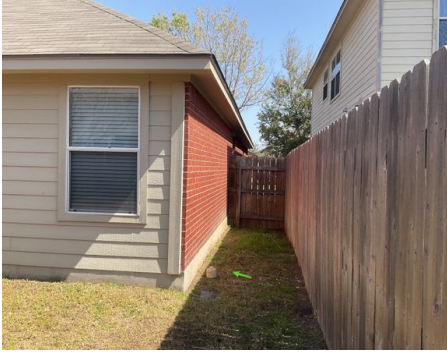
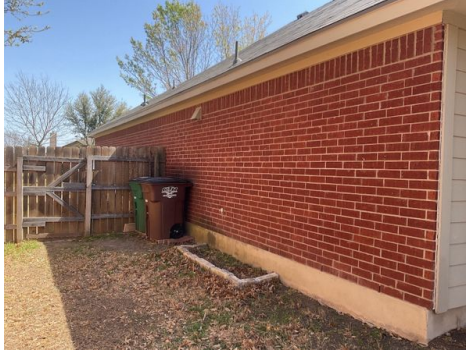
Slope of Grade

Positive, Negative, Flat
